SUBJECT: OPERATING REACTORS EVENTS MEETING
 SEPTEMBER 2, 1992 - MEETING 92-15

OPERATING REACTORS EVENTS BRIEFING 92-15
EVENTS ASSESSMENT BRANCH
LOCATION: 8 B11, WHITE FLINT
WEDNESDAY, SEPTEMBER 2, 1992, 11:00 A.M.

LA SALLE, UNIT 2
SCRAM WITHOUT FEEDWATER TRIP
AND OTHER EQUIPMENT FAILURES
AUGUST 27, 1992

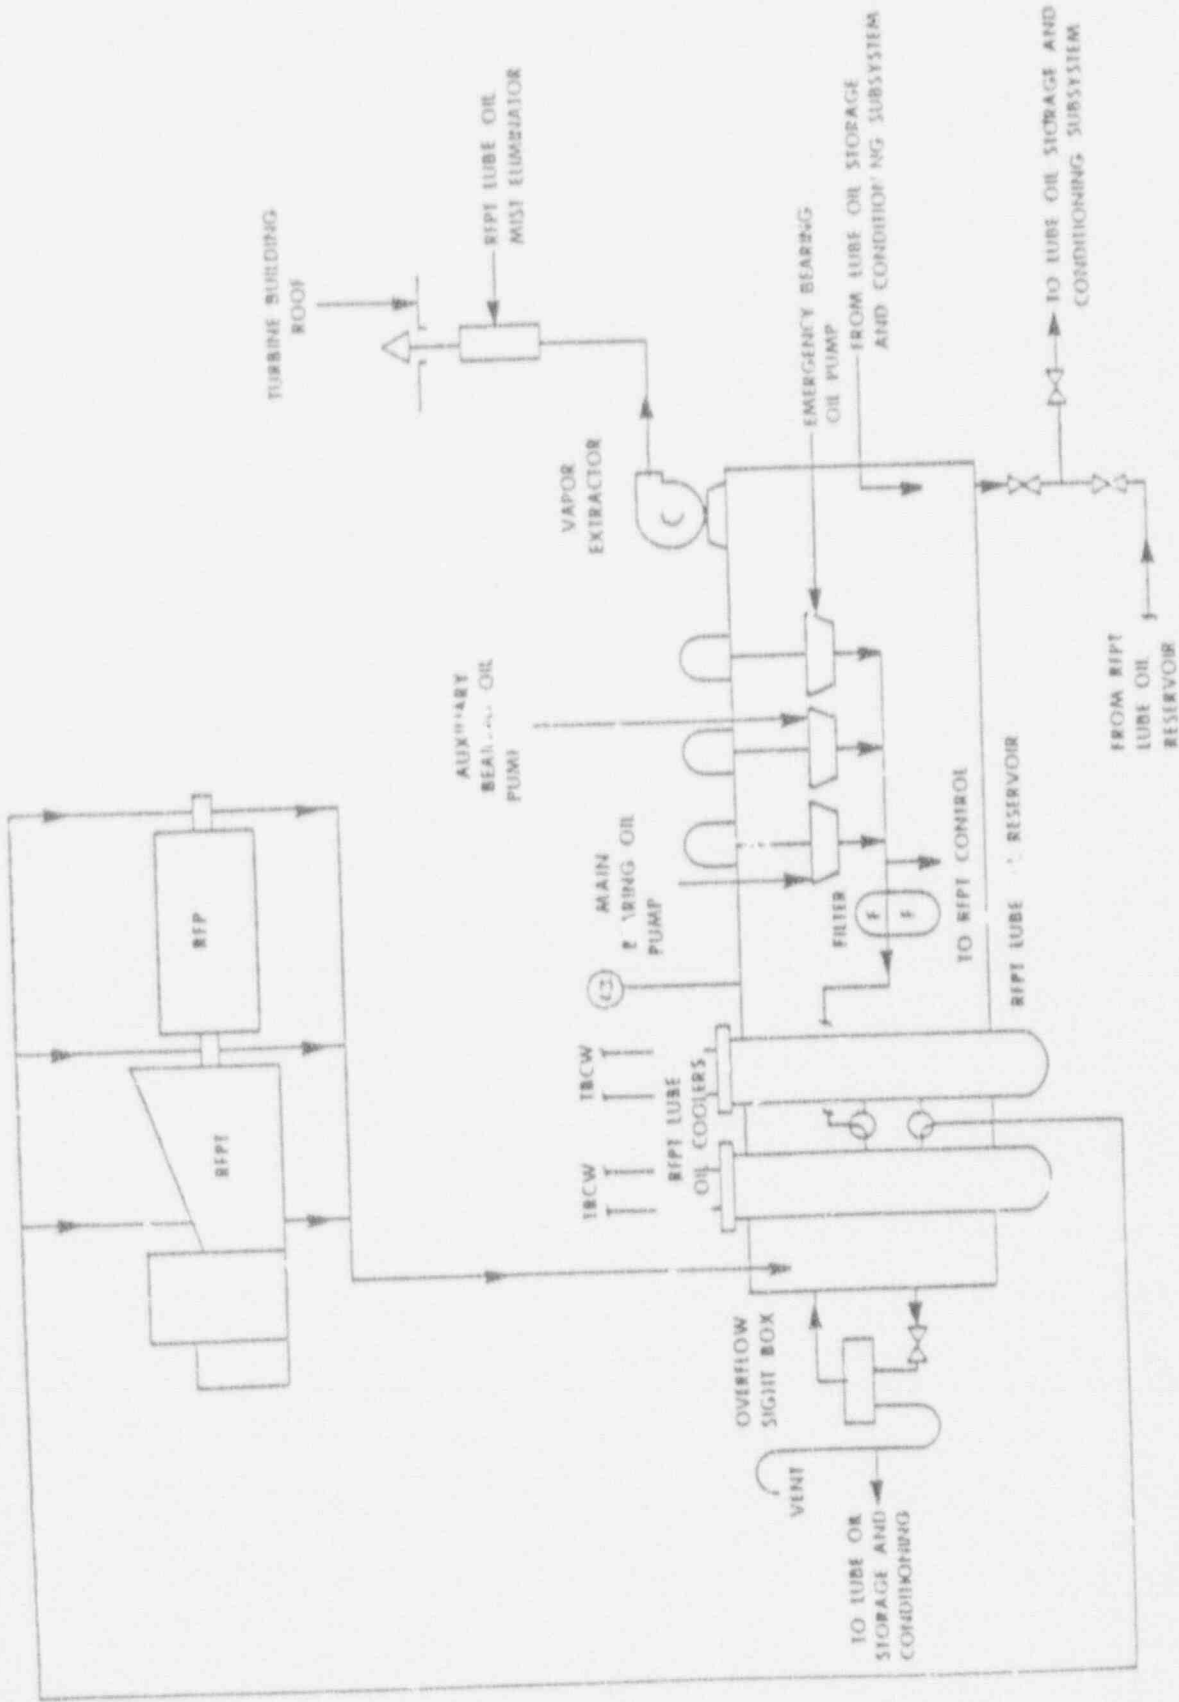
FIGURE 2.6 RFP LUBE OIL SYSTEM

THE REACTOR SCRAM WAS CAUSED BY A TURBINE TRIP. THE TURBINE TRIP WAS DUE TO A TRIP SIGNAL FROM THE THRUST BEARING WEAR DETECTOR. FAILURE OF FW PUMPS TO TRIP CAUSED BY CONTAMINATED OIL.

- 0 AIT SENT TO SITE. TEAM LEADER IS ROLF WESTBERG.
- 0 CAUSE OF TURBINE TRIP BELIEVED TO BE FAILED THRUST BEARING.
- 0 FIRST OUT ANNUNCIATION FAILED DUE TO A BURNED OUT LIGHT BULB.
- 0 ROOT CAUSE OF FW PUMPS TRIP DIFFICULTIES BEING ATTRIBUTED TO CONTAMINATED OIL.
- 0 FAILURE OF THE FW PUMPS TO TRIP CAUSED WATER TO FILL THE RCIC STEAM INLET LINE. WHEN RCIC STARTED, A SLUG OF WATER WENT THROUGH THE TURBINE, FLASHED TO STEAM, AND CAUSED A HIGH BACK PRESSURE TRIP WHICH PREVENTED THE RCIC FROM STARTING.
