UNITED STATES
NUCLEAR REGULATORY COMMISSION
WASHINGTON, D. C. 20555

SUBJECT: TRIP REPORT: AUDIT OF STRUCTURES AND CIVIL ENGINEERING
FEATURES, BEAVER VALLEY POWER STATION, UNIT 1.
TAC NO.: M83708

Enclosure 1 is a detailed trip report with five attachments. The attachments contain the following information:

Enclosure 1

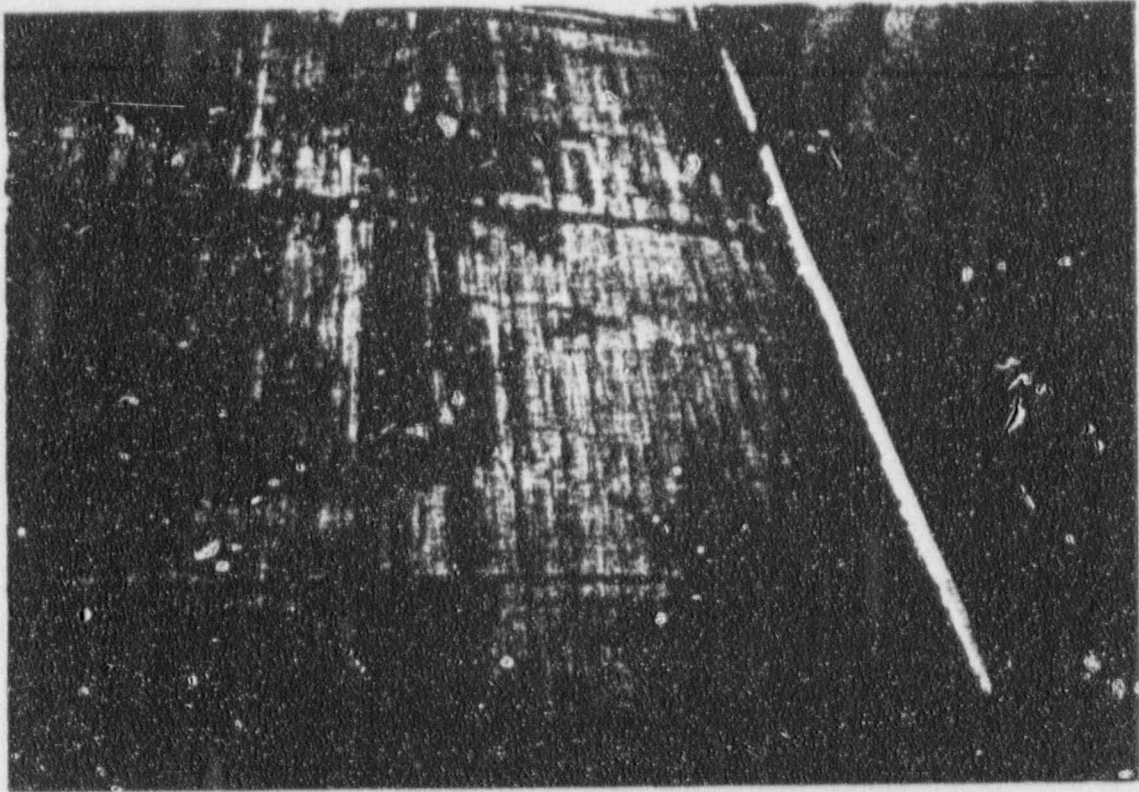
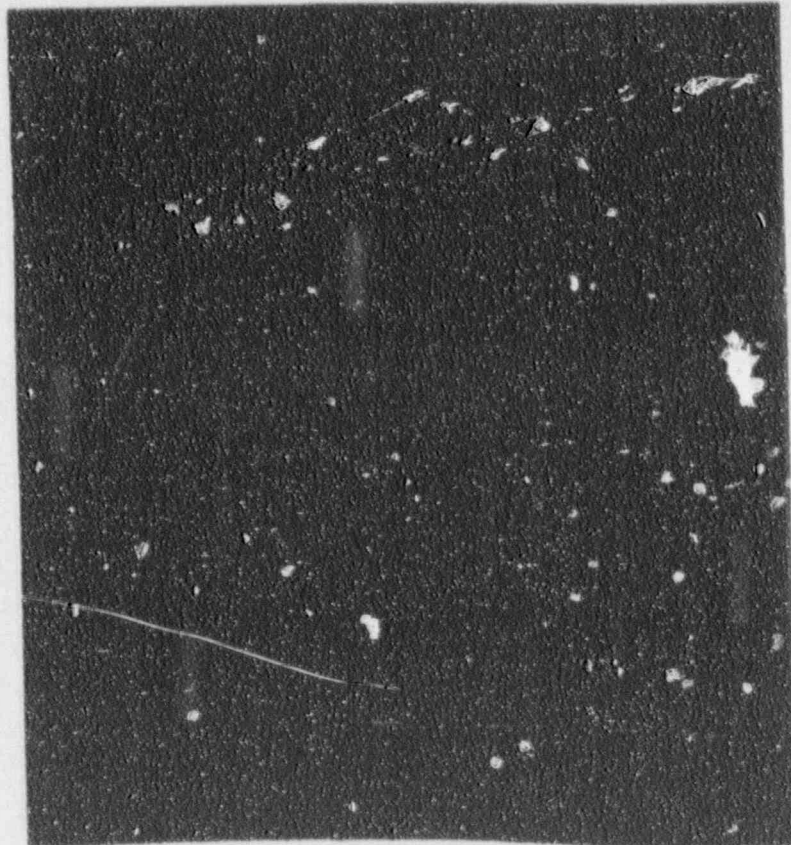
An examination of the exterior condition of the containment structure from the ground and from the roof of the adjacent buildings showed no significant signs of concrete degradation. Only minor surface cracking was observed. However, original patches over construction-related holes are deteriorating and falling out, giving the appearance that small chunks of concrete are spalling. Monitoring of this condition and repair of the patches would be beneficial for the long term integrity of the containment.

Outside Containment Wall - Concrete Crack Pattern (A-10 & A-12)*

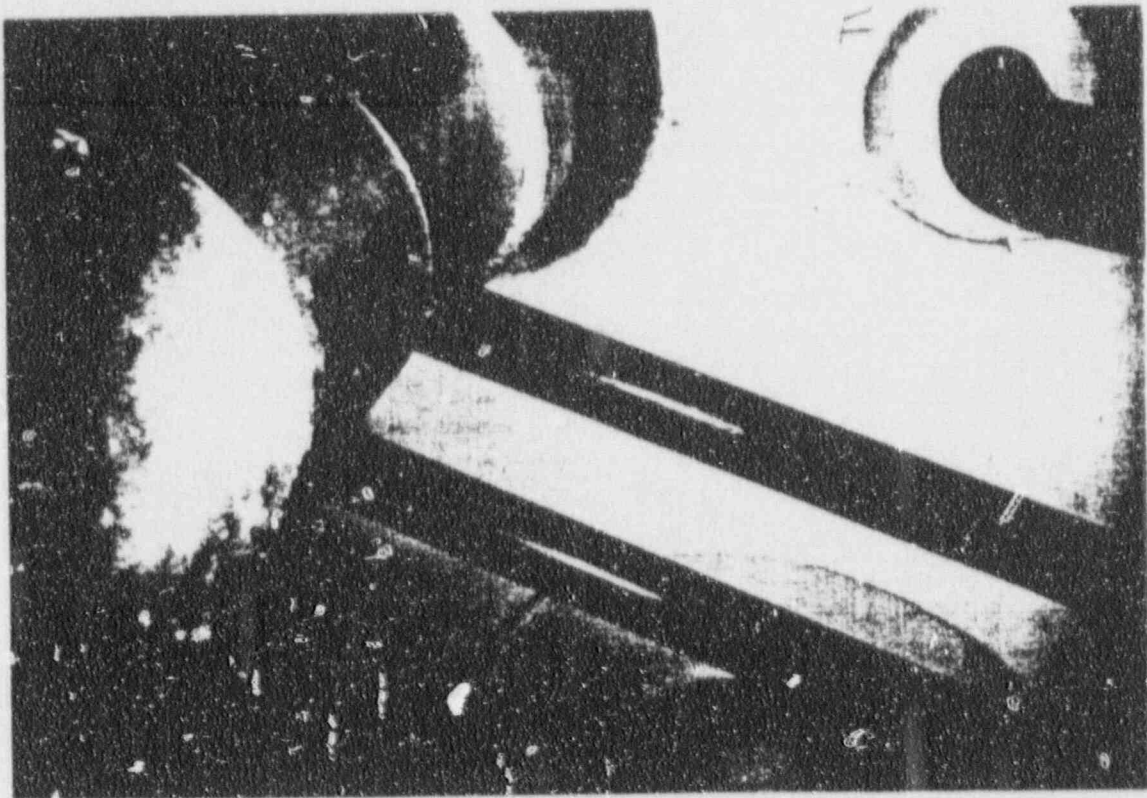
Containment-Corrosion of Containment Penetration
for Component Cooling Line (C-8)

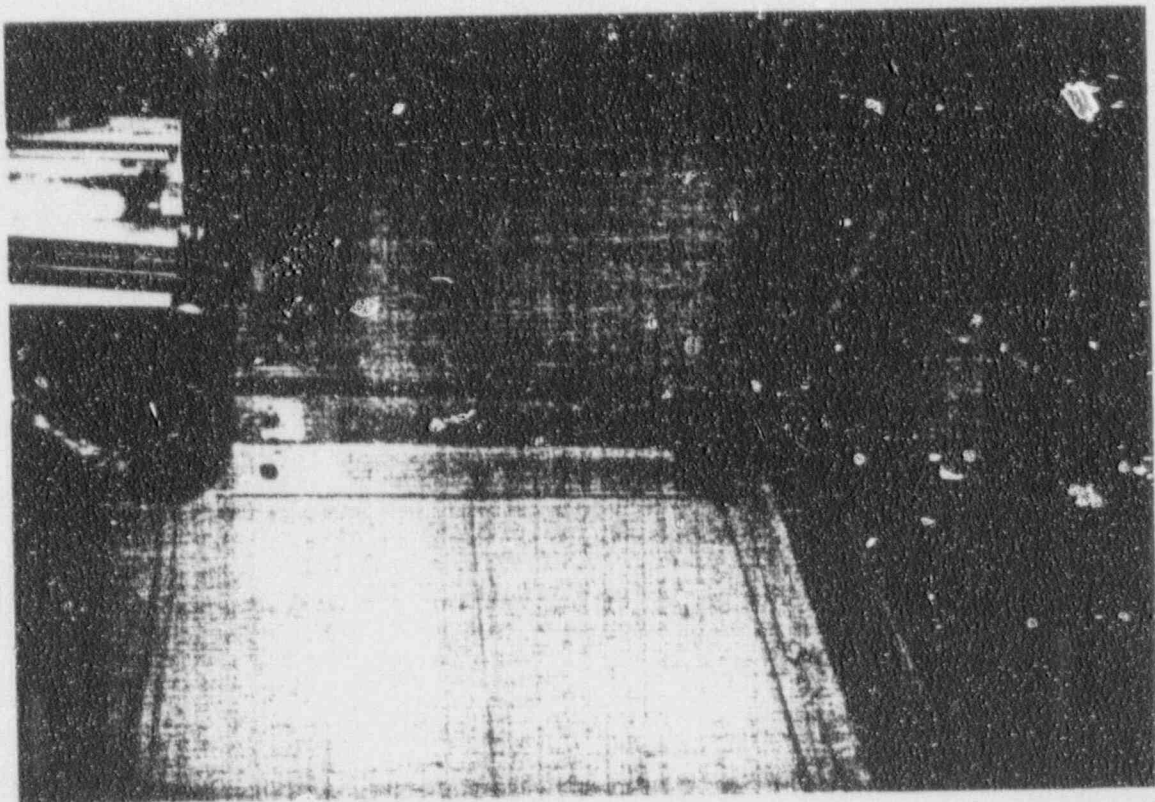
Safeguards Structure - Water Infiltration
and Corrosion of Steel Angles (C-12)

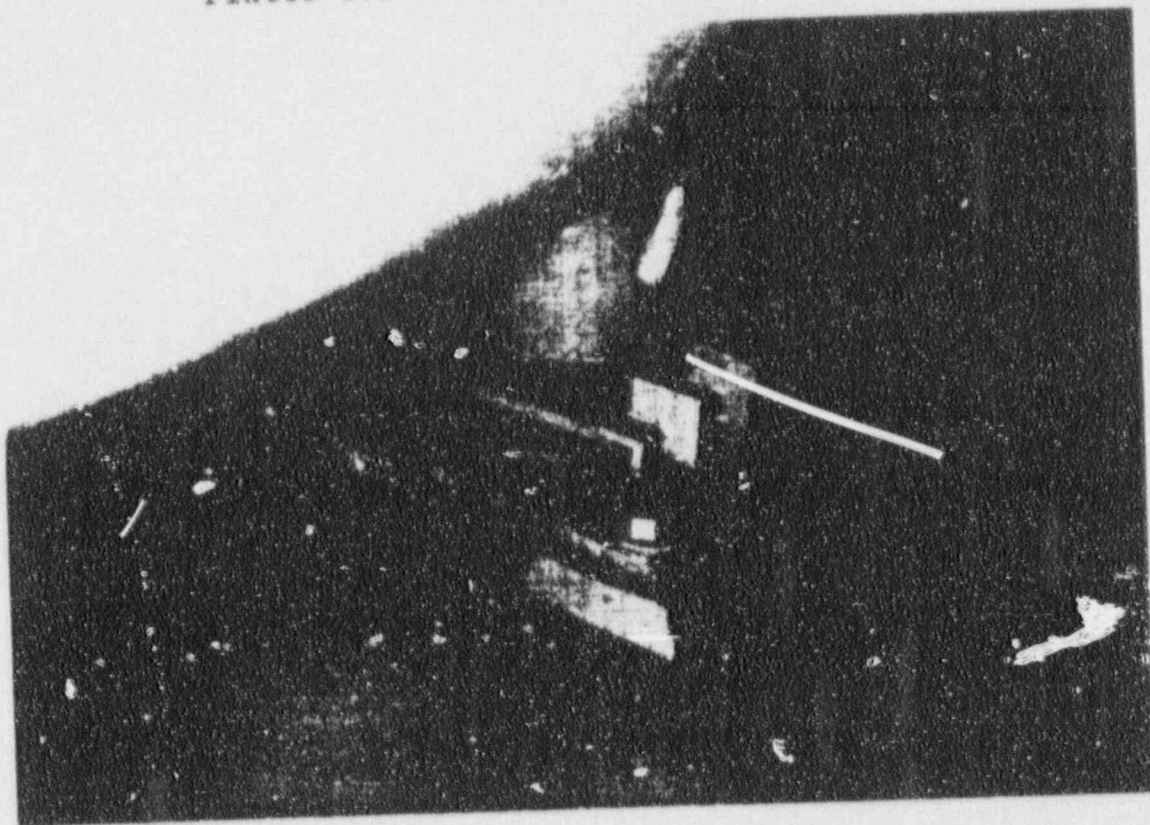
Safeguards Structure-Corrosion of Sliding Support
Plates for River Water Piping (C-5)

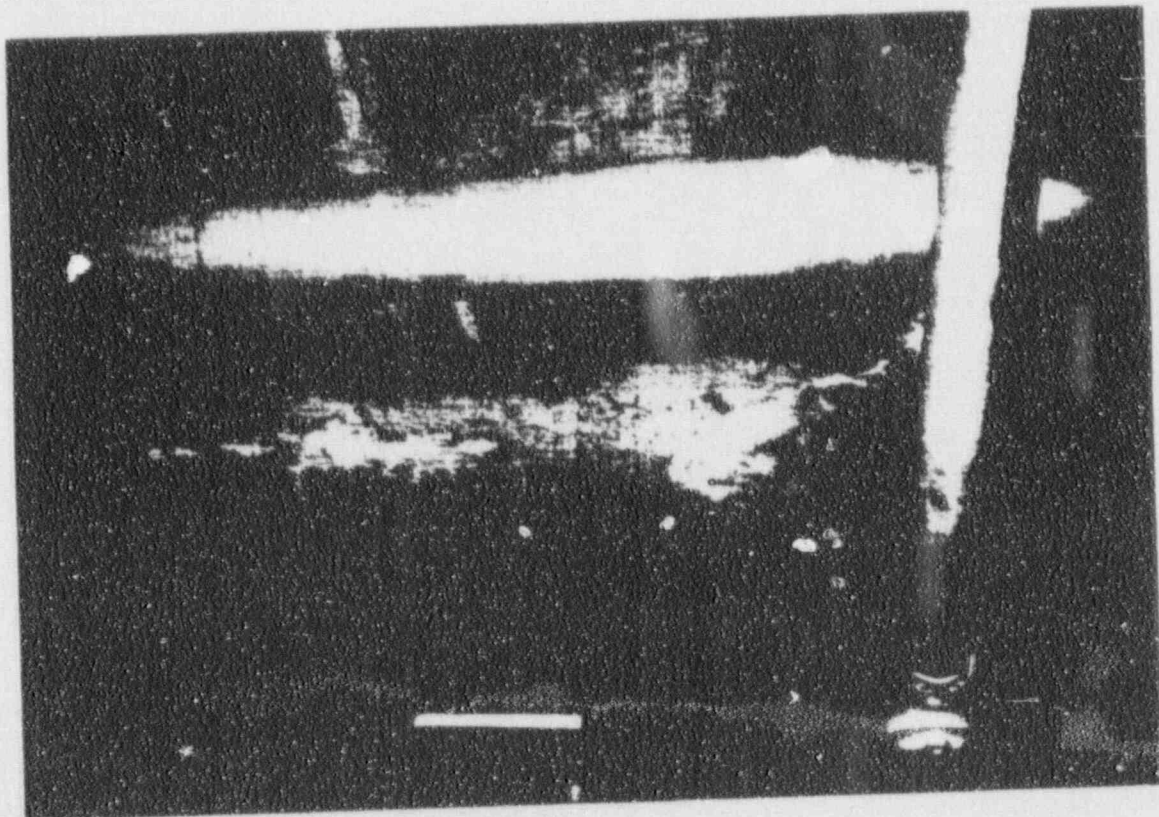
Service Building - Water Infiltration and Calcium Formation (B-23)

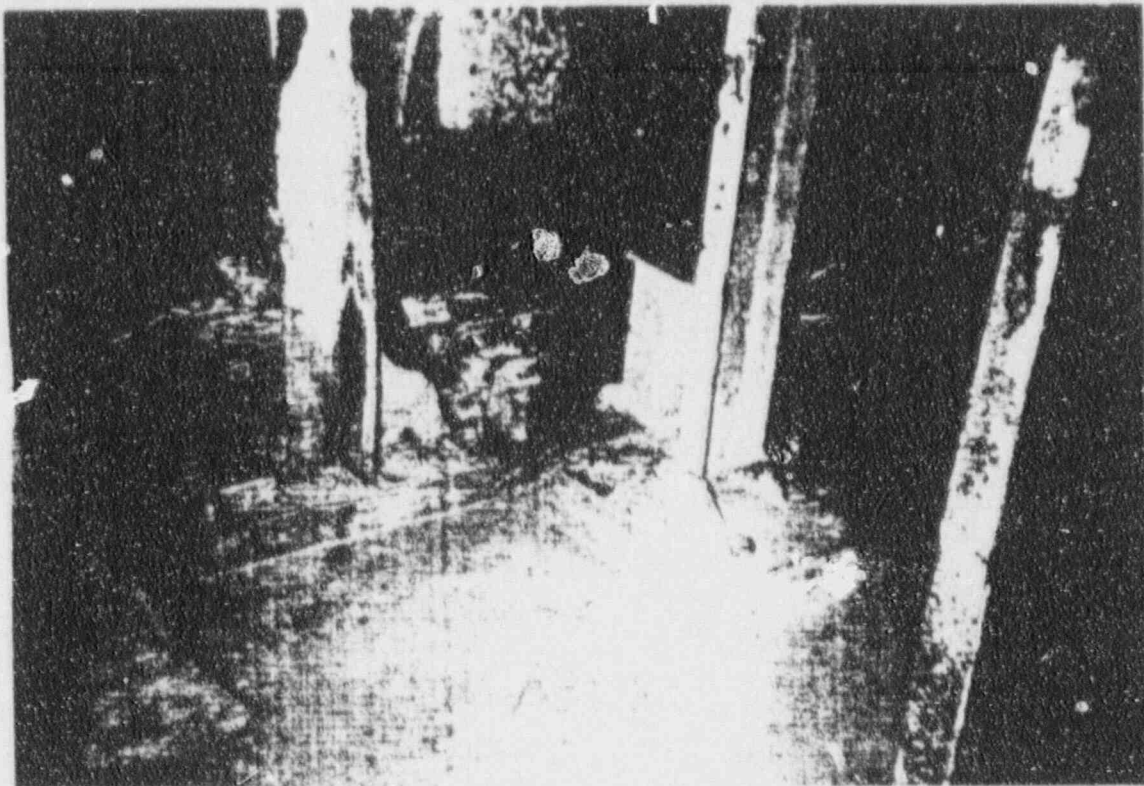
Service Building - Control Room Condenser Unit

Degradation of Base/Foundation and Corrosion of Steel Supports (B-21)

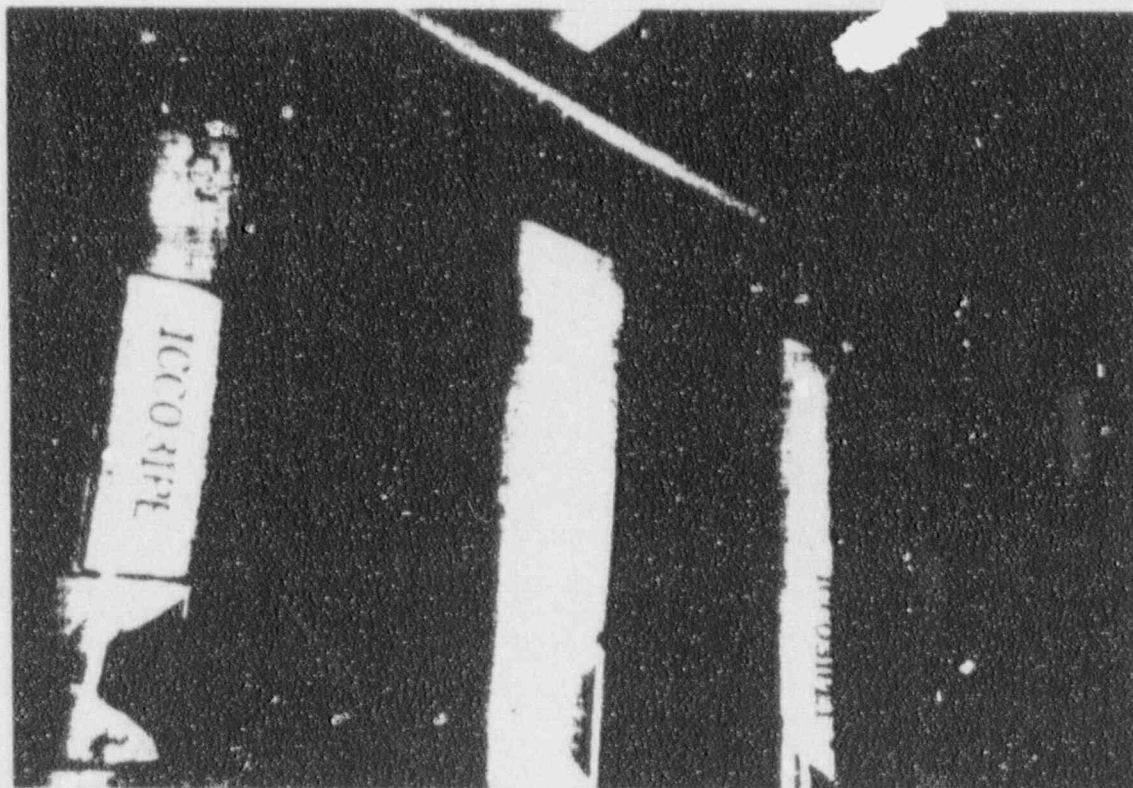
Metal Corrosion of Frame Support (B-22)

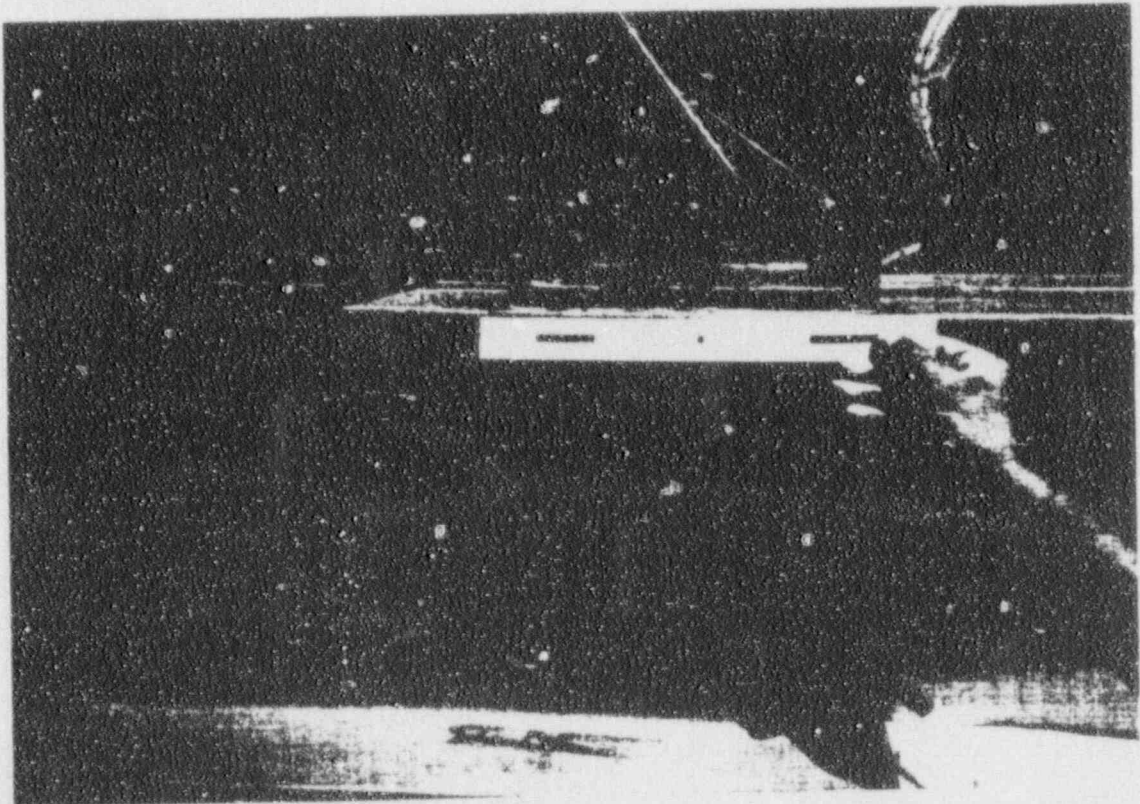
Corrosion of Structural Steel for Main Steam/Feedwater Piping (A-16)

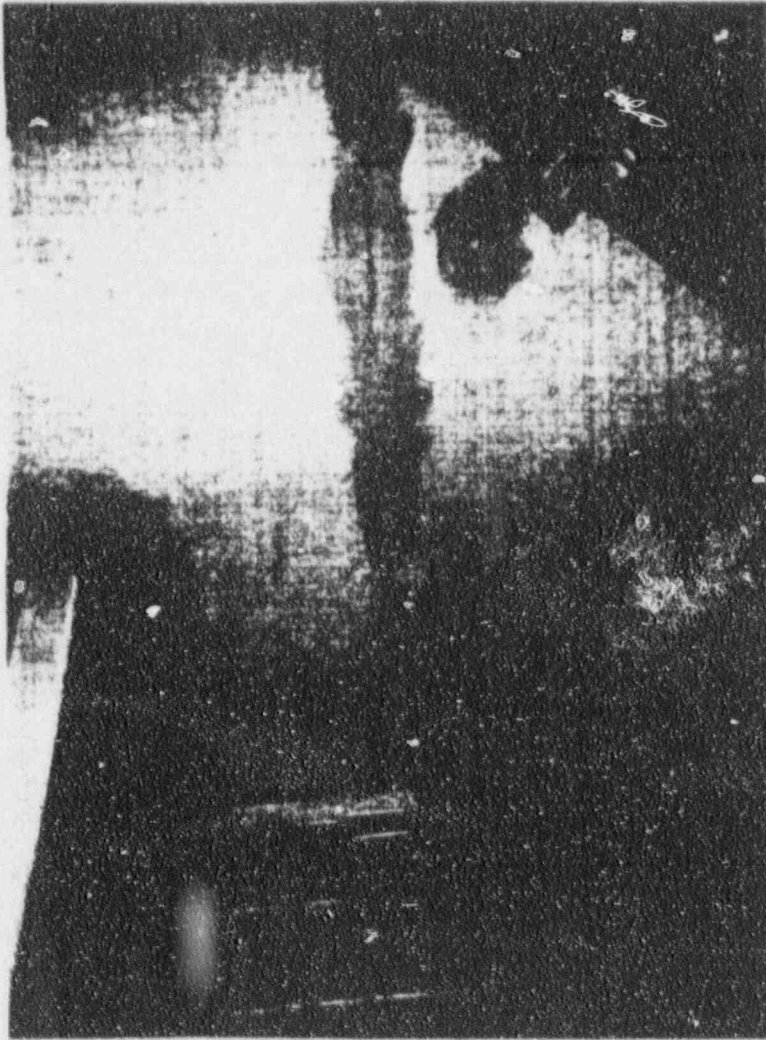
Concrete Crack and
Rust Discoloration
at Ceiling (B-3)
