SUBJECT: PALO VERDE VIBRATION PROBLEMS - REQUEST FOR
ADDITIONAL INFORMATION

REPORT ON
PALO VERDE UNIT 1
SAFETY INJECTION NOZZLE
THERMAL LINER

Prepared by: COMBUSTION ENGINEERING, INC.
WINDSOR, CONNECTICUT

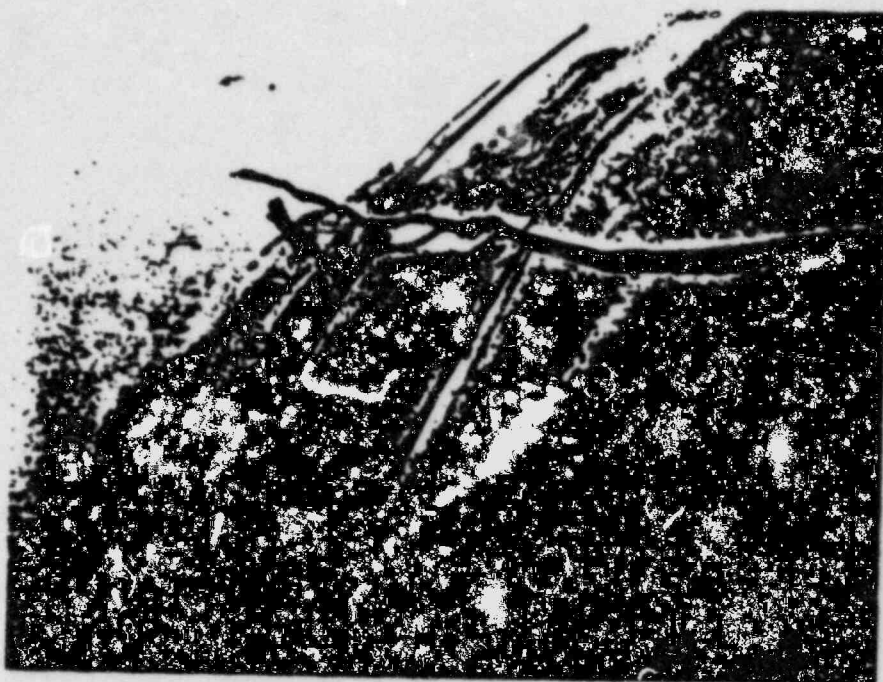
FIGURE 16
1A THERMAL LINER

CENTERING PAD CRACKS

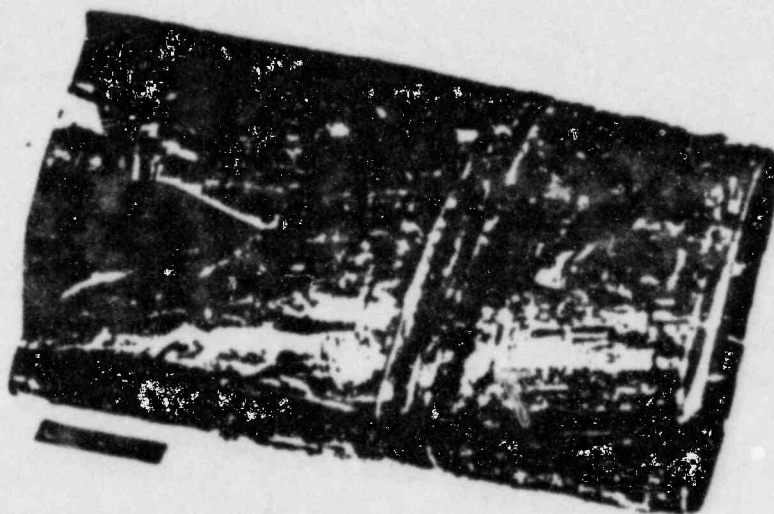
LARGE TEAR

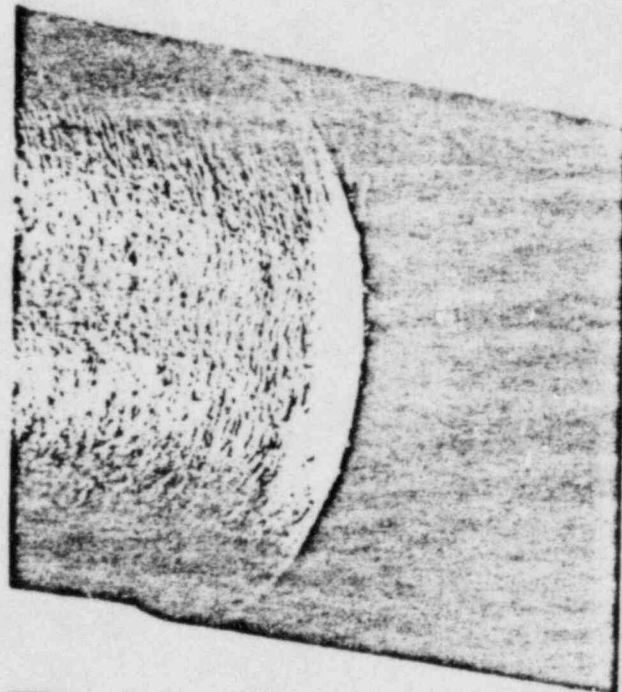
62705
Figure 3.2-5
Wear Area on
Thermowell No.112CD

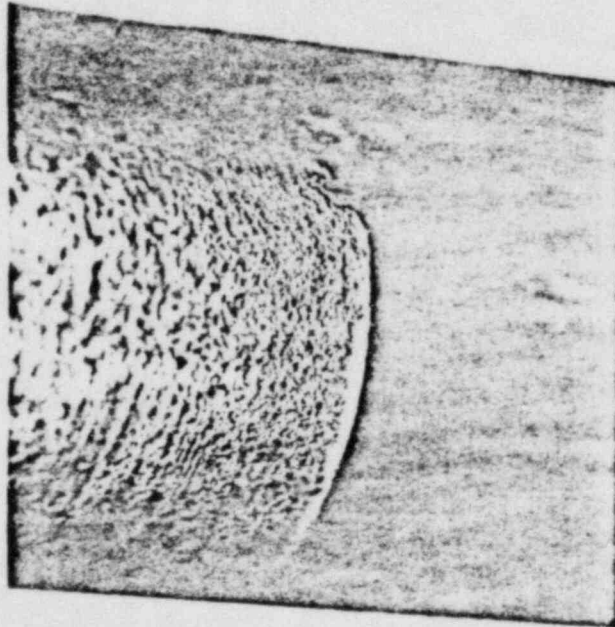
Figure 3.2-9 62406
Close-up of Wear and
Fractured Surfaces of
Thermowell No. 112CA.
The wear area is as
indicated; the fractured
end is on the right
hand side.

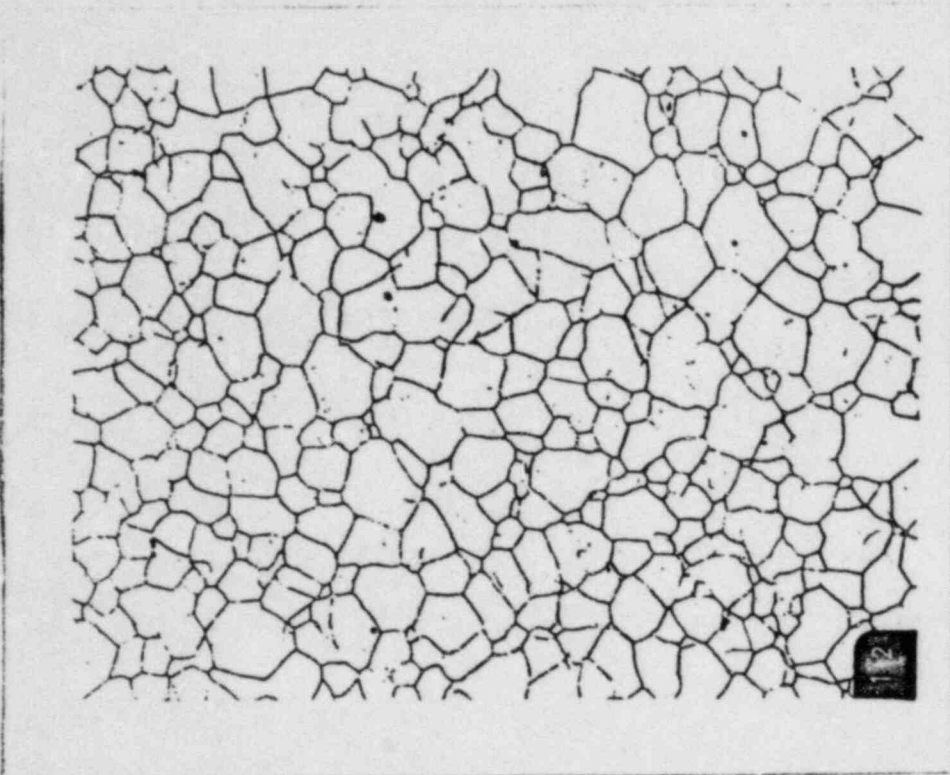
Etchant: Nital
Figure 3.2-19 Microstructure of Thermowell 111Y,
Transverse Cross Section

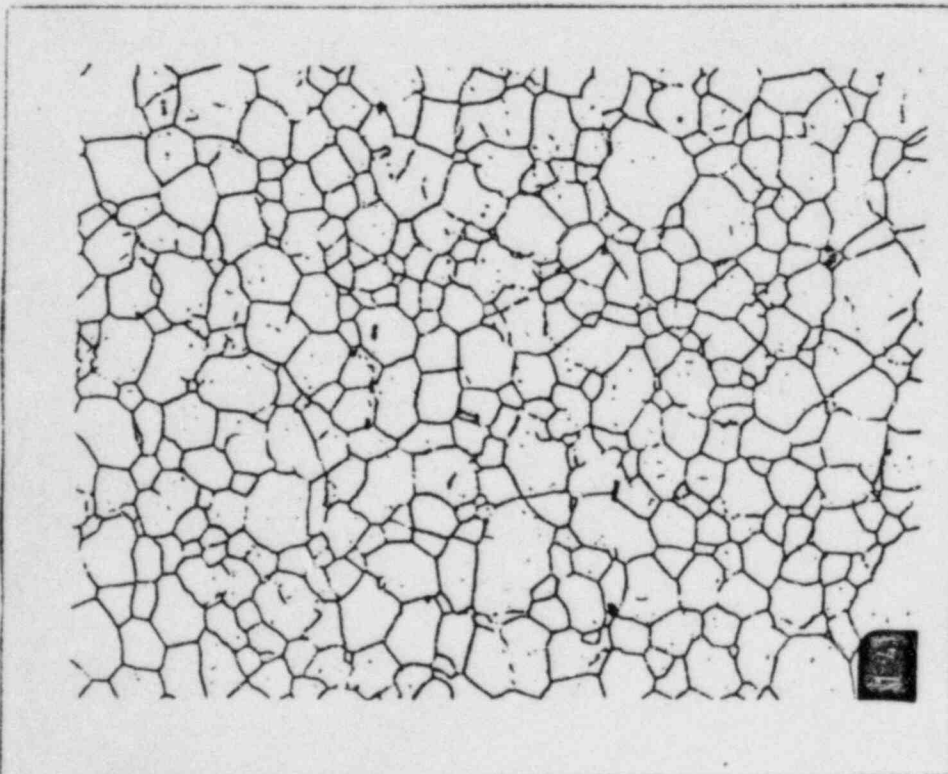
Etchant: Nital
Figure 3.2-20 Microstructure of Thermowell 111Y,
Longitudinal Cross Section

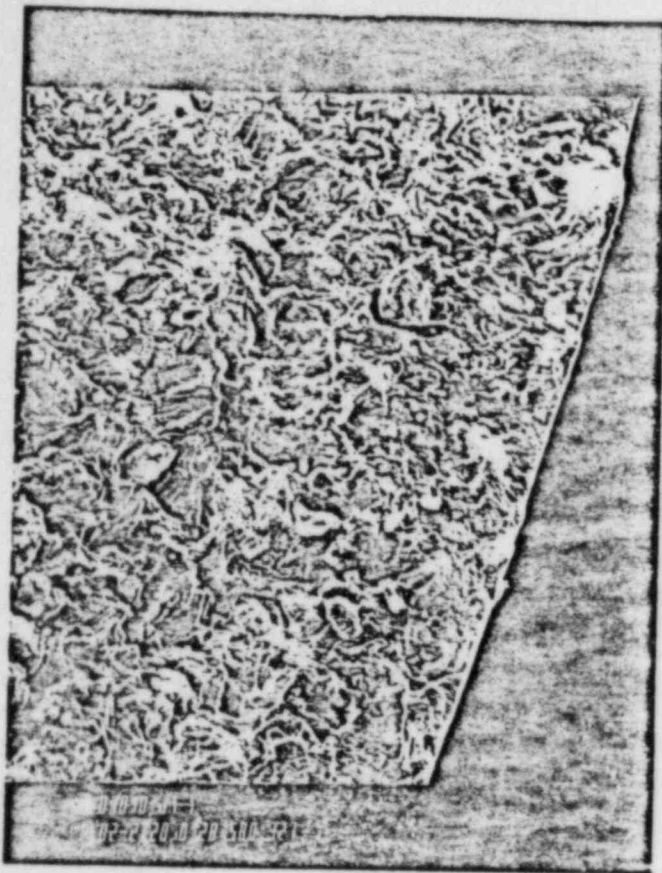
62559
Figure 3.2-42
Possible Crack Initiation
Point in Area 4 of
Thermowell No.111Y
