UNITED STATES
NUCLEAR REGULATORY COMMISSION
WASHINGTON, D. C. 20555

Docket No.: 50-382

APPLICANT: Louisiana Power and Light Company
FACILITY: Waterford 3
FROM: J. H. Wilson, Project Manager, Licensee Branch No. 3, DL
SUBJECT: MEETING SUMMARY FOR LP&L'S PRESENTATION OF BASEMAT ADEQUACY
AT WATERFORD 3

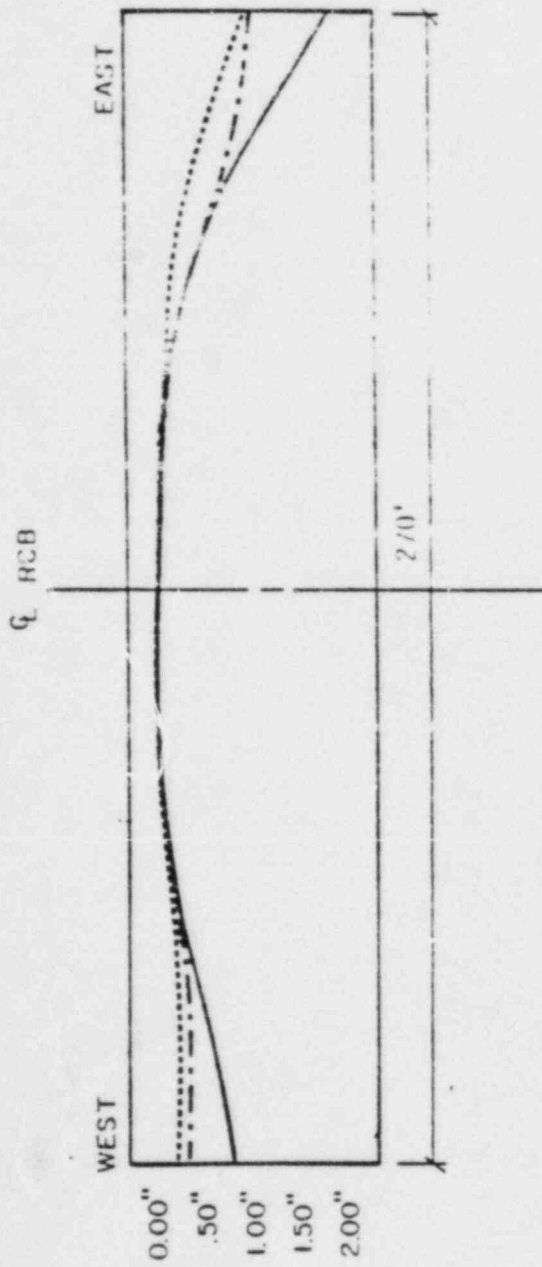
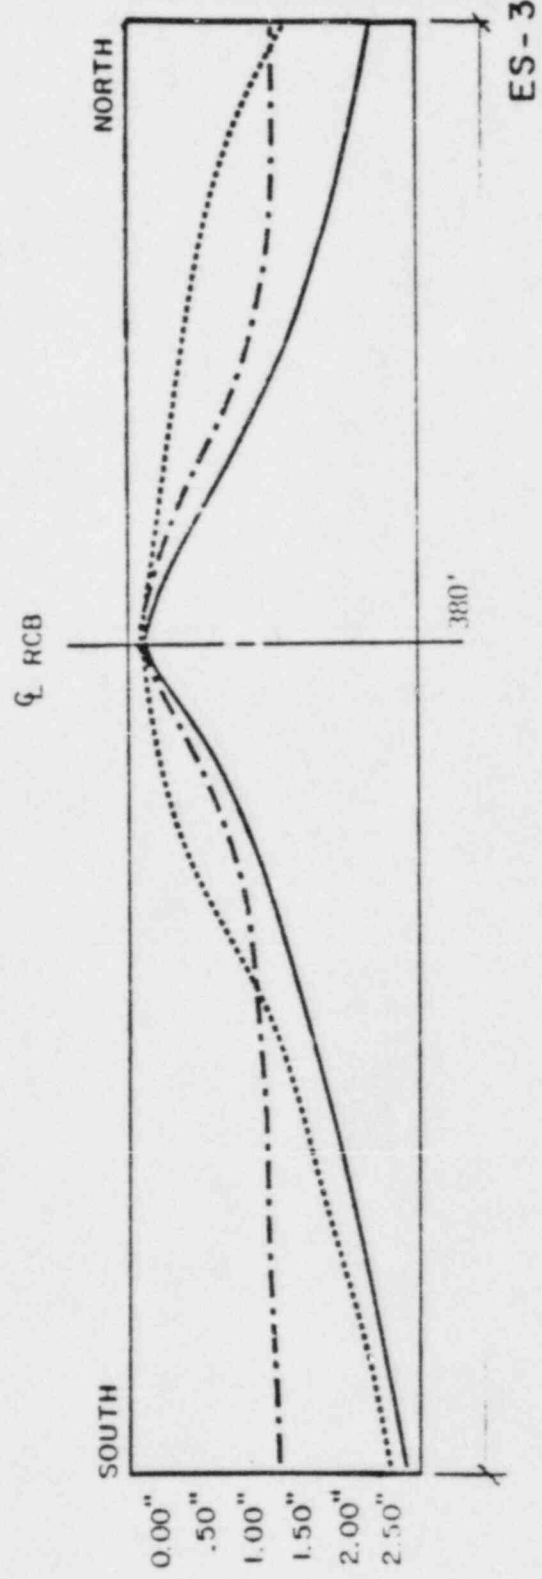
Attached is a graph (Figure ES-3) reflecting the contours obtained from the maps generated on April 22, 1977, November 10, 1977, and October 9, 1979. These curves reflect a before mat (ring wall) loading, after ring wall placement and a majority of concrete construction complete. These contours do reflect a convex mat with maximum differential of two inches (2").

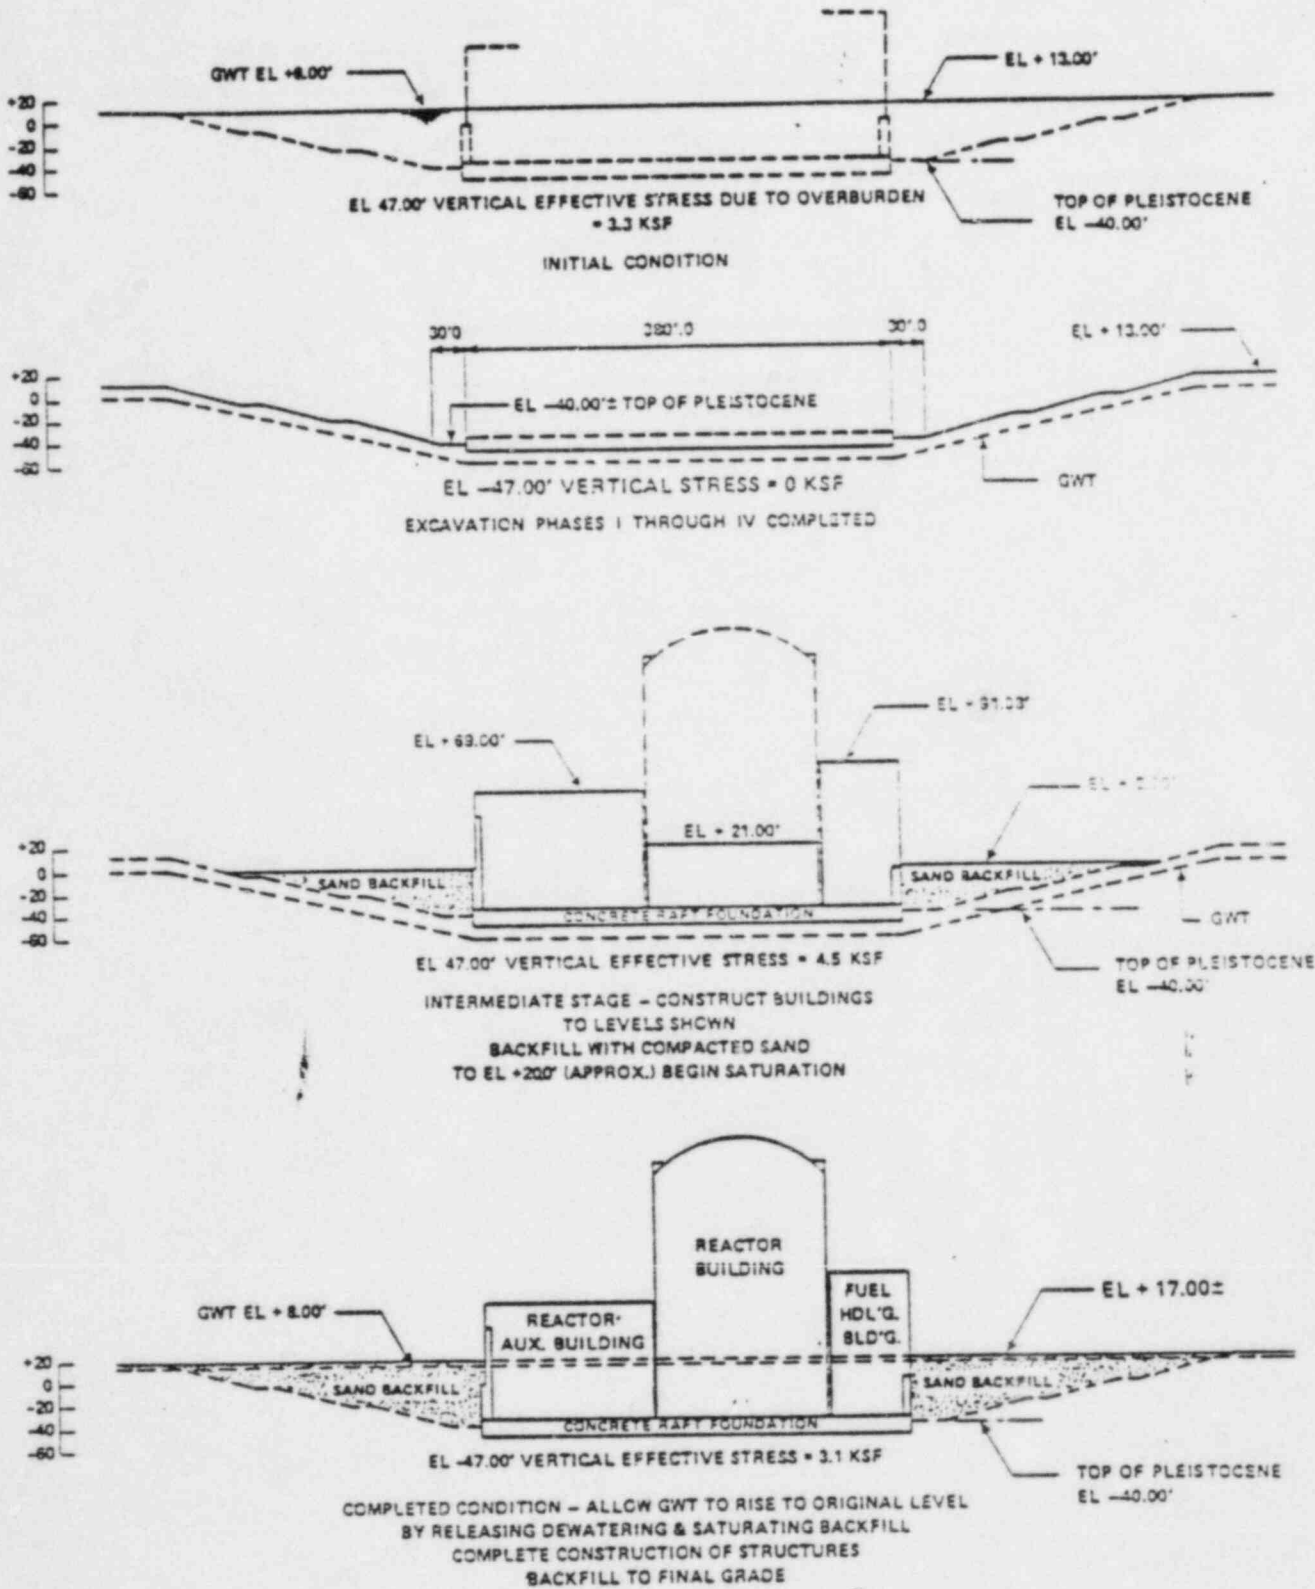
Figure
2.5-103

BEARING PRESSURE HISTORY AT -47 FT. ESL

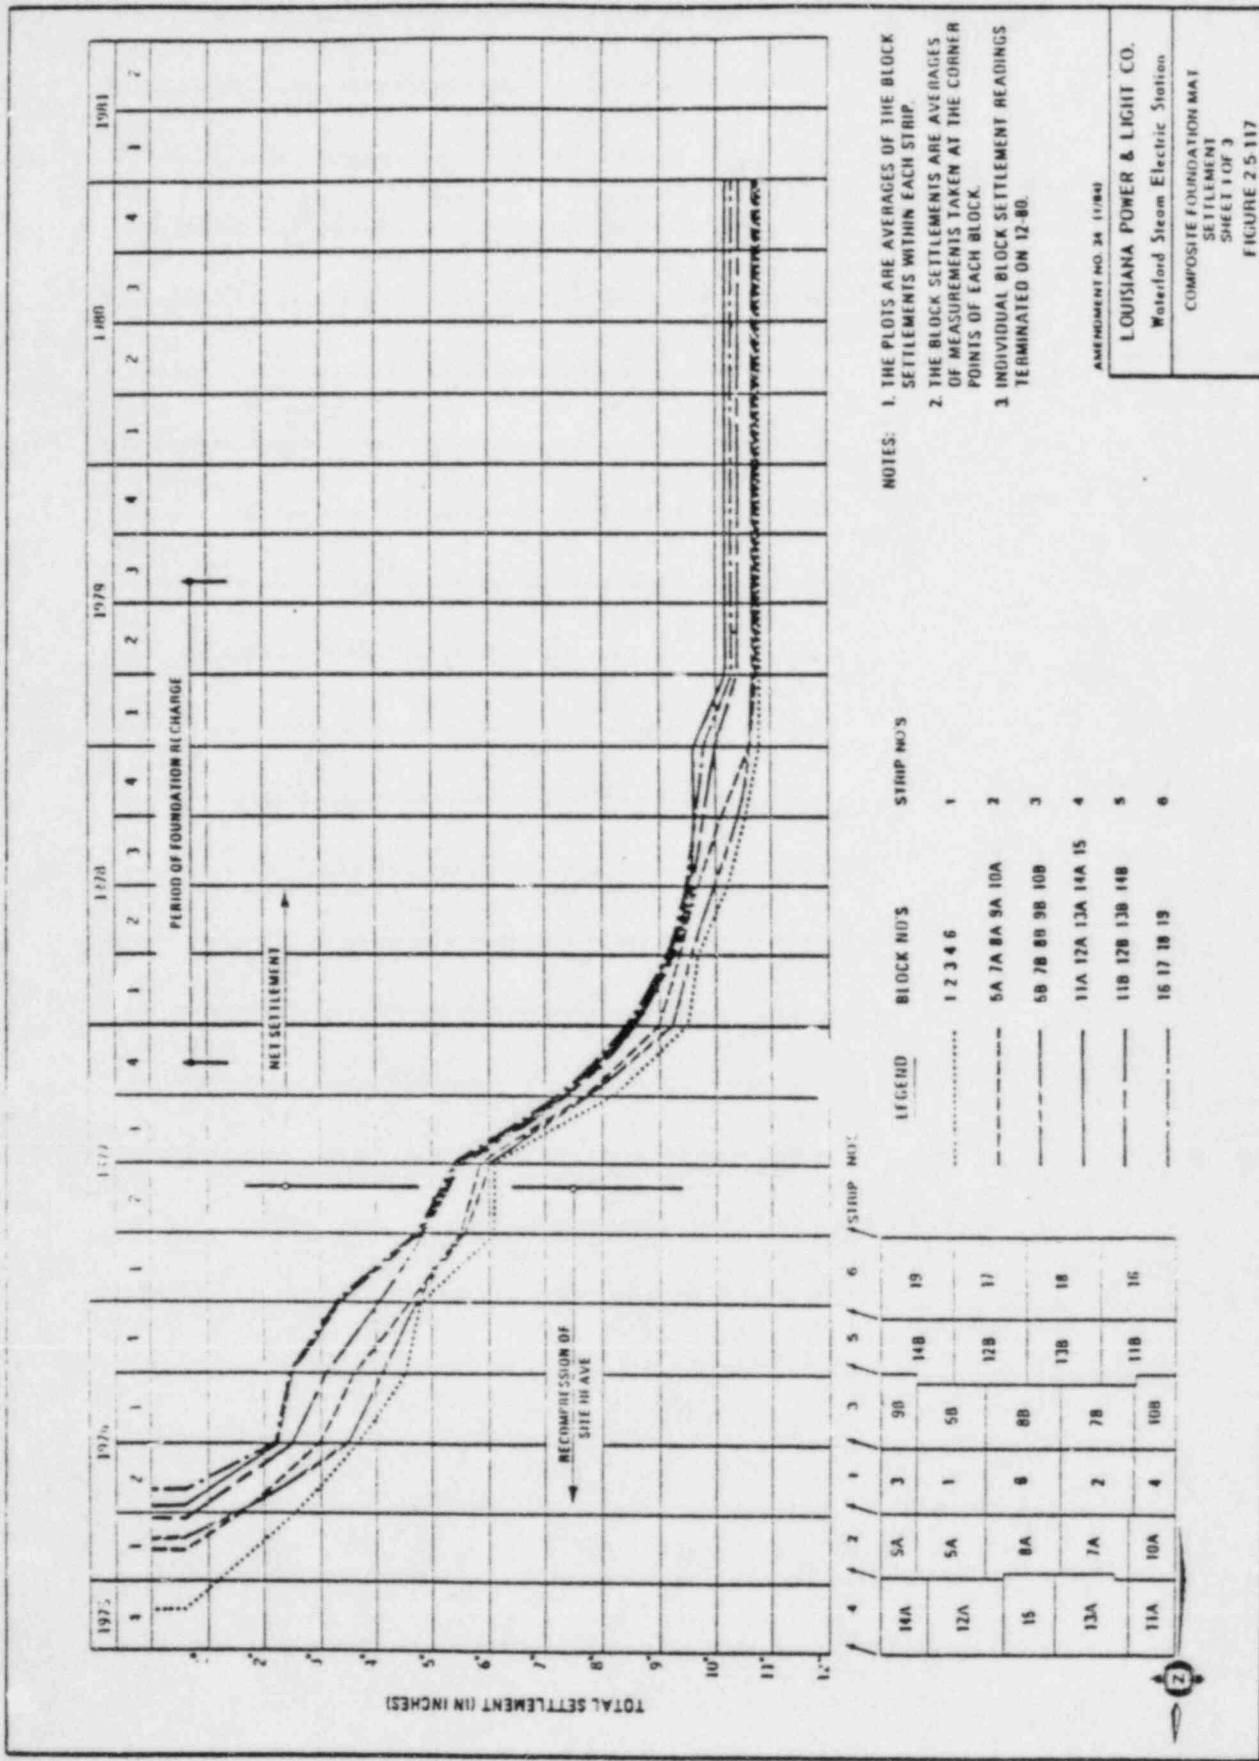
AMENDMENT NO. 34 (1/78)
 LOUISIANA POWER & LIGHT CO.
 Waterford Steam Electric Station
 COMPOSITE FOUNDATION MAT
 SETTLEMENT
 SHEET 1 OF 3
 FIGURE 2 5 117

As can be noted on the Composite Foundation Mat Settlement (Figure 2.5-117 in the FSAR), recharging of the water table began in late 1977 and was gradually charged until completion in late 1979. Recharging commenced based on total stresses achieving the 4.5 KSF criteria. The initiation of recharging the mat was approximately week no. 85 of construction.

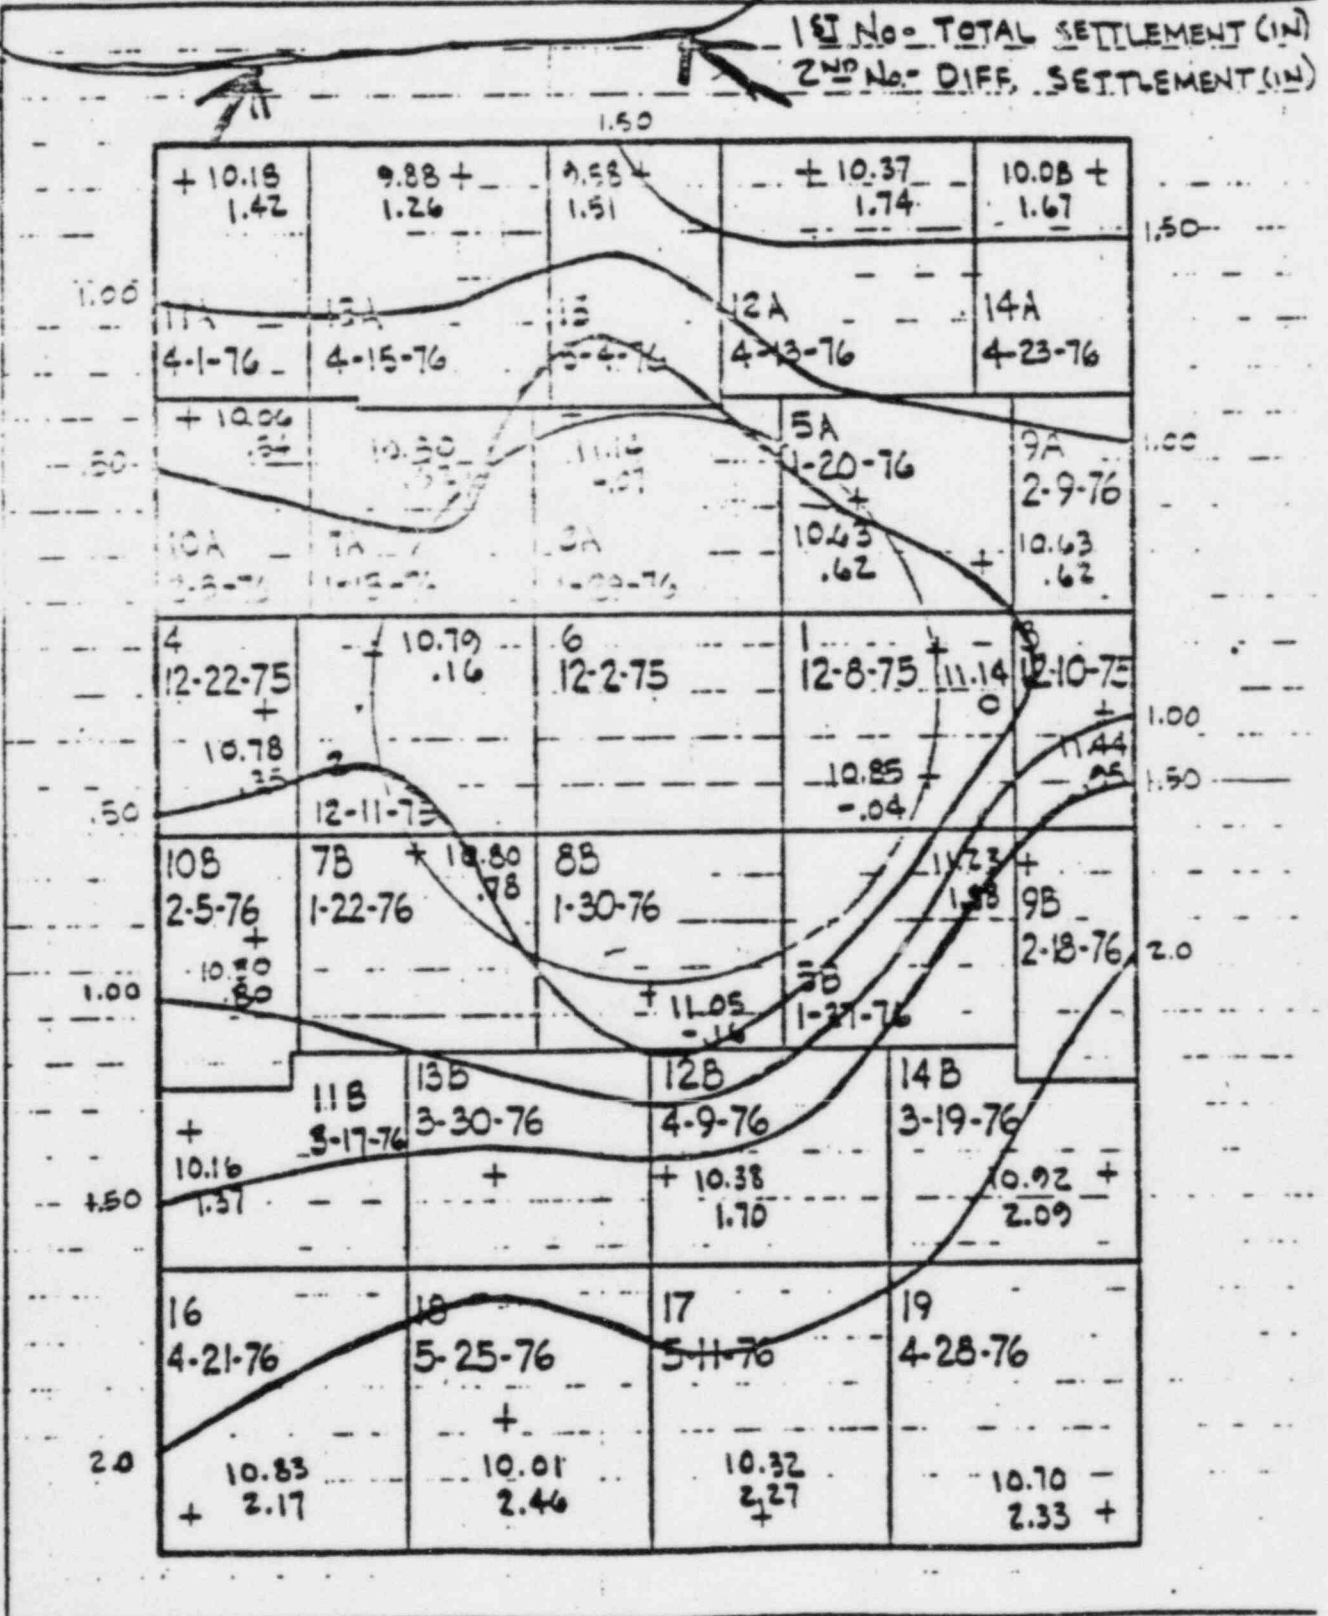
SUBJECT MAT SETTLEMENT - AUGUST, 1979

18. According to the settlement contours shown in figure 2.5.118 the curvature is concave downward in both directions. This implies cracks on the top surface in both directions which would not penetrate all the way through.

In view of the above why did the water seep thru? Why doesn't the crack pattern match the given differential settlement?
