NUCLEAR REGULATORY COMMISSION

Report Nos. 50-254/92021(DRSS); 50-265/92021(DRSS)

Facility Name: Quad Cities Nuclear Power Station - Units 1 and 2

Enforcement Conference Summary

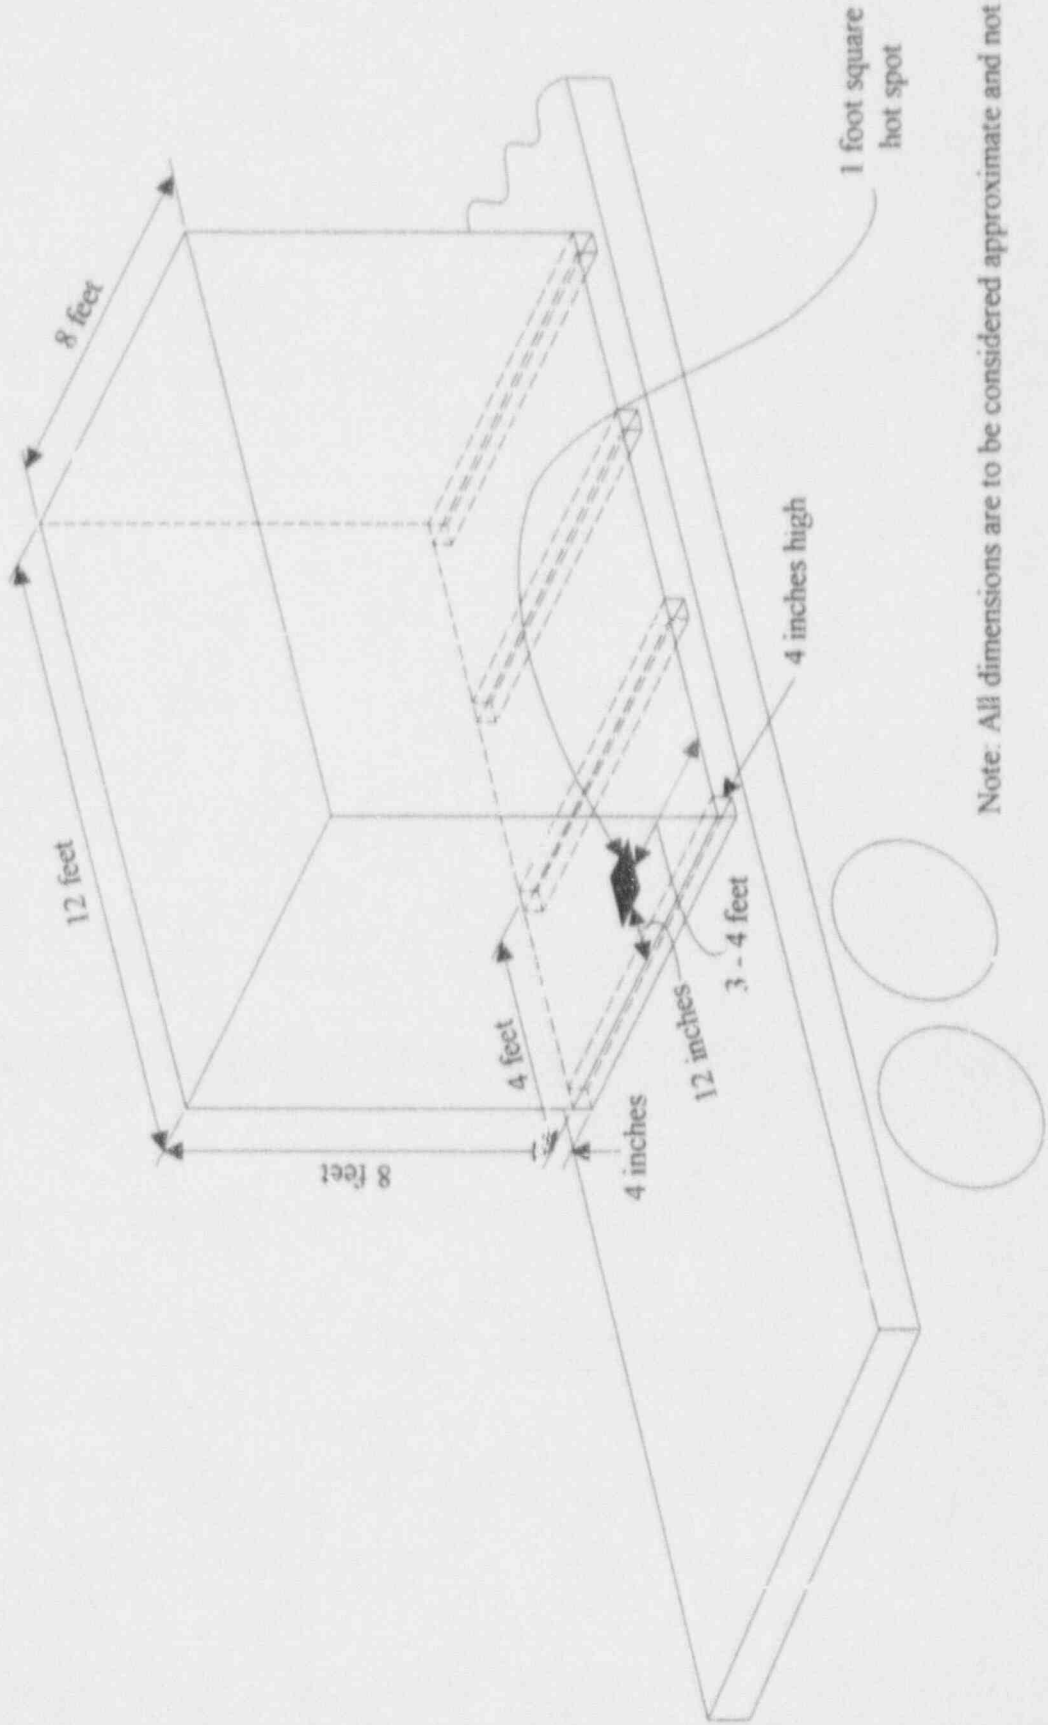
- A one square foot area hot spot on the bottom of the shipping container (located approximately 3 feet from the outer edge of the container) with dose rates of 200 to 1500 mR/hr.
- A 1 inch by 2 inch area on the side of the container (located approximately 1 foot from the back and 4 inches up from the bottom) with a dose rate of 200 to 220 mR/hr.
- Vehicle dose rates were below DOT limits.

- 7/20 The teletector used for the departure survey was checked and found to be in proper working order.
- 7/22 The shipping container is opened and contents are surveyed by CECo and Millstone. The contents of the container were in place and had not moved during shipment. Hot spot of 2.2 R/hr is identified on dump bucket 1 with a small diameter ionization chamber.

- Shipment was transported via an exclusive use vehicle. This precluded unauthorized individuals from handling the package during transport.
- The area of concern (i.e. 1500 mR/hr) was not accessible:
 - The hot spot was located near the bottom center of the package, approximately three feet from the outer edge of the shipping container.
 - The clearance between the bottom of the container and the bed of the truck was approximately 4 inches.
 - The weight of the container (approximately 2600 pounds) would require a mechanical lifting device to move the container.
- Vehicle dose rates were below DOT limits.
- Individuals involved in the transport of the shipment did not incur unnecessary exposure.
