U.S. NUCLEAR REGULATORY COMMISSION  
REGION IV

Inspection Report 50-285/92-21 Operating License: DPR-40

Facility Name: Fort Calhoun Station

A special inspection was conducted from August 24 through September 3, 1992, of the events related to the premature opening of Pressurizer Safety Valve RC-142 on August 22, 1992. The inspection included the evaluation of the initiating event, the plant and personnel response to the event and the actions implemented to preclude recurrence of the event. The inspectors also evaluated the actions implemented to verify proper operation of the affected systems and components, and the post-event valve testing activities conducted onsite and at the Wyle Laboratory.

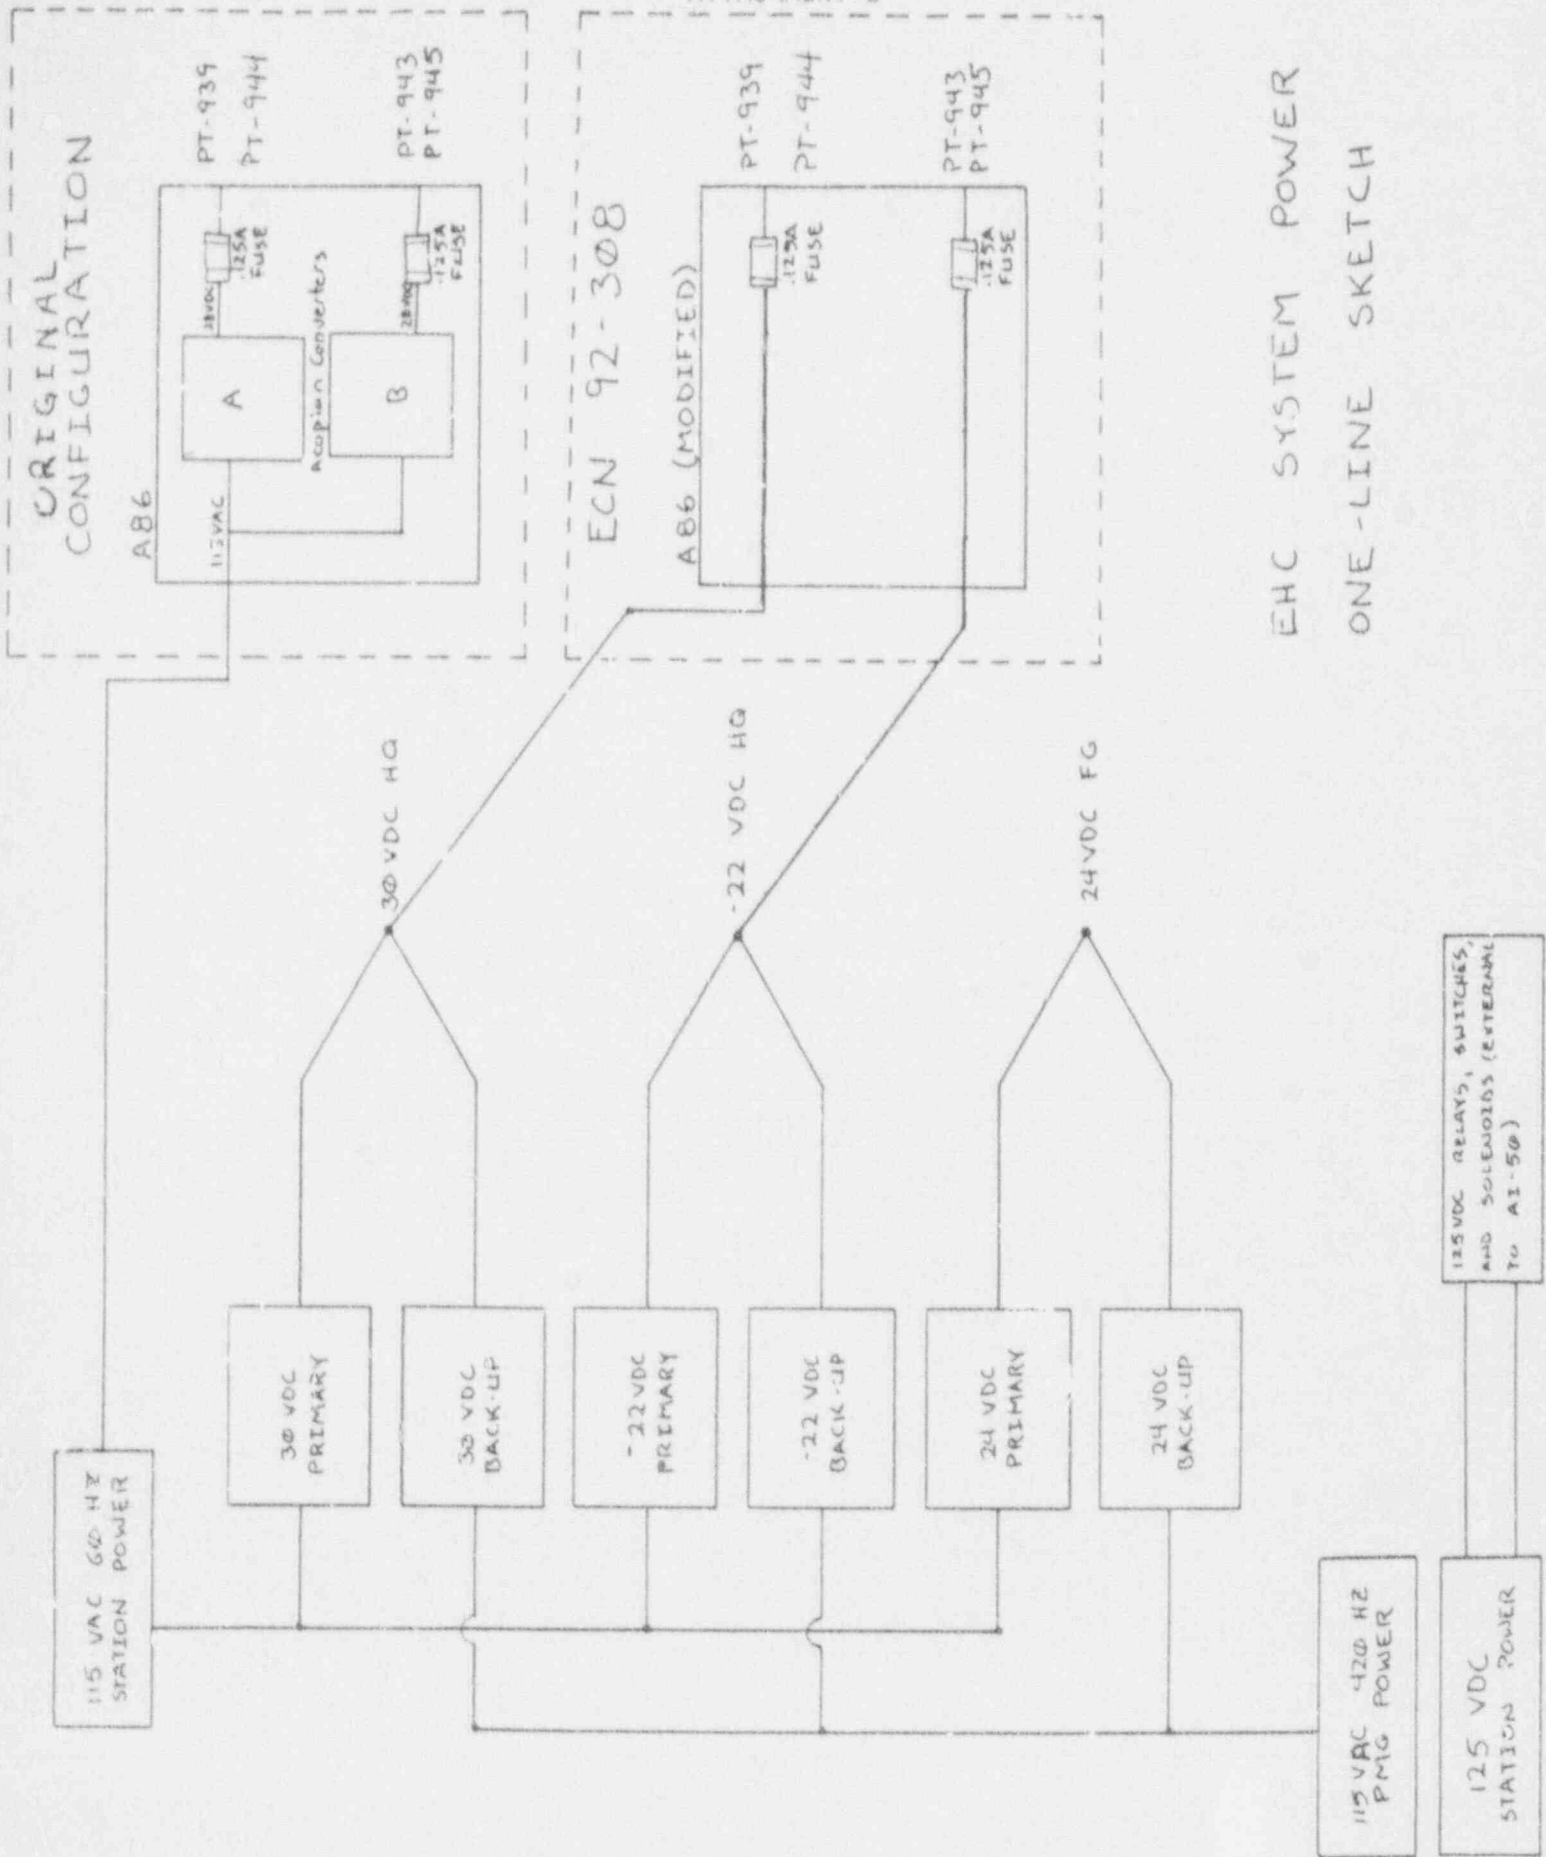
EHC SYSTEM POWER  
ONE-LINE SKETCH

The electrohydraulic control system includes devices which convert the power supplied from the plant's electrical distribution system through distribution panel AI-50 to four separate voltage levels to operate various components. Most of the electrohydraulic control system components were connected to the +30, +24, or -22 Vdc internal power distribution busses. These three power distribution busses were supplied from duplicated power conversion devices; one receiving power from the licensee's distribution system and the other receiving power from a permanent magnet generator attached to the shaft of the main generator. There were, however, four pressure transmitters which had two separate power conversion devices that were only connected to the licensee's distribution system. One of the conversion devices provided power for Pressure Transmitters PT-939, "Throttle Pressure Sensor," and PT-944, "Intermediate Pressure Transducer," and the other conversion device provided power for Pressure Transmitters PT-943, "Throttle Compensation Pressure Sensor," and PT-945, "First-Stage Turbine Pressure Sensor." A simplified sketch of this power distribution configuration is provided as Attachment B.

On August 22, 1992, the failure of the internal power conversion device for Pressure Transmitters PT-943 and -945 caused their output signal to drop to 0 Vdc. The loss of power to only two of the four pressure transmitters caused the control valves to ramp in the closed direction but not close completely enough to initiate a turbine trip signal. The resultant reactor systems response was similar to, but not as severe as, the July 3 event.

As a result of the August 22 event and to further improve the reliability of the electrohydraulic control system and thereby limit challenges to the reactor protective system, the licensee initiated Engineering Change Notice No. 92-308 to evaluate additional modifications to the electrohydraulic control system. The licensee determined that the system would be enhanced by connecting the four pressure transmitters discussed above to the distribution systems internal to the electrohydraulic control system rather than the separate power conversion devices (Acopian Convertors) that had been used. The power for Pressure Transmitters PT-939 and PT-944 was connected to the +30 Vdc power distribution system and the power for PT-943 and PT-945 was connected to the -22 Vdc distribution system (see Attachment B). These modifications provided an automatic backup power supply to the transmitters to improve their reliability.

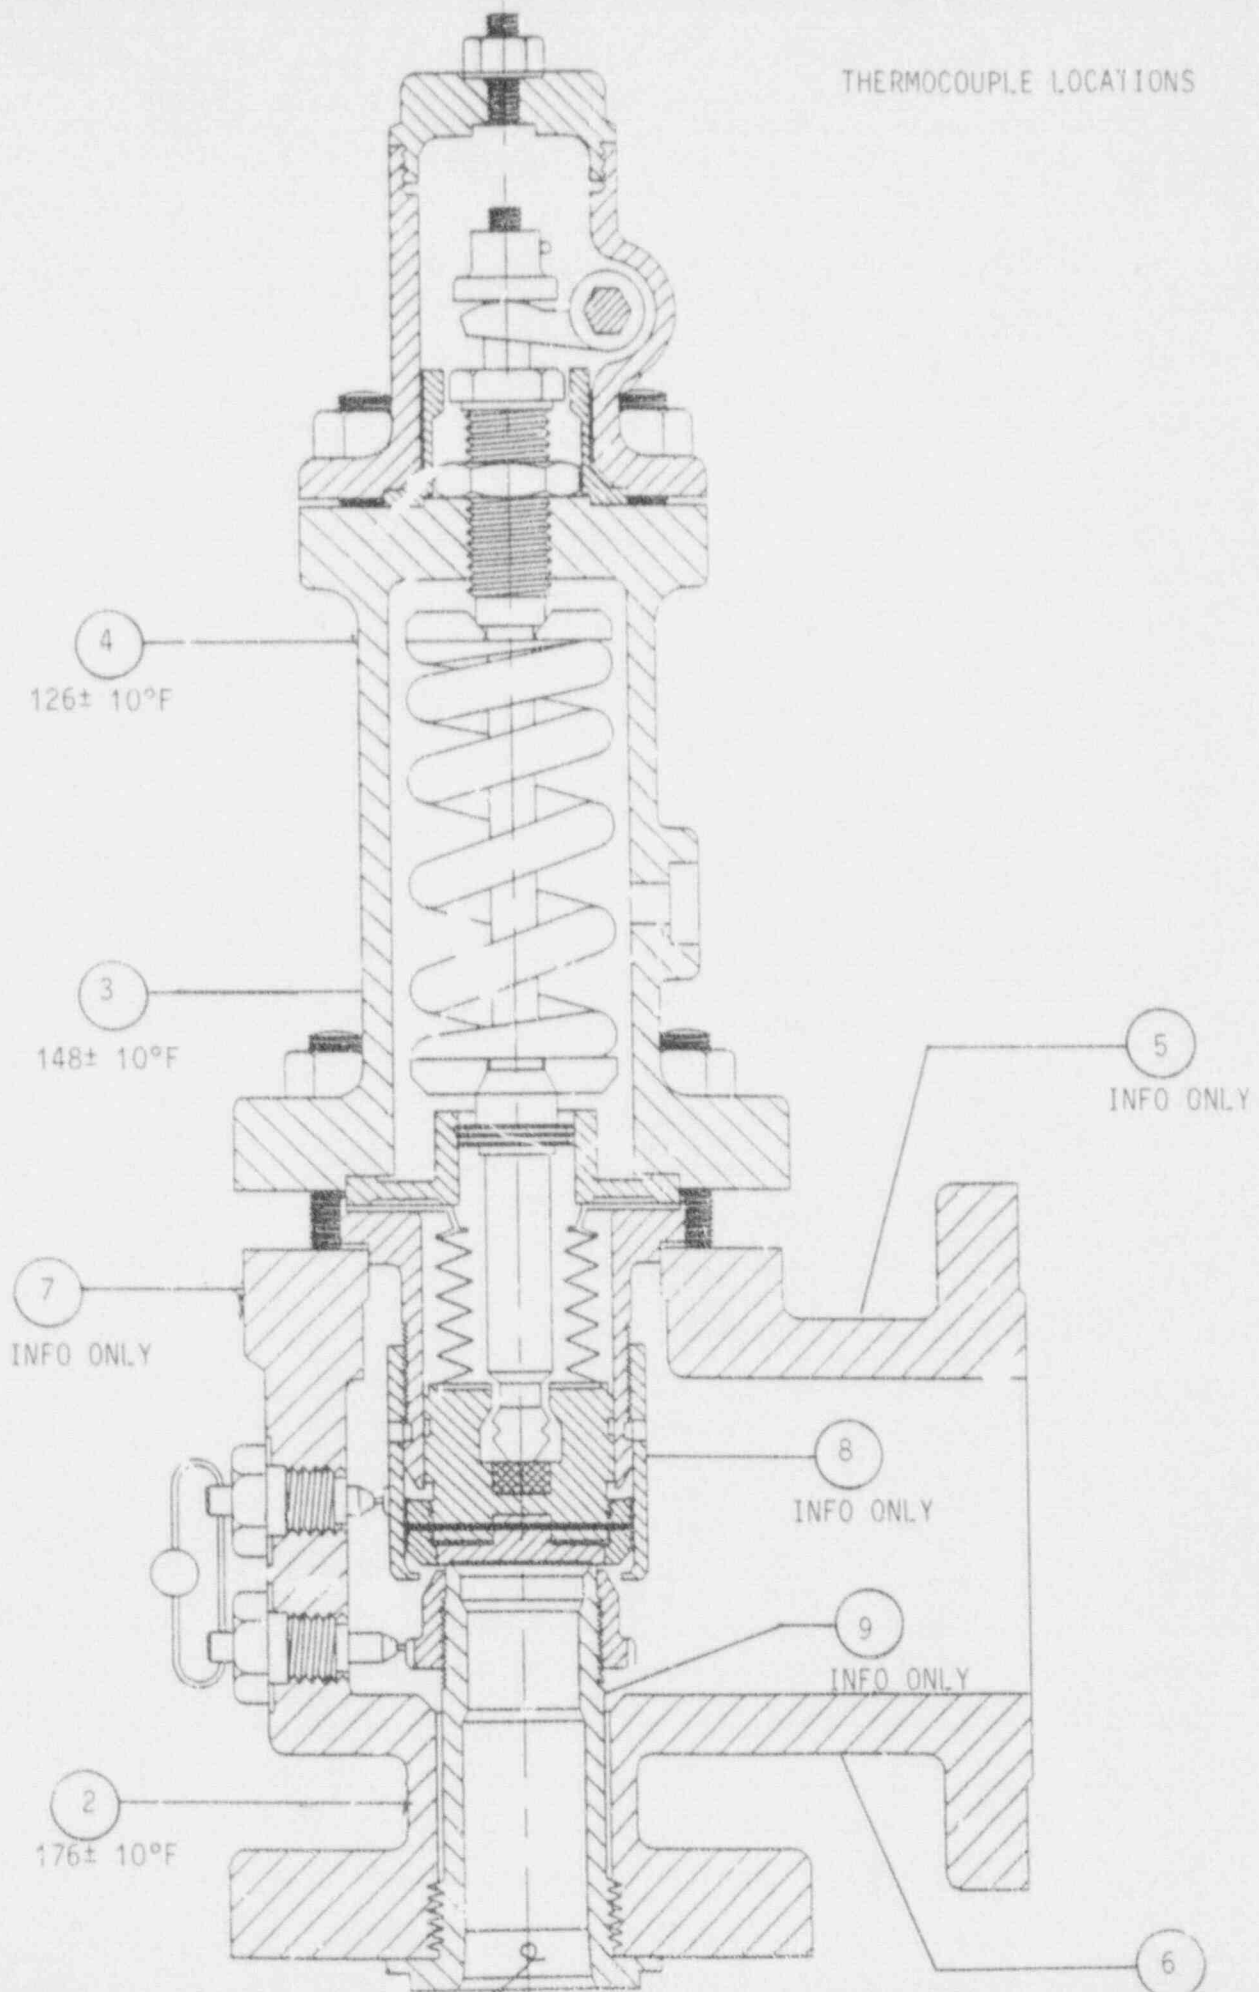
THERMOCOUPLE LOCATIONS

Set pressure tests were performed to first determine the set pressures of the valves under simulated normal operating conditions of the plant and then the set pressures of the valves were adjusted and the valves tested under steam conditions in accordance with Wyle Test Procedure Number 41011, Revision A, as modified by OPPD engineering and dated August 29, 1992. To simulate the normal plant operating conditions with the valve mounted on a loop seal, an attempt was made to thermally stabilize the valve using low pressure steam at 235°F at the inlet of the valve in order to obtain temperatures of  $176^{\circ} \pm 10^{\circ}\text{F}$  at the body inlet neck,  $148^{\circ} \pm 10^{\circ}\text{F}$  at the lower bonnet, and  $126^{\circ} \pm 10^{\circ}\text{F}$  at the upper bonnet of the valve. Thermocouples were installed on the valve at these locations and the valve was insulated using the Fort Calhoun valve insulation materials. The stabilization temperatures were based on temperature measurements obtained from in-situ test data. In addition, thermocouples were installed on the valve at the upper body, the upper, and

lower portions of the outlet flange neck, the nozzle and the adjusting ring for information purposes (see Attachment C for thermocouple locations).

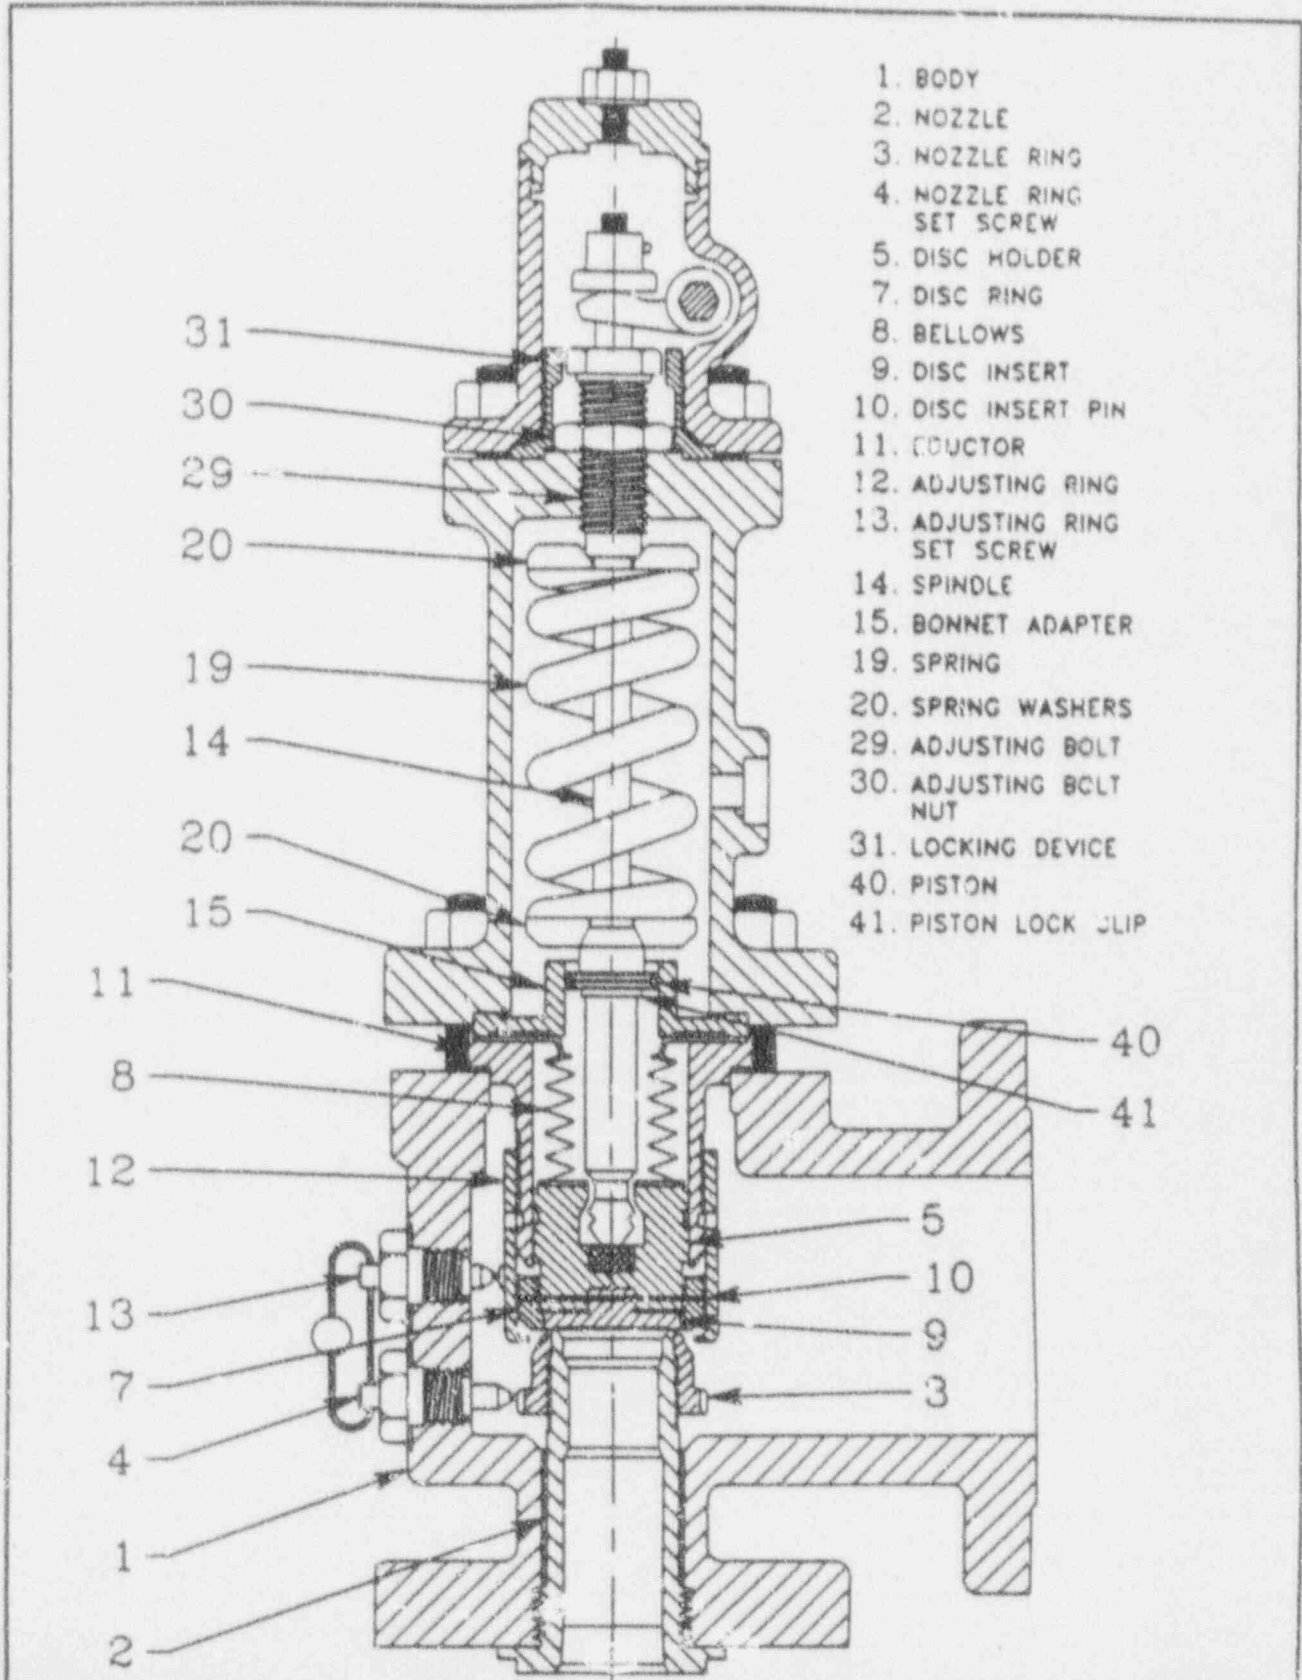
**PRESSURIZER SAFETY VALVE (RC-141/142)**

The receipt inspection of RC-142 included a partial disassembly of the valve which was performed to determine if any of the valve internal components had been damaged during the event. The valve cap was removed, the nozzle ring and adjusting ring were checked for binding, and a jacking device was used to compress the spring and lift the valve internals off of the nozzle seat so that the valve could be disassembled without disturbing the valve set pressure. During disassembly, the only damage noted were a few nicks and scratches on the nozzle seat. The valve seats were lapped with a minimal material removal (<0.001 inches), and the valve was reassembled for testing.
