LOUISIANA POWER & LIGHT COMPANY

WATERFORD SES, UNIT NO. 3

PRE LICENSING ISSUES

FINAL REPORT

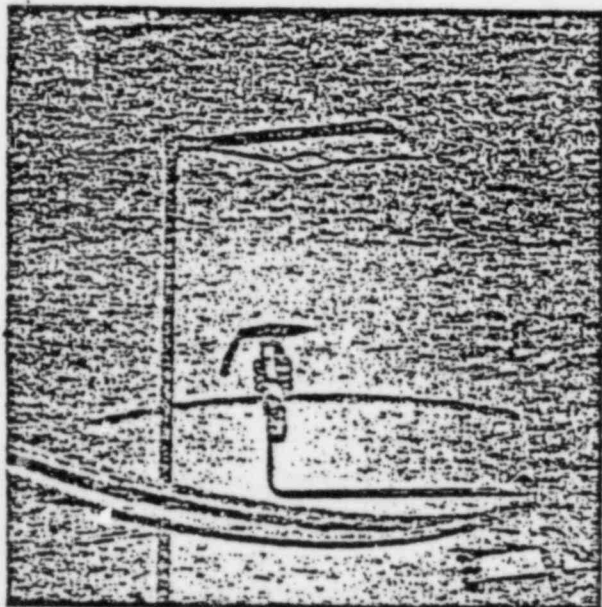
SUBJECT RCB Walkdown - Problem I.D #1

Problem Identification: 1" line from top of the fitting
 to UNSCR Tubing. Supports still need to be installed
 on line ZSE-1609-4 (value shown)

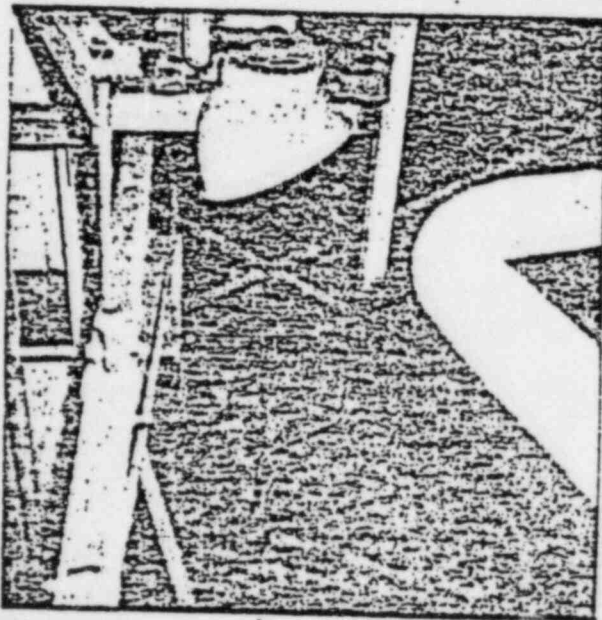
SUBJECT RUB Walkdown - Problem I.D #2

Problem Identification: 2" Ø FP line over intake cabinet 6-20.
line supported by Ribs only. Box under line labeled "Sound"
RUB

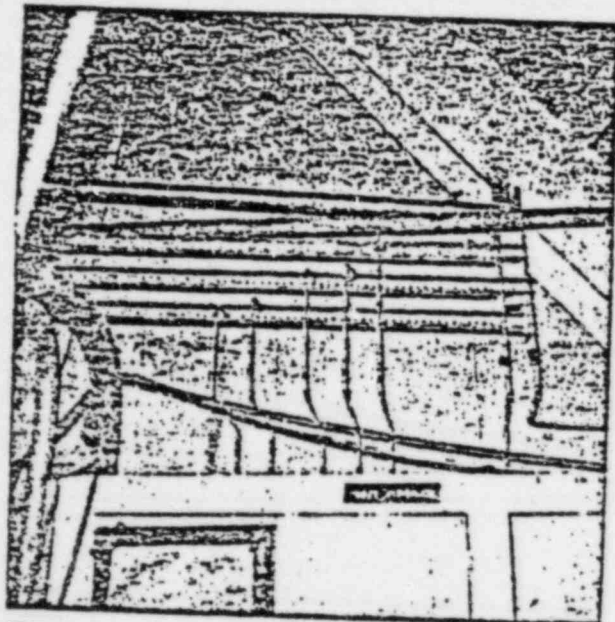
SUBJECT RLB Walkdown - Problem I.D 3

Problem Identification: 2" ϕ AP line on RLB running above & over base line & cabinet 2-9" Space line is problem #2

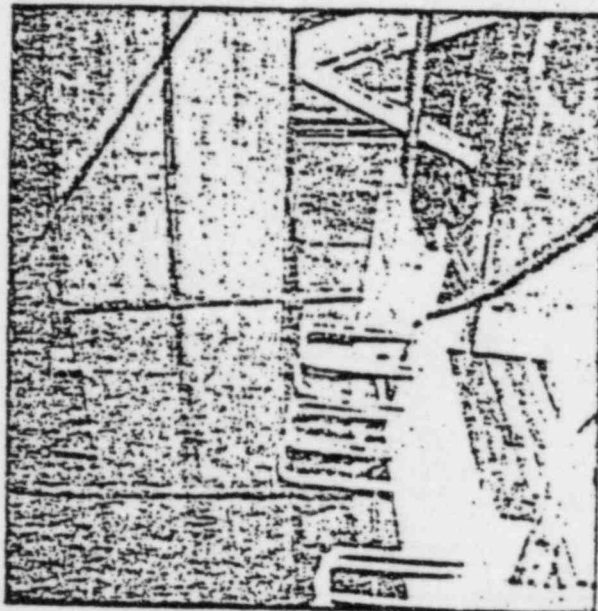
SUBJECT RUB Walkdown - Problem I.D. #4

Problem Identification: 8FP3-43 could perhaps find and hit
 the line, exp. loops and finally cabinet C-6B
 (Note, FP line is above & behind exp. loops in picture)
 (Cabinet in pic. is C-6B, C-6A right next to it in some pictures)
 Location: -4.0 @ Col. 7, background well is secondary
 shield well
