To: Sherwin E. Turk
Deputy Assistant Chief Hearing Counsel, DELD

From: J. T. Chen, Geotechnical Engineer
EGEP/DE/NRR

Subject: APPLICANT'S RESPONSE TO STAFF AFFIDAVITS FILED IN THE
WATERFORD PROCEEDING

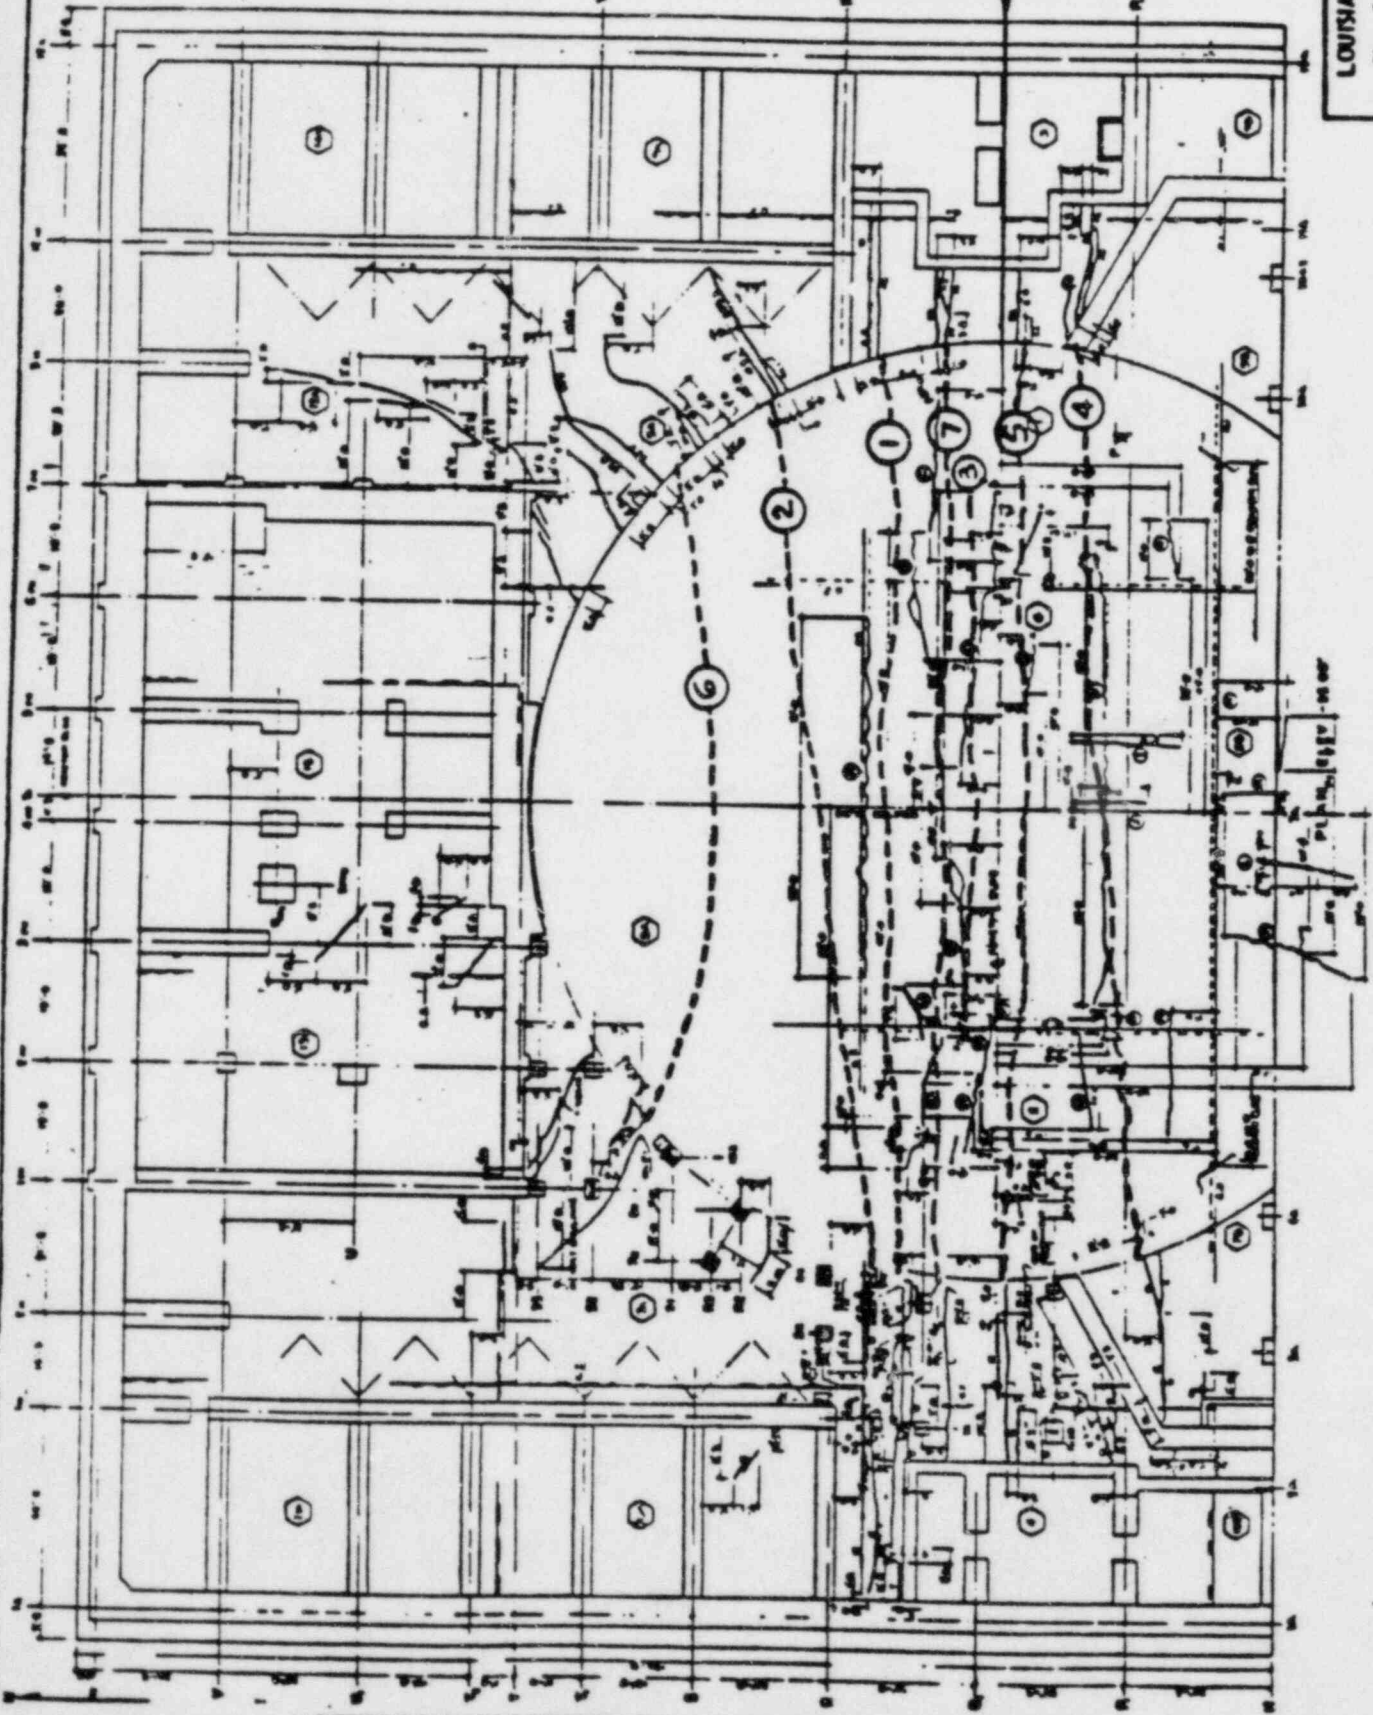
LOUISIANA POWER & LIGHT CO.
Waterford Steam Electric Station
BASE MAT
CRACK MAP
FIGURE 1

5. The cracking pattern was cited to be symmetric with the centerline of the reactor building (Ehasz Affidavit, page 15). However, the NDT results, as presented in Figure 1, clearly indicated that the cracking pattern is far from symmetric--5 major cracks were detected in the northern half of the reactor building while only 2 major cracks were detected in the southern half of the reactor building (see Figures 1 & 5).

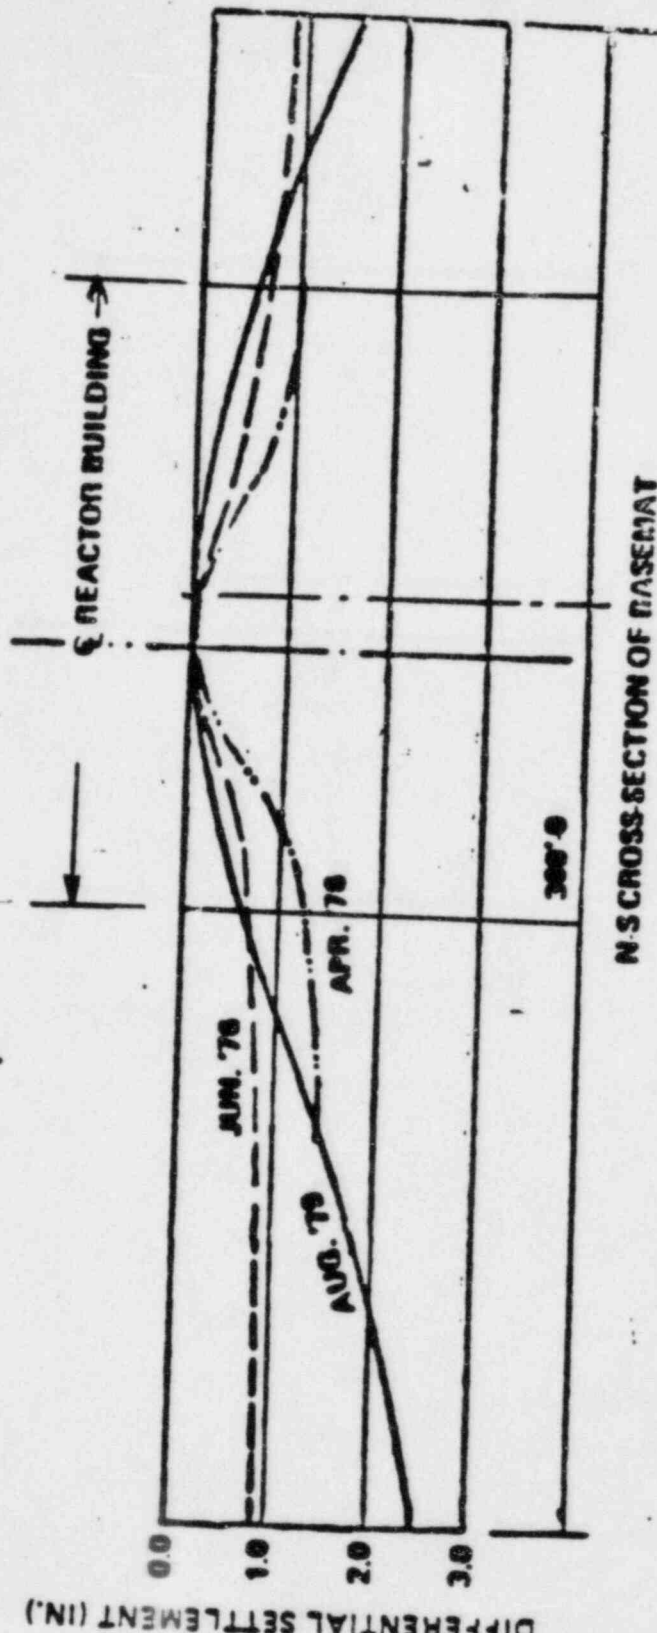
3. Figure 2 was used to illustrate the convexity of the basemat during construction (Ehasz Affidavit, page 12). However, the validity of this figure is questionable because it lacks measured data in the containment area to back it up. Based on LP&L's March 1984 submittal, settlements within the containment area were not surveyed since mid March 1976 due to the inaccessibility to the surveying pins. Therefore, the "actual" settlements within the containment area as shown in Figure 2 was imagined by LP&L, not necessarily be real. The measured settlements outside the containment area, however, showed that the top of the basemat has a concaved shape (see Figure 3). The data available directly measured data within the containment area (March 1976 data), also, showed a somewhat concaved shape (see Figure 4). Therefore, LP&L's statement about the convexity of the basemat, "As illustrated in Figure 2...reactor building centerline.", is somehow questionable!
