SUBJECT: COMMENTS ON THE APPLICANT'S RESPONSE TO STAFF AFFIDAVITS FILED
IN THE WATERFORD PROCEEDING

SUBJECT: Waterford 3 SES
Docket No. 50-382
Response to NRC Basemat Questions

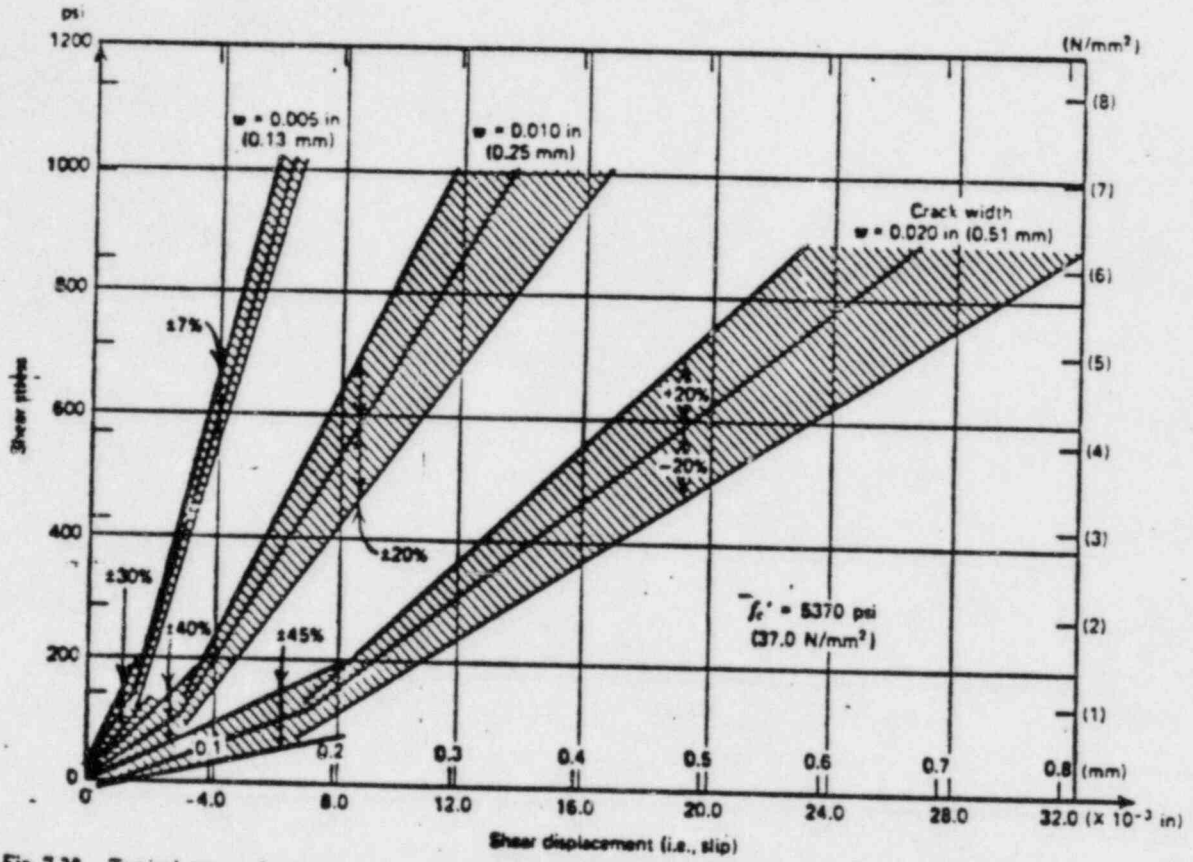
Laboratory testing results have indicated that the shear stiffness of a crack section is influenced by many factors, such as test methods, the amount of reinforcing steel across the crack surfaces and its distribution along the depth of the crack section, and size effect. Nevertheless, test data have confirmed that the crack width is the most important factor influencing the shear stiffness. The pictorial test data in Enclosure 1 present a good indication of the amount of reduction in shear stiffness versus crack widths with other factors being kept constant. The test data have also negated the Applicant's claim that "...there is [the crack's result] no change in the rigidity [stiffness] of the mat and no effect upon the dynamic response of the basemat to the earthquake." (Ehasz's affidavit, Attachment 1, page 23).

Fig. 7.28. Typical mean shear stress-shear displacement relationships for aggregate interlock mechanism.^{7,11}
