Contaminated Mexican Steel Incident

Importation of Steel Into the United States That Had Been
Inadvertently Contaminated With Cobalt-60 as a Result of
Scrapping of a Teletherapy Unit

**U.S. Nuclear Regulatory
Commission**

Office of Inspection and Enforcement

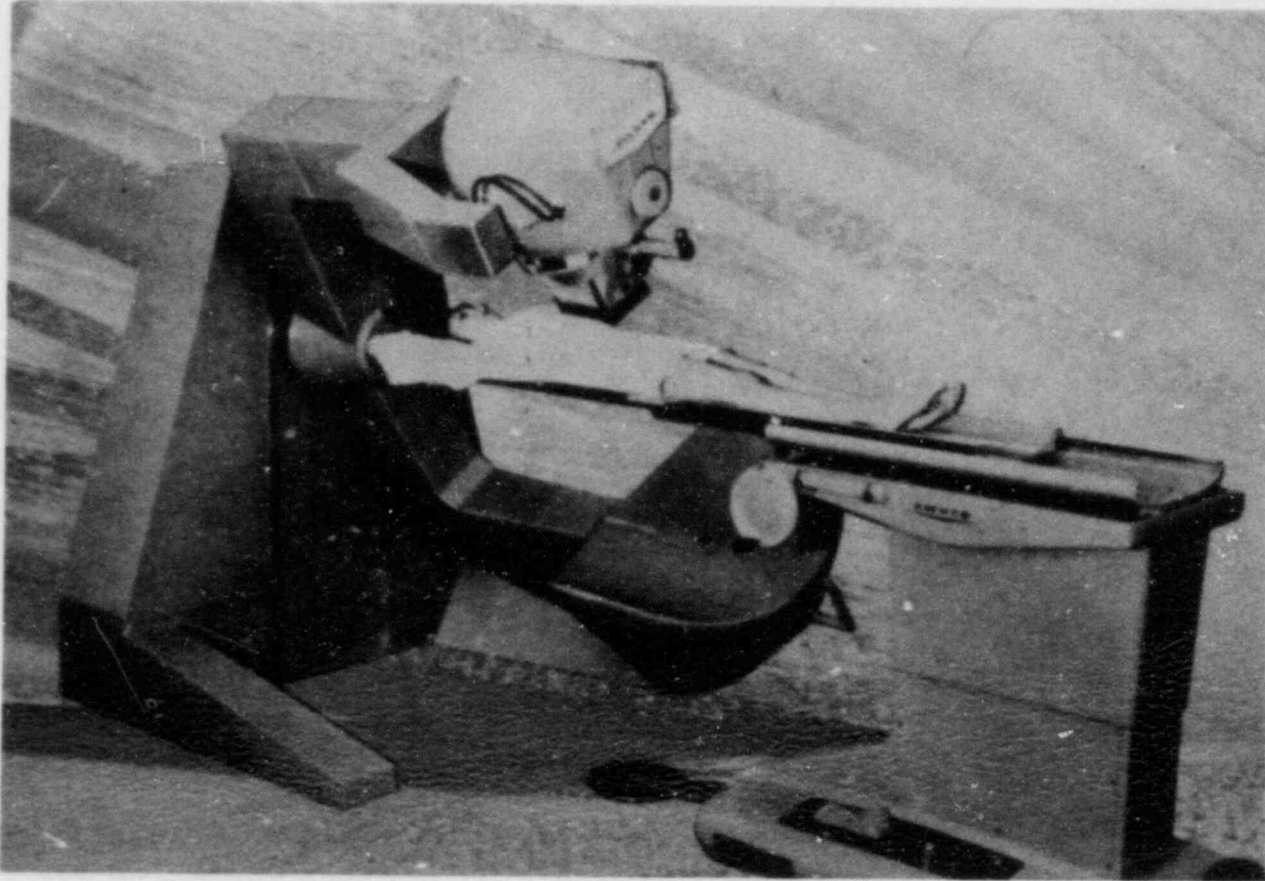
* During the course of the investigation to identify the source, Advance Medical Systems indicated that in 1982, the Picker C-3000 unit had been declared obsolete because of an apparent structural defect in the "C" arm mechanism. Because structural failure of the "C" arm, while the machine was in operation, could have resulted in the arm collapsing on a patient causing injury or death, the company notified owners of the C-3000 unit and recommended that they be scrapped. In addition, the company informed owners that no new sources would be installed in these units unless the owner legally released the company of responsibility for structural failure (see Appendix D).

Figure 3.1 Picker C-3000 (75cm SAD) cobalt therapy unit

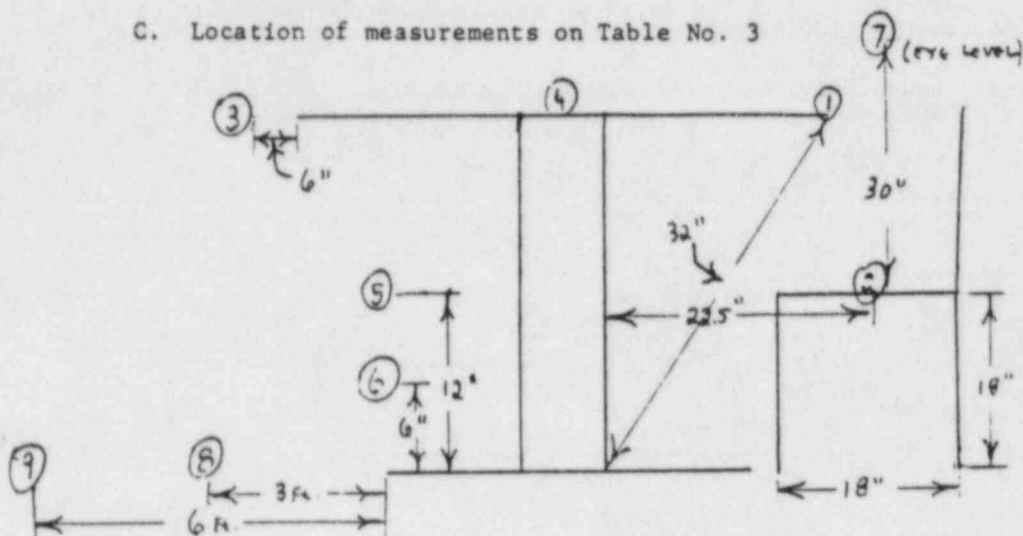
C. Location of measurements on Table No. 3

Position No.	μ R meter	PIC-6A	Eberline E-520
1	2.4	2.6	2.6
2	3.0	3.4	3.4
3	2.0	2.0	2.0
4	2.4	2.4	2.6
5	-	17	16
6	-	35	50
7	1.3	-	1.0
8	1.2	1.5	1.4
9	0.3	-	0.4
