Subject: Oconee Nuclear Station, Units 1, 2, and 3
Docket Nos. 50-269, -270, -287

Duke Power Company
Oconee Nuclear Station
Special Report

230KV Overhead Line Between Keowee and
Oconee Isolated Due to Opening of PCB-9

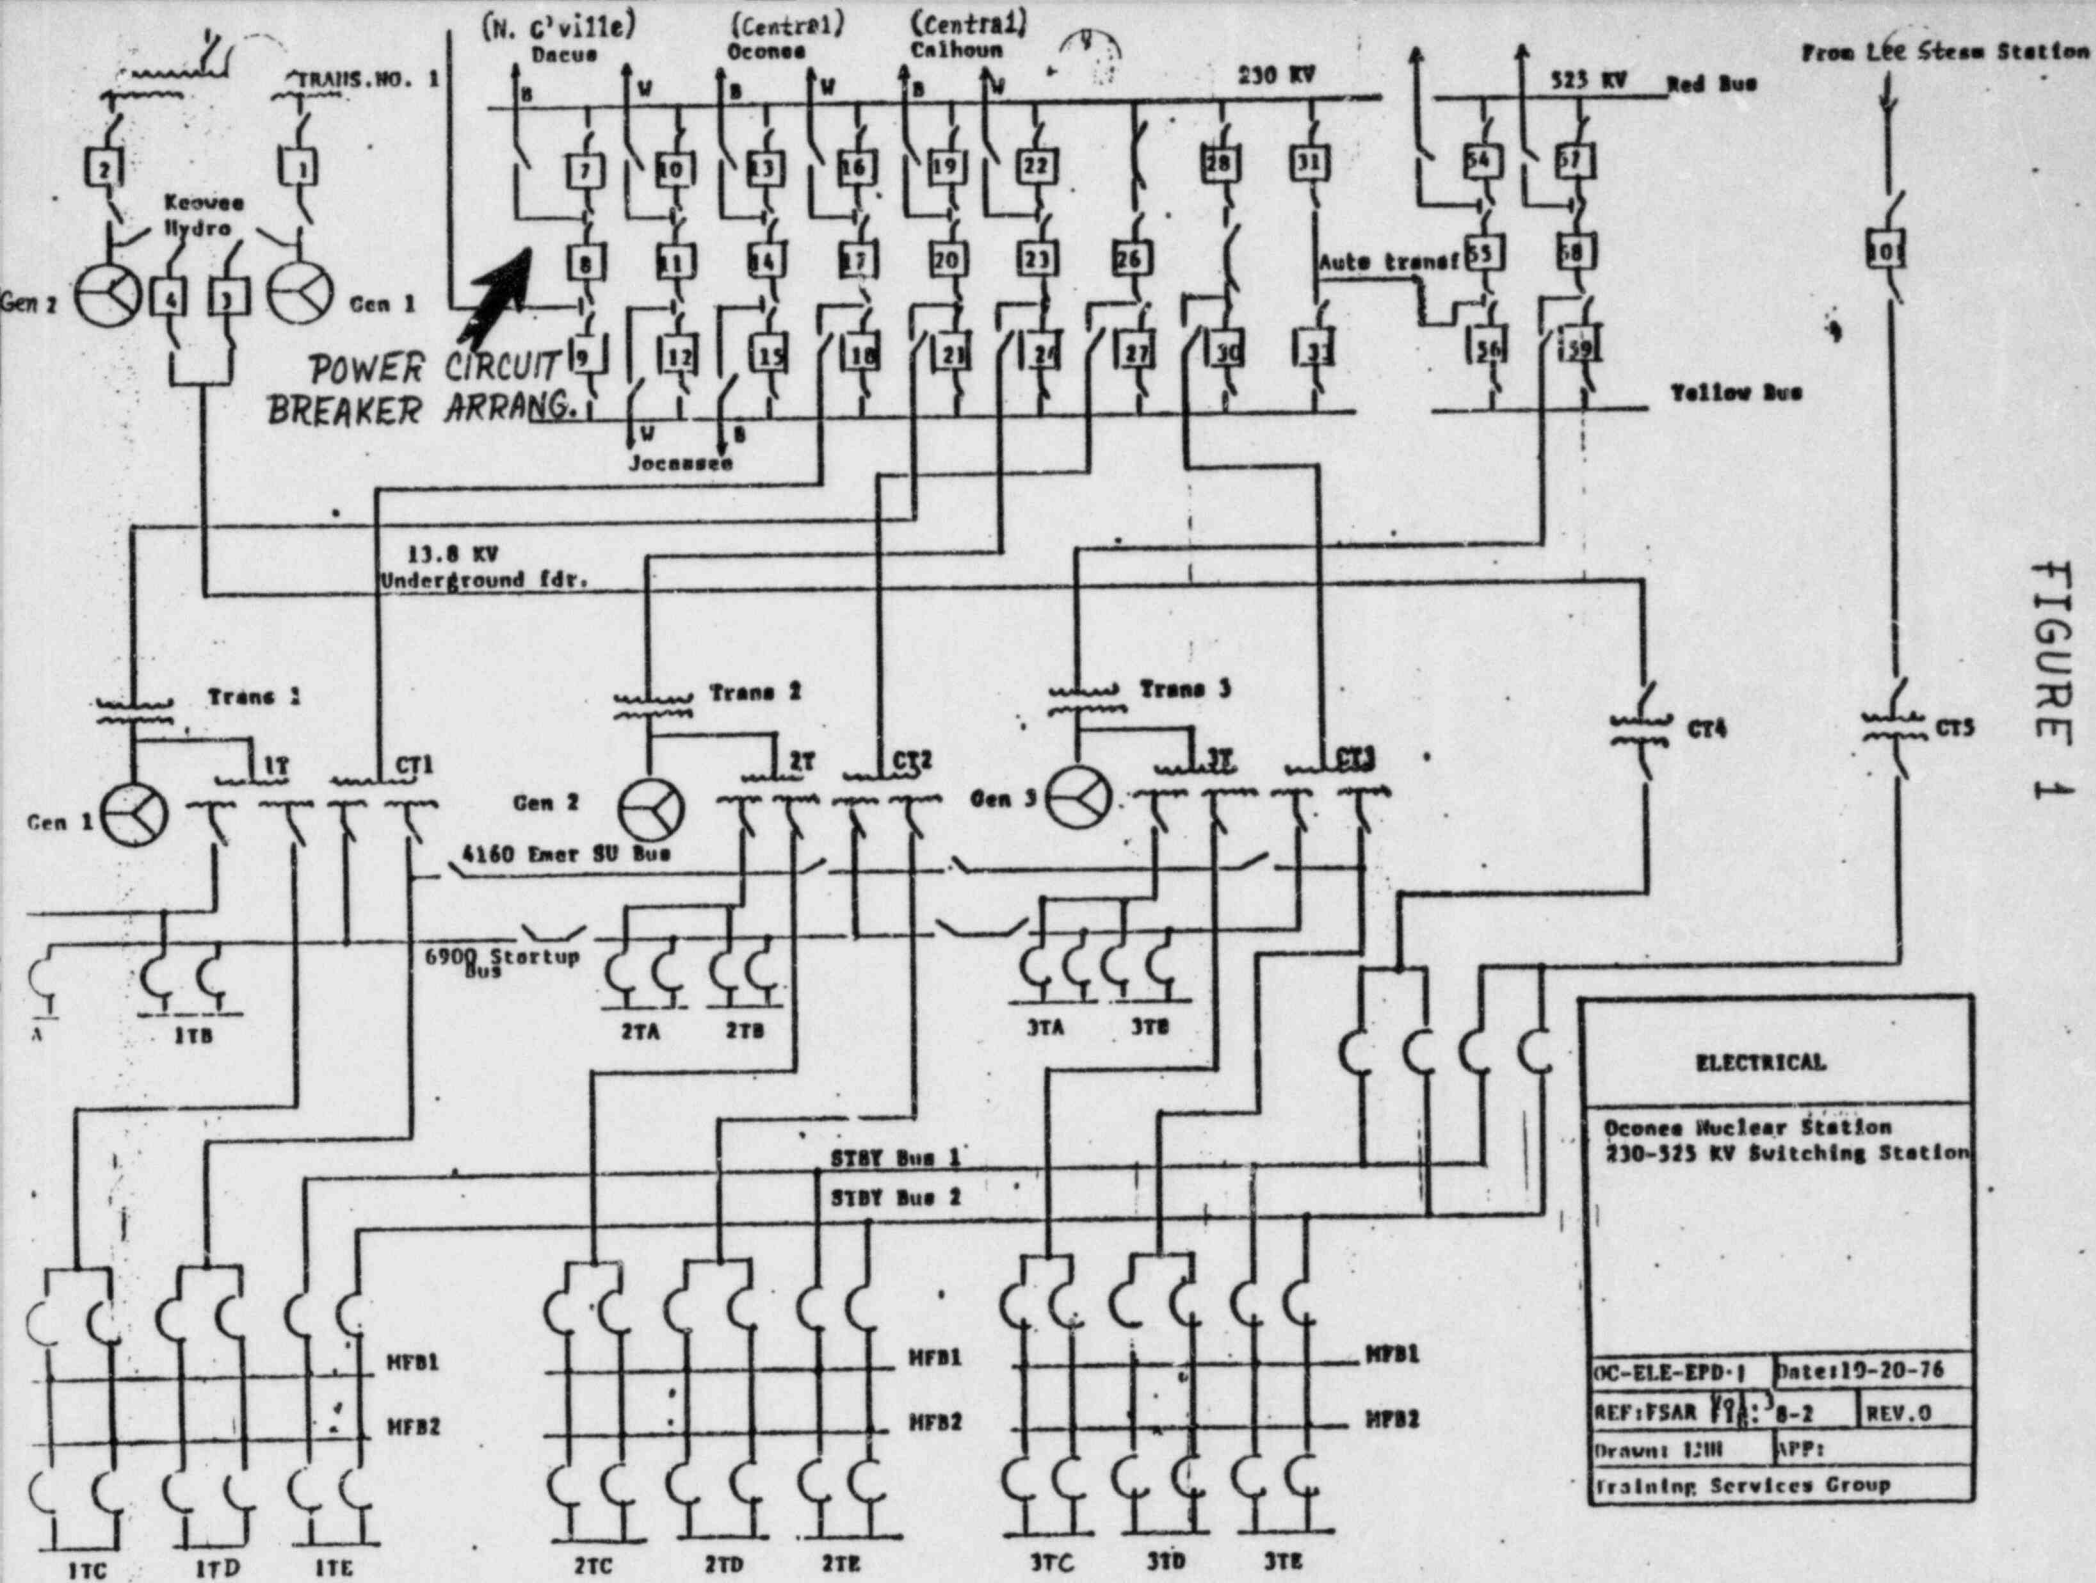
FIGURE 1

On September 28, 1984 at 1321 hours, Power Circuit Breaker (PCB) 22 explosively short-circuited while being put back into service following the repair of an SF₆ gas leak. The short circuit tripped PCB-22 which caused a red bus differential lockout and opened PCBs 7, 8, 9, 10, 13, 16, 19, 23, 26, 28, and 31. The unexpected opening of PCB-9 isolated the 230KV overhead line from the Keowee Hydroelectric Station (the primary emergency AC power source) resulting in operation contrary to an applicable technical specification: The technical specification states that when one Keowee unit is unavailable for longer than 72 hours, then the remaining unit shall be available to the 230KV overhead transmission circuit. Keowee Unit 2 was unavailable due to a scheduled maintenance outage. Operations personnel determined that the safest manner in which to resume operation under the technical specification was to close PCB-9; this was done after confirmation that the red bus differential lockout indeed had been caused by the PCB-22 failure. The red bus differential lockout was reset at 1427 hours and PCBs 7, 8, 10, 13, 16, 19, 26, 28, and 31 were reclosed. PCB-22 was isolated so that its inspection and repair could begin. PCB-23 was reclosed at 1521 hours following an inspection for possible damage due to its proximity to the PCB-22 explosion.

Figure 1 is an electrical schematic diagram of the Oconee switching station which shows the relative positions of the various breakers. A drawing of power circuit breaker PCB-22 is included as Figure 2. The short circuit occurred inside the third (3rd) phase section of PCB-22. The porcelain insulator on the west side of this section was shattered by the short circuit. The cause of the short circuit had not been determined as of October 3rd.

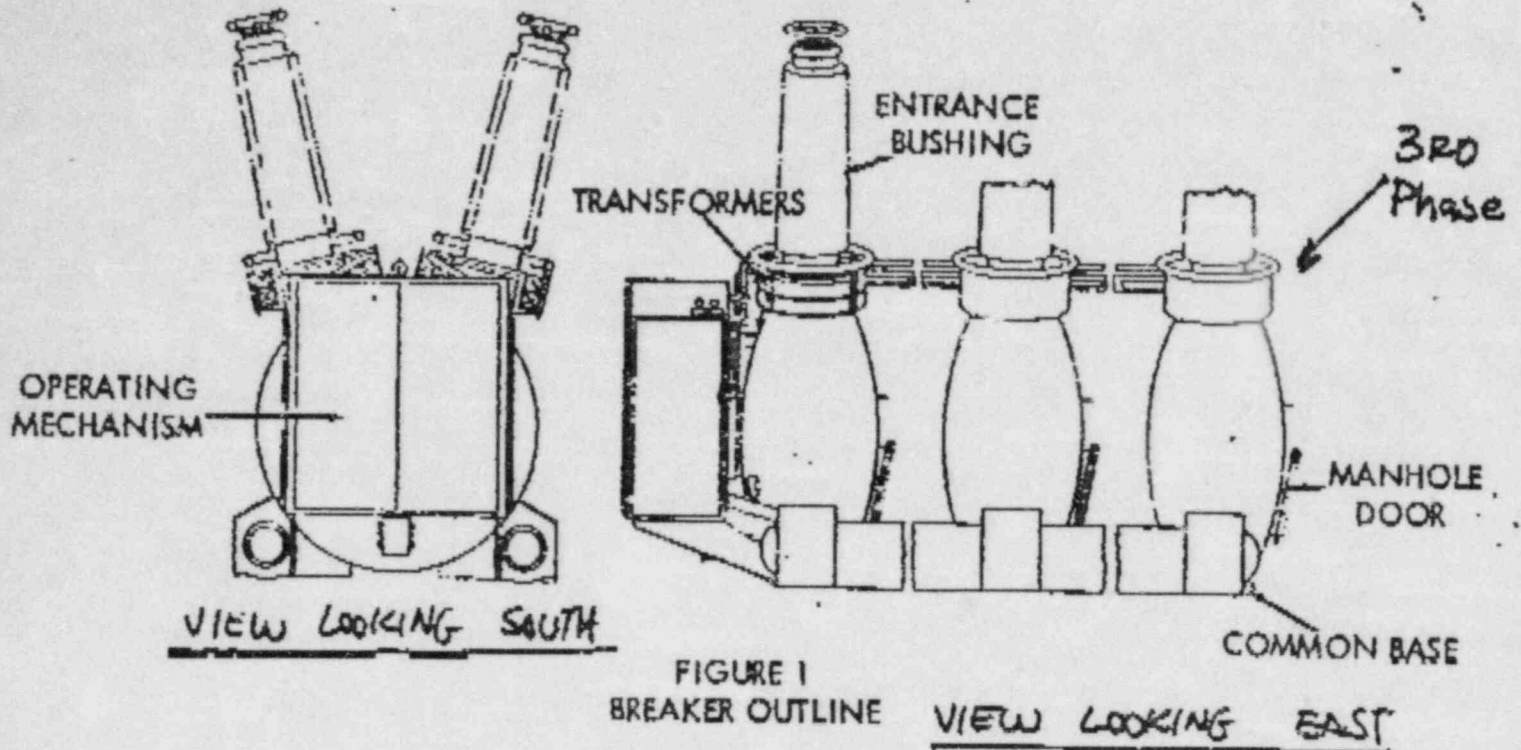
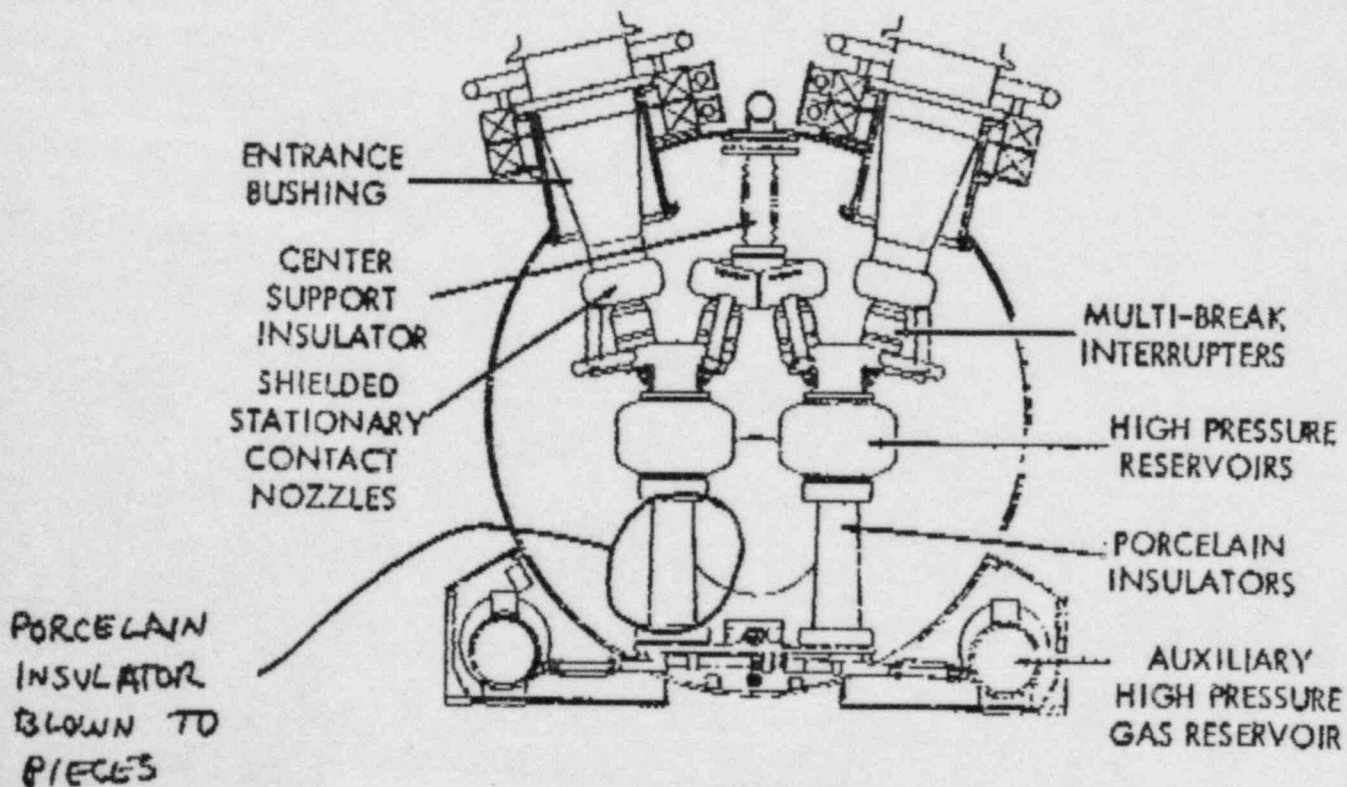
FIGURE 2

An SF₆ gas leak had been identified prior to September 25, 1984 when PCB-22 was isolated for maintenance. The leak was found in a cracked weld in the lower part of the third (3rd) phase support section. The weld was repaired but a smaller leak still existed on September 28, when PCB-22 was being put back into service. The leak was small enough that PCB-22 was to be put into service during the period of September 29th and 30th and then removed from service October 1st for the smaller gas leak to be repaired.

Following an on-the-spot safety evaluation by Operations personnel, PCB-9 was reclosed, thus ensuring that station operation would proceed in accordance with the technical specification. The Keowee Unit 2 maintenance outage was completed earlier than scheduled and a routine maintenance step requires Unit 1 to be temporarily removed from service so that both units can be returned to service. Return of the units is expected by October 5, 1984, at which time the affected technical specification will no longer apply. Repair work is proceeding on PCB-22. While the Keowee units are out of service, tests using input signals are being conducted to determine why PCBs 8 and 9 opened on the red bus differential lockout.
