UNITED STATES
NUCLEAR REGULATORY COMMISSION
WASHINGTON, D. C. 20555

In early July I directed my staff, with assistance from Region IV, to perform an audit of Fort St. Vrain operations including problem areas associated with the June 23, 1984 event regarding the failure of a number of control rods to insert.

This preliminary report documents the NRC's special assessment of the operation of Fort St. Vrain Nuclear Generating Station (FSV). This assessment was requested by the Director, Office of Nuclear Reactor Regulation as a result of his review of several operating problems that occurred at Fort St. Vrain. This plant, which is located in Weld County, Colorado, is owned and operated by the Public Service Company of Colorado (PSC). Based on the results of this assessment, which found problems in each audit area, the staff has concluded that Fort St. Vrain not be restarted until all control rod drives have been inspected and refurbished or until modifications have been made or other appropriate corrective actions have been taken, that will provide reasonable assurance that the control rods will scram automatically on receipt of a scram signal. This report is preliminary in that vari

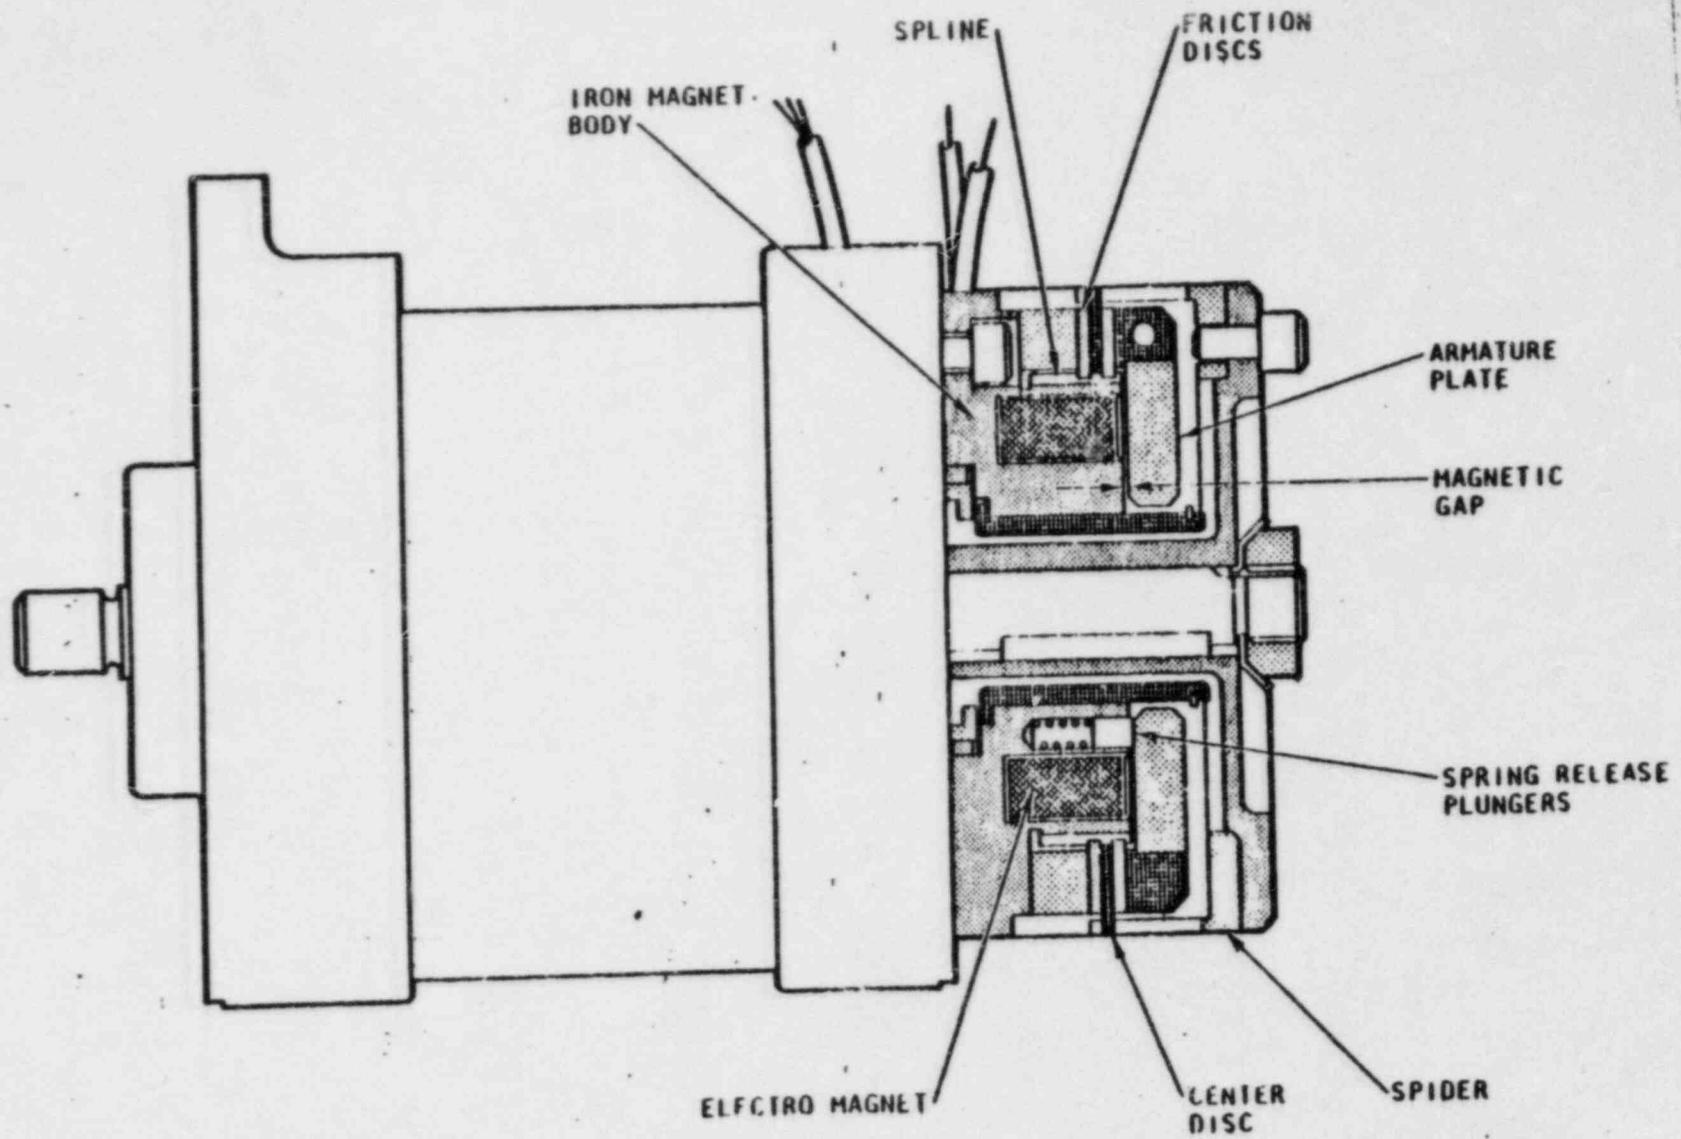
FIGURE 2 Control Rod Drive Brake

Another materials aspect is the possibility that at elevated temperatures, a reduced spring constant coupled with increased remanence of the magnetized disc may have kept the brake from disengaging (remanence is the induced magnetism remaining in a material when the magnetizing force is reduced to zero). This is not considered a likely contributor to the control rod insertion failure.

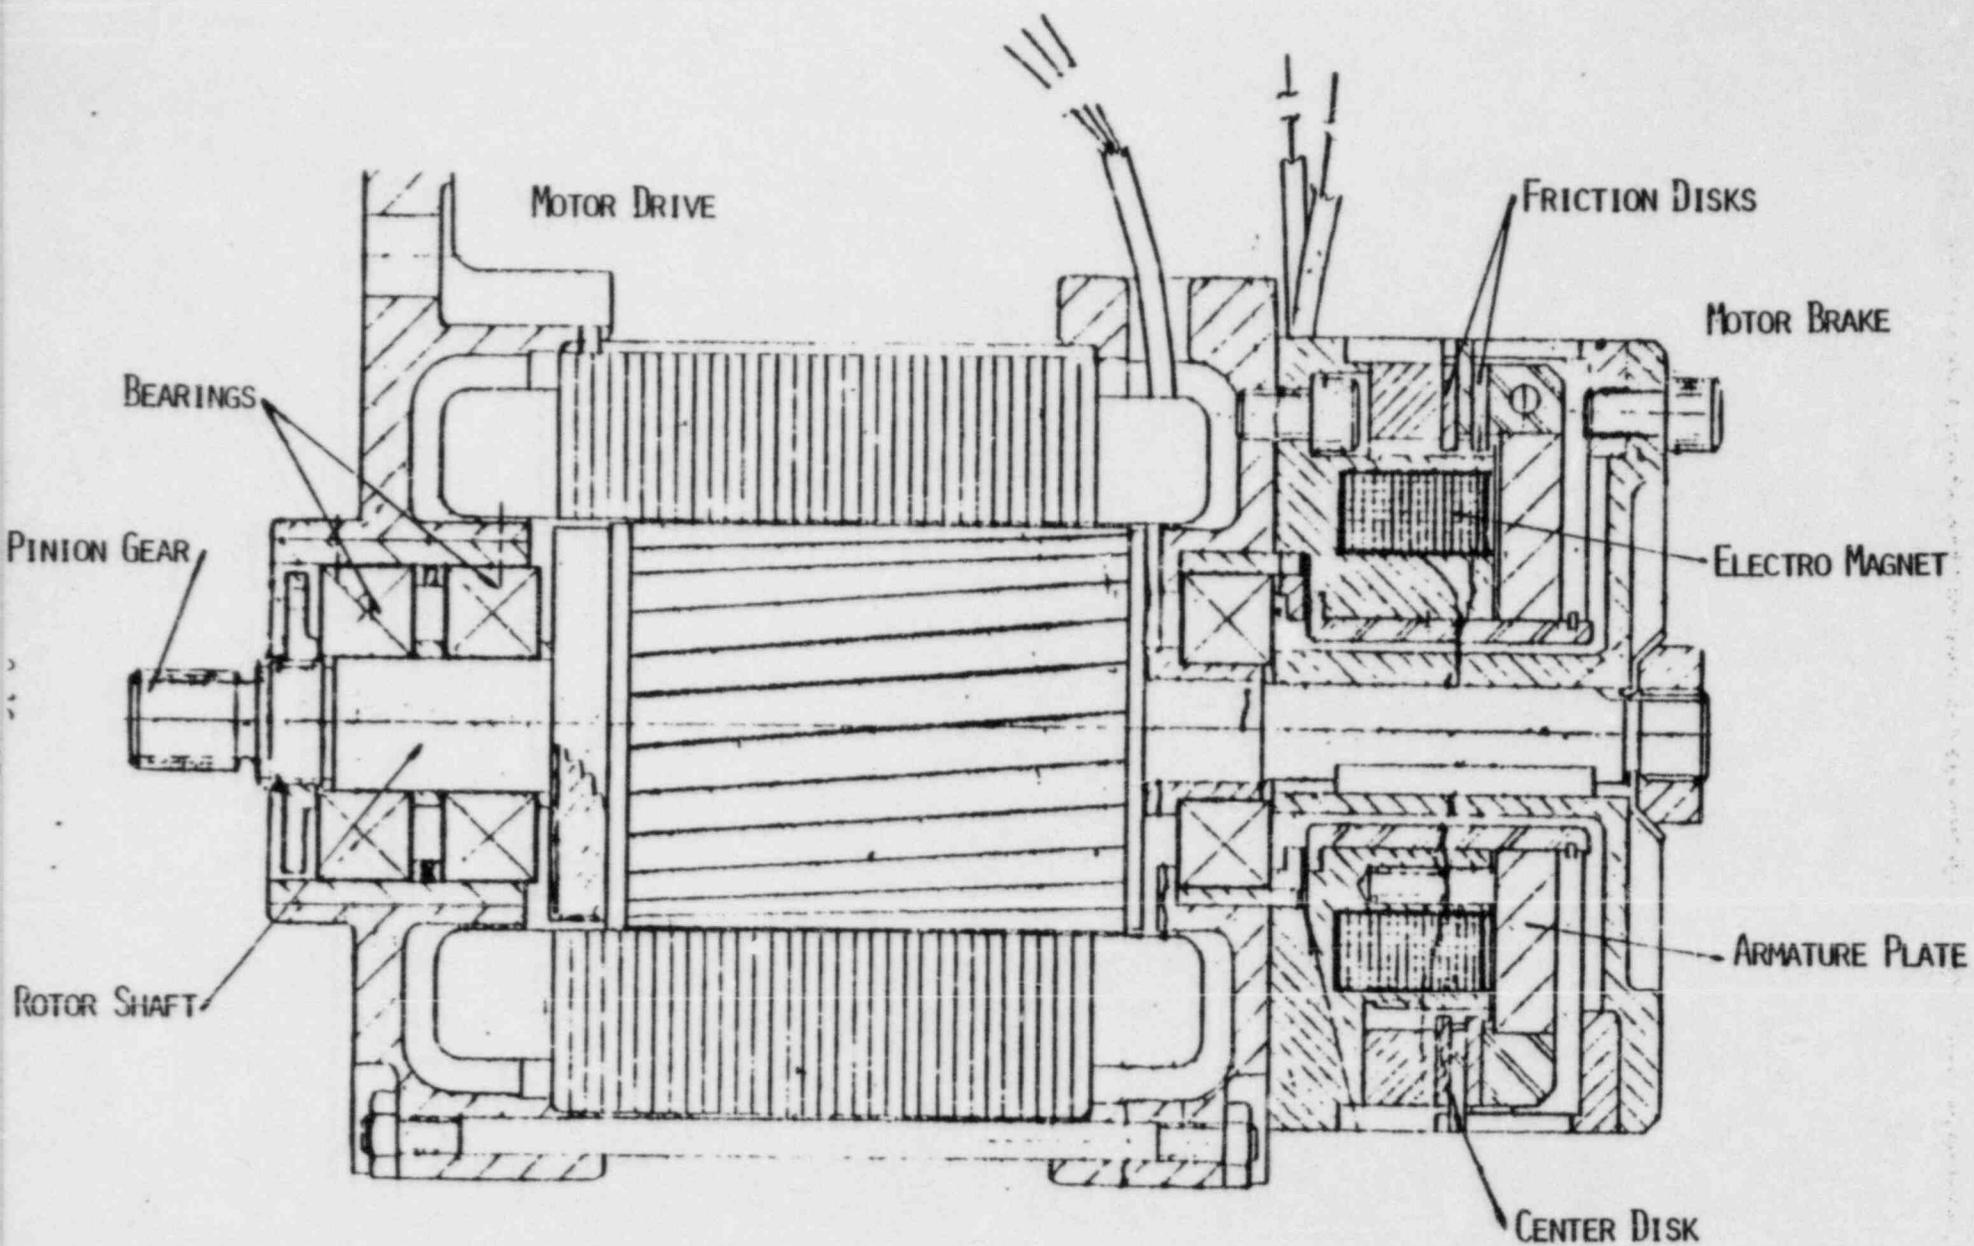
FIGURE 3 MOTOR & BRAKE ASS'Y

The motor/brake assembly from Region 14 showed adherent corrosion on all parts. Water drop patterns were observable on the top of the motor housing and water-staining appeared at the intersection of the center disk and spider in the brake. PSC personnel stated that several other CRDMs had previously shown similar water marks, implying that the CRDMs being examined were probably not very different in appearance from the remainder of the CRDMs in the reactor.

A videotape of the Region 7 mechanism showed the disassembly of the motor/brake assembly and the gears in the reduction train. Rust-type corrosion was evident on most of the CRDM components, but gear teeth surfaces were shiny and appeared to be meshing properly. From the amount of corrosion and its appearance, it can be concluded that the corrosion process has been long term.

An unknown quantity and composition of dusty debris, appearing to be "old" rust, blanketed the CRDM and the housing and was found between the rotor and stator in the motor drive. The black, dusty debris was somewhat magnetic; there was no evidence that it was graphitic. Magnetic debris could be from Fe_3O_4 (a type of corrosion product) or particles worn from the gears. The nonmagnetic grit was possibly from the dry lubricant or from the bronze-impregnated brake plate, if the assumption is made that graphitic material was not present. However, when asked whether the dry lubricant could contribute to the debris, PSC stated that the lubricant was burnished on the CRDM components in a very thin layer, providing lubrication up to 600°F. The effects of moisture on the dry lubricant are being investigated.

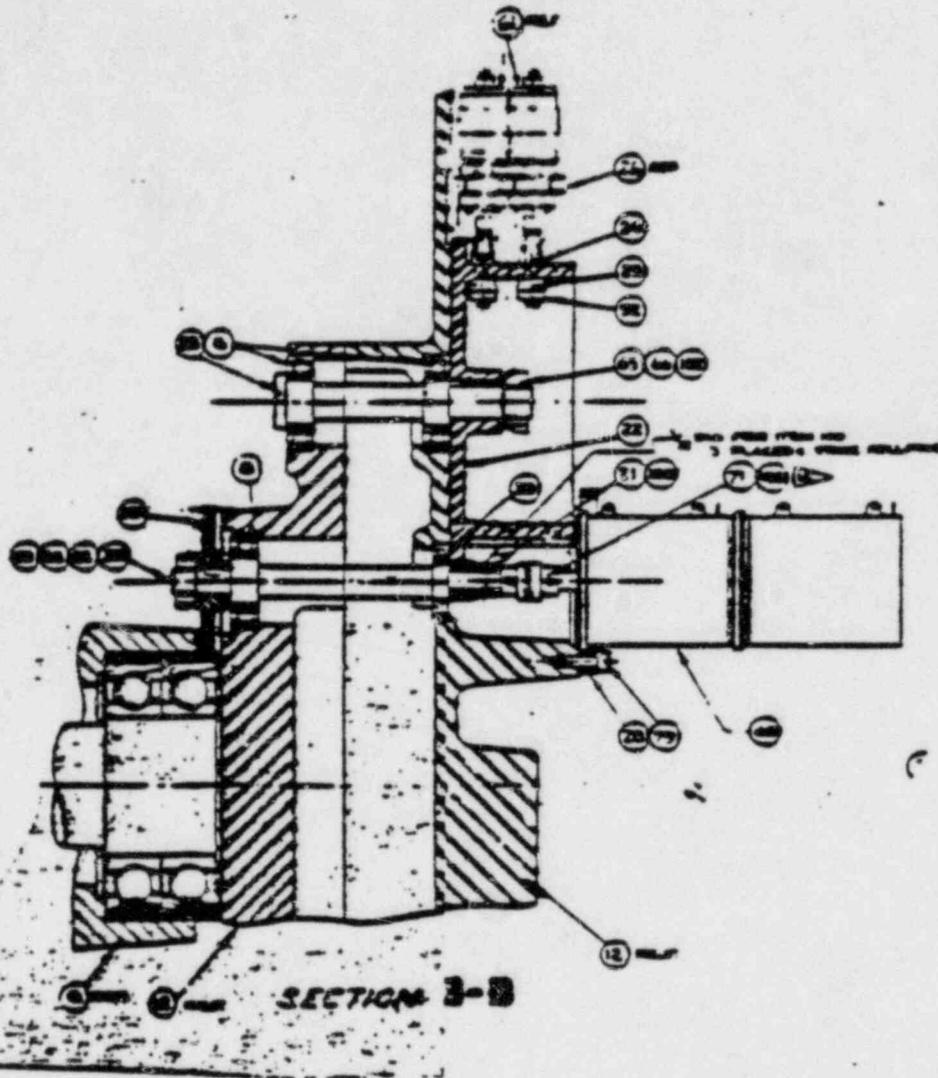
Fig. 3.2 Section BB of Drawing D-1201-200, Control Rod Assembly.

As previously mentioned, "rod-in" and "rod-out" position indication is provided by cam-actuated limit switches (the potentiometer shaft shown in Figure 3.2 also drives the cam wheel). At the full rod-in position, the cable anchor on the cable drum and the cam are at the 6 o'clock position, and both rod-in limit switches are actuated. Full rod travel (190 ± 1 inches) to the rod-out position causes the cam wheel to rotate clockwise $3/4$ turn, actuating the pair of rod-out limit switches. Limit switch actuation is indicated by steadily-lighted lamps in the control room.

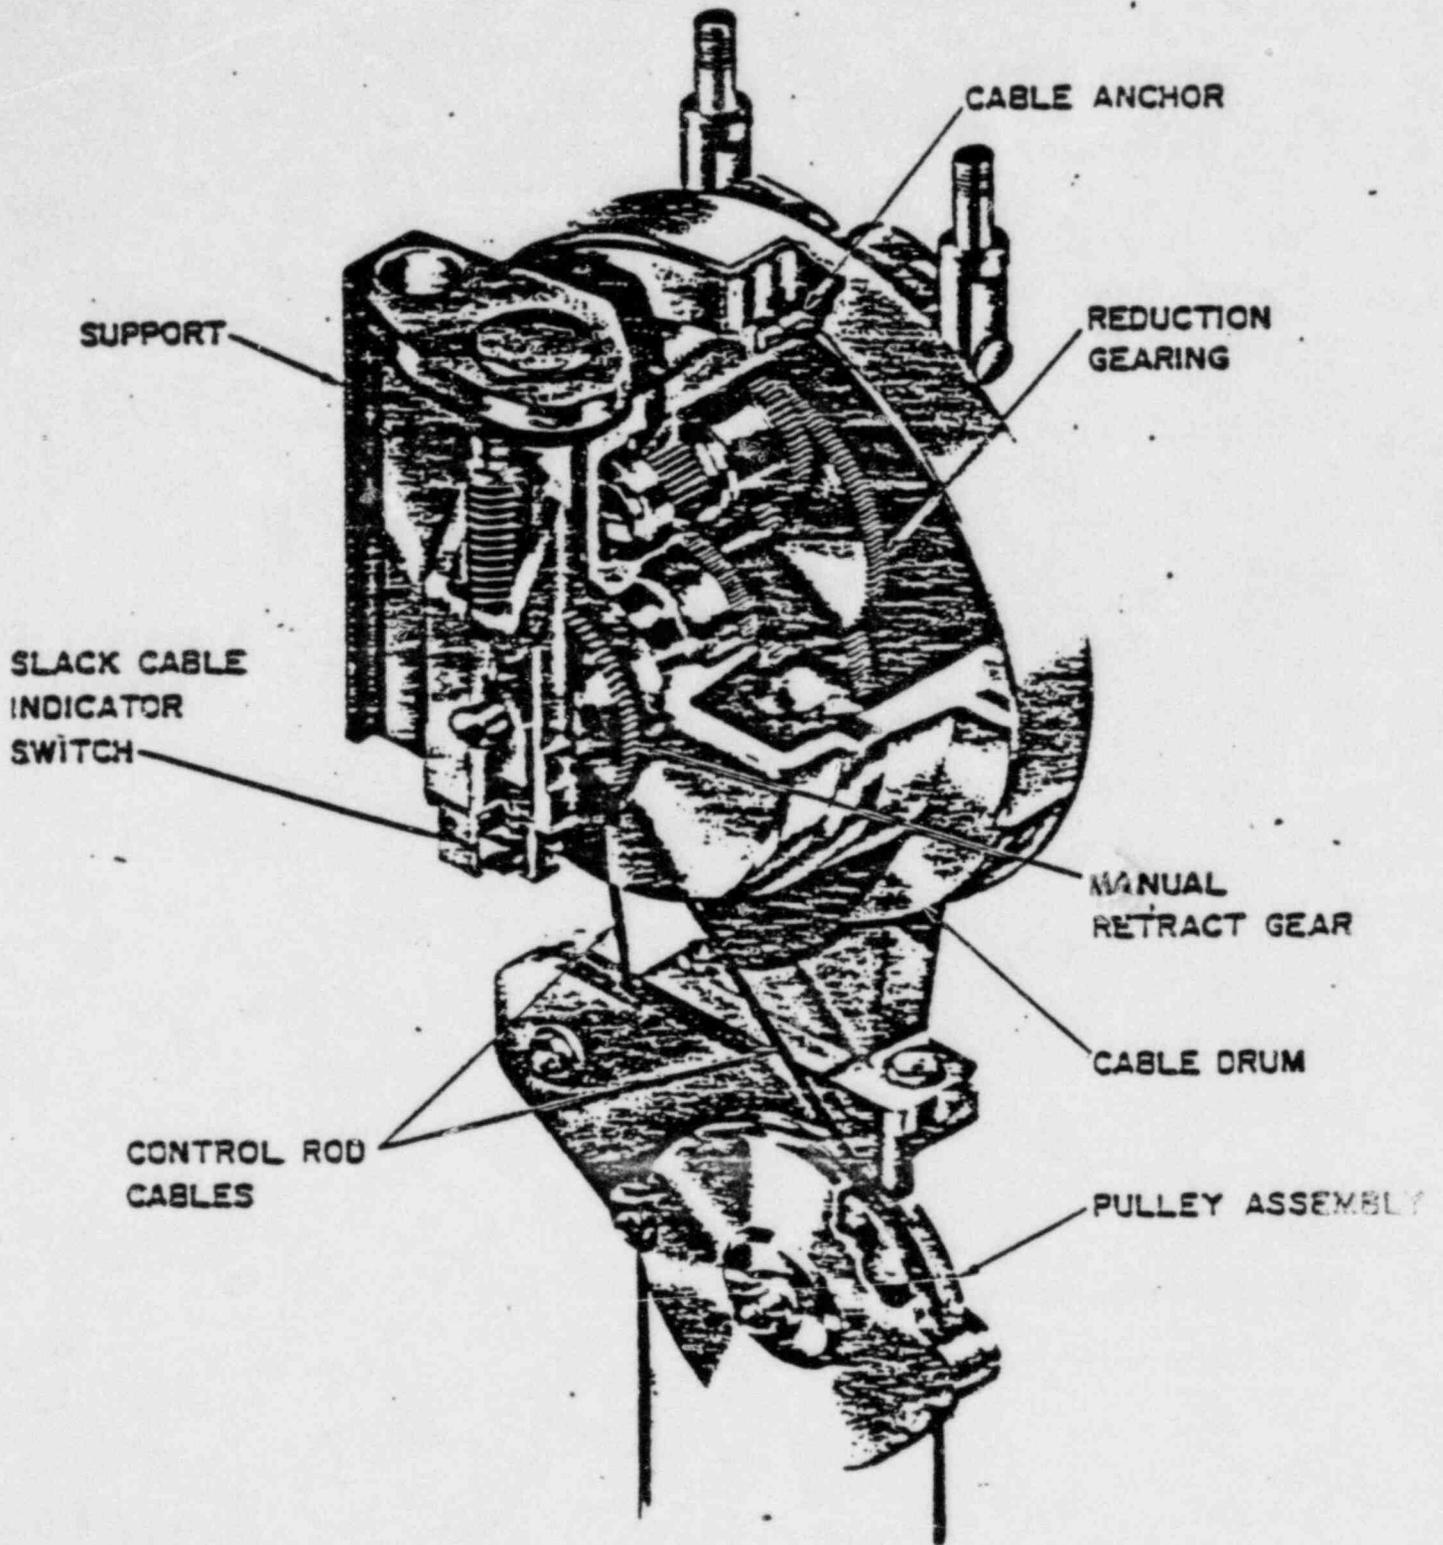
Figure 3.3 Control Rod Driver Mechanism

The slack-cable switch assembly shown in Figure 3.3 is provided for monitoring the tension in the cables supporting the control rod pair. The spring plunger exerts an upward force on the underside of the cable drum spindle, which counteracts the downward force caused by the control rod weight. In the event a control rod cable becomes slack, the upward force overcomes the control rod weight, and microswitches are actuated. Slack cable indication is signalled in the control room by both an alarm and a light.

From a mechanical perspective, the CRDM instrumentation is indeed directly coupled to the motion of the cable drum, which dictates the movement of the control rods. However, under certain conditions, the mechanical aspects can actually inhibit the performance of the instrumentation. The common shaft controlling both the rod position potentiometers and the limit switches is susceptible to damage by overdriving the control rod pair past the rod-in position. This problem has been encountered when, for some reason, a given control rod pair, when supposedly fully inserted, may not actuate the rod-in limit switch. In an attempt to actuate the switch, the operator would typically try to overdrive the control rods to attain full insertion (even though the operation manuals (Ref. 1) strongly advise against such a maneuver). In this case, the in-limit cam can rotate past the in-limit switch, and the out-limit cam can rotate to interfere with other mechanical components resulting in damage to potentiometer shaft. This damage can occur because neither a positive stop is provided to restrict cam wheel overrotation nor is there sufficient clearance for the cam to overrotate. If the shaft is damaged by overtorquing or shearing, or the multi-jaw coupling is displaced, the two rod position potentiometers at the end of the shaft can give: the same erroneous signal about the actual position of the control rods on both readouts, different analog and digital outputs for the same rod position, or no output signals at all. On the other hand, if the control rods are overdriven by 1/4 turn of the cable drum (about 10 inches), the cable anchor can become wedged in the cable groove of the drum, and then upon withdrawal, the control rod cables may not feed onto the drum correctly, or can become entangled. It is clear that this type of integration of mechanical and instrumentation components can result in a single point failure, can potentially result in

damage to the instrumentation, and does not provide an independent indication of control rod full-in position.

1. Damage due to overtravel should be precluded either by the installation of a positive mechanical stop or by providing sufficient clearance to prevent damage.

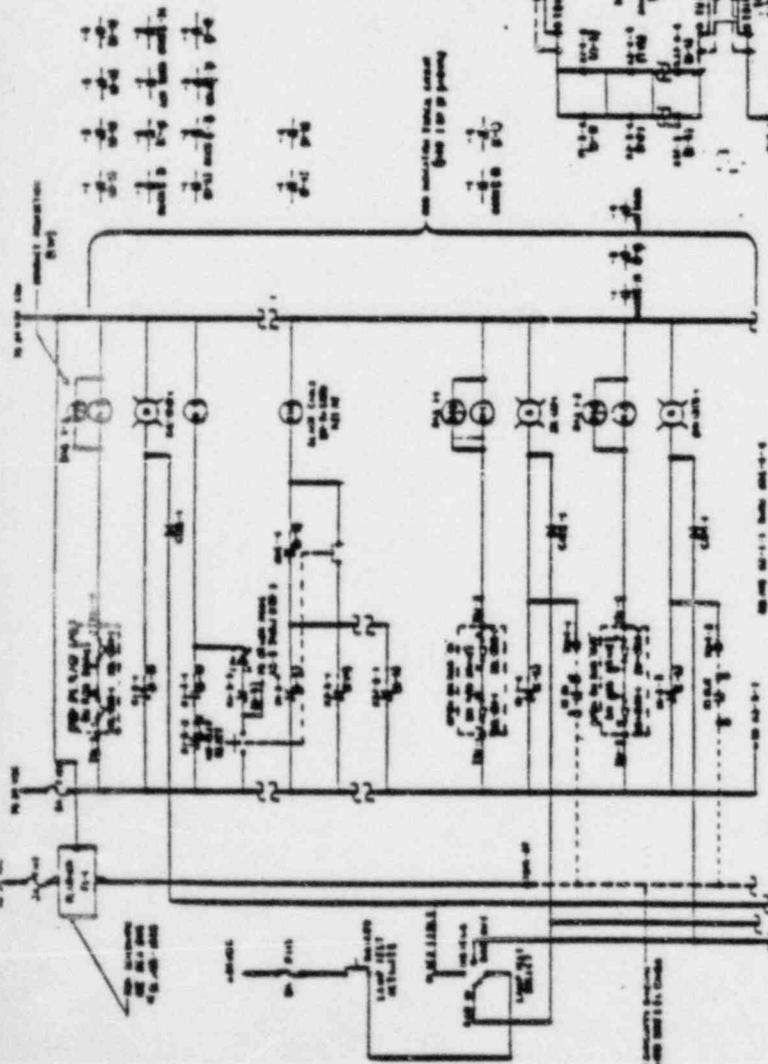
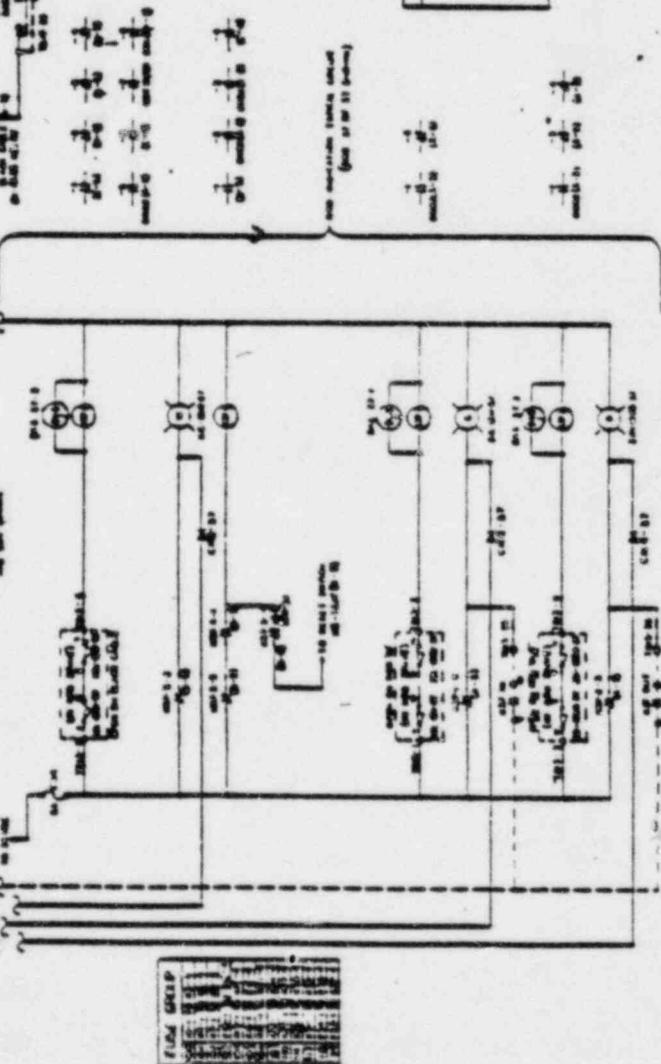
SCHEMATIC MOD CONTROL SYSTEM (NO LAMP)

A number of questions were raised as to the effective redundancy in circuits such as rod-in and rod-out limit switch indications. According to the electrical schematic (Figure 3.4), the rod position limit switches may not be, in effect, redundant, because the loss of one switch of the pair is not detectable. In other words, a single circuit switch failure would go undetected. If this occurs the loss of the second switch will result in complete loss of full-in or full-out indication. The rod-in and rod-out limit switches are integrated into the mechanical aspects of the CRDM to the extent that the same switches are used for both rod drive control and rod position indication.
