CATAWBA NUCLEAR STATION  
DIESEL ENGINE 1B COMPONENT REVALIDATION INSPECTION  
FINAL REPORT

PREPARED BY  
DUKE POWER COMPANY

September 28, 1984

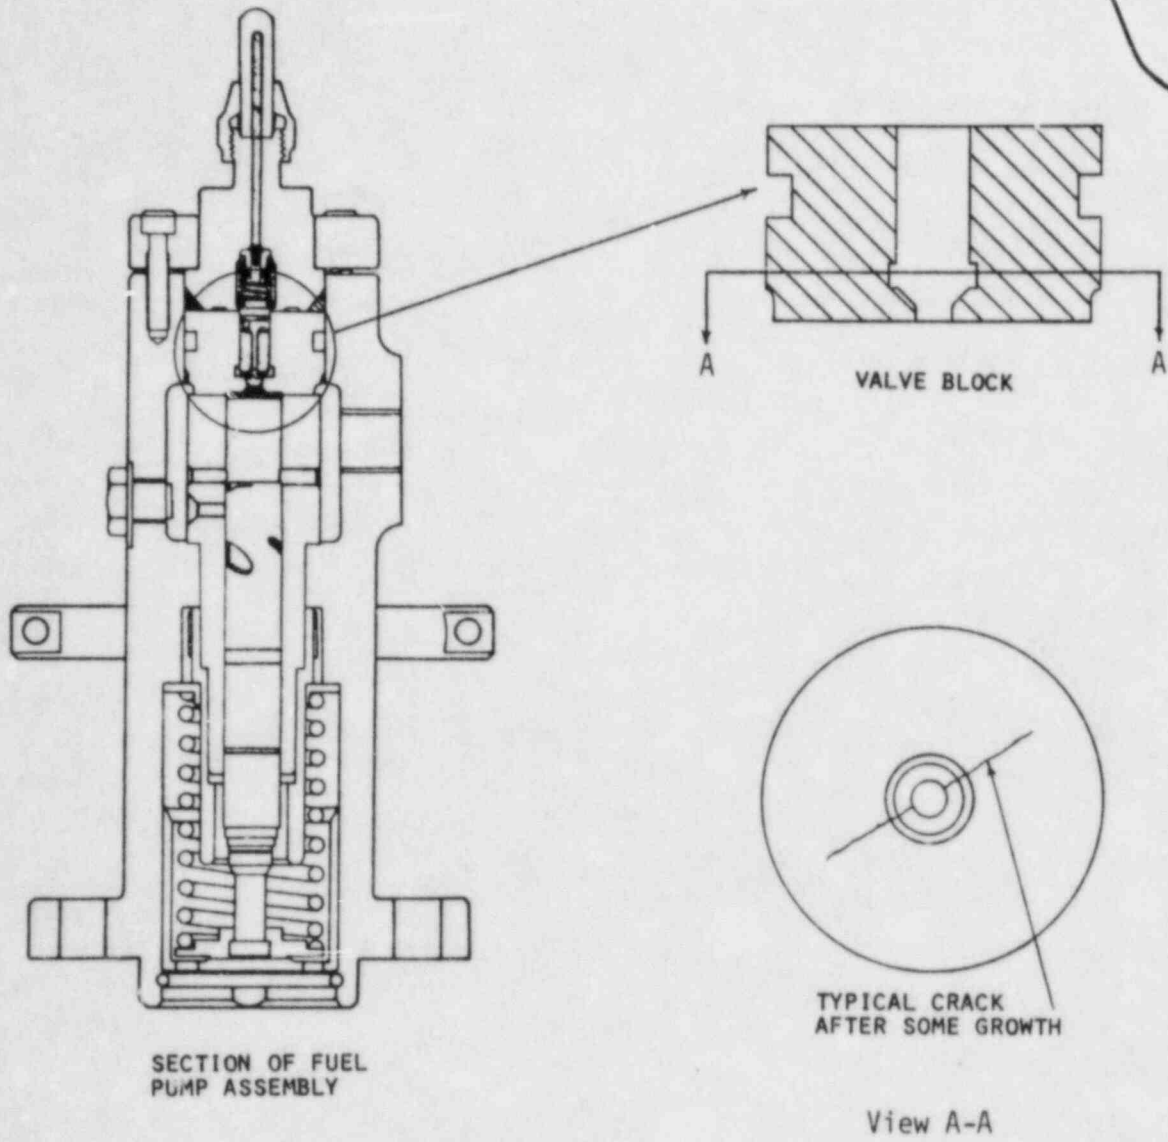
Figure 2-1. Cracked Fuel Pump Delivery Valve Block

A total of three delivery valve blocks were found to be cracked. Two were noted during the extended operation test. These were detected by a gradually falling cylinder temperature. One delivery valve block was found partially cracked during inspection after the extended operation test. The cracks are axial in nature and are produced by fuel pressure induced hoop stresses. Operationally a valve block crack results in less fuel being injected into the cylinder, i.e. it bypasses more fuel back to the fuel oil tank. Metallurgical examination results show that the cracks were fatigue induced, initiating from the valve seat. Based on discussions with the vendor, the cracks originated from heat check cracks in the valve seat caused by excessive grinding temperatures during manufacture. Other valve blocks on 1B have been magnetic particle inspected with no sign of the heat checking. The failure is shown in Figure 2-1 and further discussed in Section 4.2.2.
