# Precursors to Potential Severe Core Damage Accidents: 1991 A Status Report

Appendices B, C, and D

Prepared by  
J. W. Minarick, J. W. Cletcher, D. A. Copinger, D. W. Dolan

Oak Ridge National Laboratory

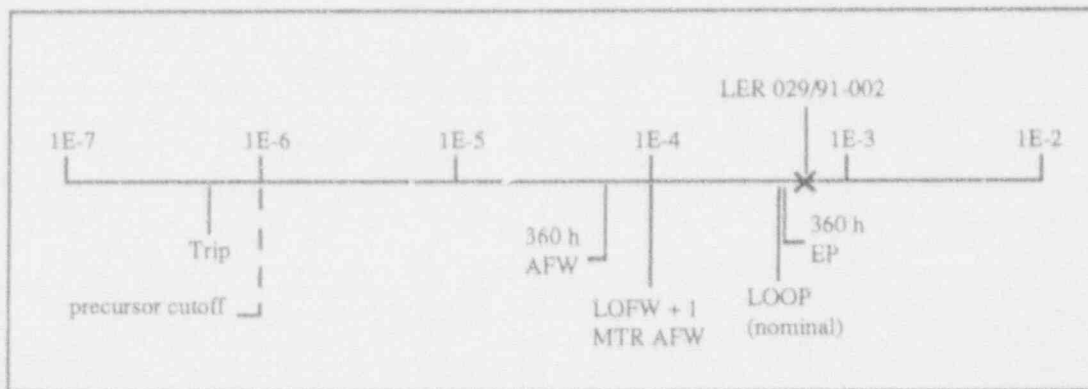
Yankee Rowe lost offsite power for 24 min due to a lightning strike. All three emergency diesel generators (EDGs) operated as designed. As a result of the lightning, surge protection fuses from the normal DC supplies blew on both vital power supply inverters. Both inverters transferred to their alternate (EDG-backed) AC sources. However, in the event of failure of the EDGs, 120-VAC instrument power would have been lost.

The conditional probability of core damage associated with this event is  $6.1 \times 10^{-4}$ . The relative significance of the event compared to other postulated events at Yankee Rowe is shown below:

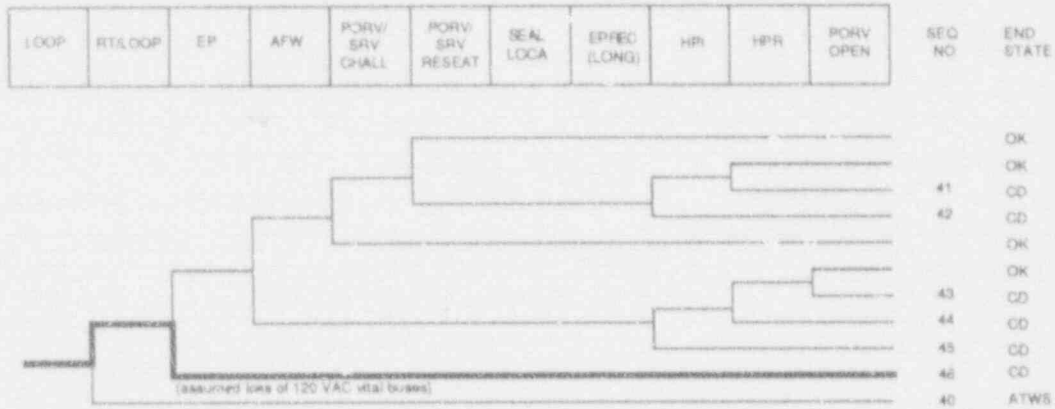
Dominant core damage sequence for LER 029/91-002

The conditional probability of core damage estimated for this event is  $6.1 \times 10^{-4}$ . The dominant core damage sequence, highlighted on the following event tree, involves a station blackout. In the event that RCS and SG parameters can be successfully monitored without 120-VAC power to allow decay heat removal, the conditional core damage probability estimated for the event is  $4.3 \times 10^{-4}$ .

Immediate corrective actions involved testing the No. 3 SST. All lightning arresters on both No. 2 SST and No. 3 SST were replaced. Also, one of the three surge arresters on the main transformer was replaced. Subsequent to the performance of acceptable tests, the No. 3 SST was reenergized. The damaged insulator on the 2-126-5 disconnect switch was replaced. Extensive testing of selected plant protective relays, voltage regulators and oil circuit breakers on the two offsite power transmission lines was also

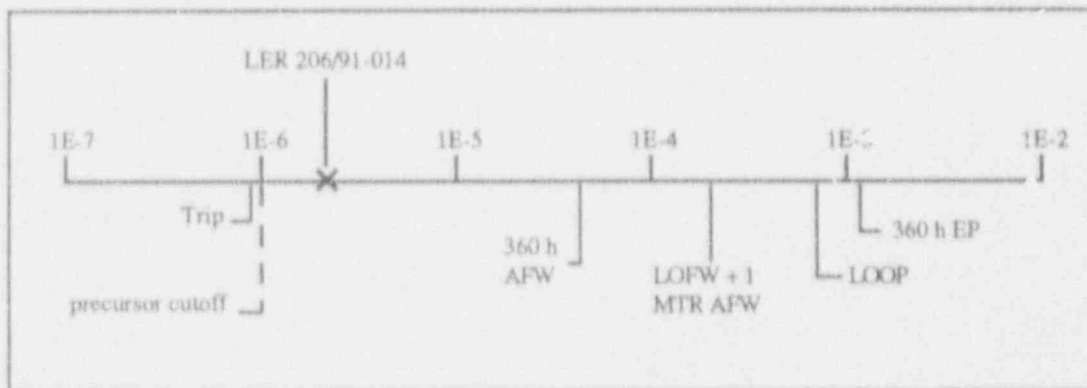
The automatic actuation for re-alignment of the charging pumps from the volume control tank (VCT) to the refueling water storage tank (RWST) on low VCT level was disabled. In the event of a small-break loss-of-coolant accident (LOCA), and if manual realignment failed, the charging pumps would become gas bound due to hydrogen from the VCT. This condition existed for ~17 h.

The conditional probability of core damage associated with this event is  $2.1 \times 10^{-6}$ . The relative significance of the event compared to other postulated events at San Onofre 1 is shown below:

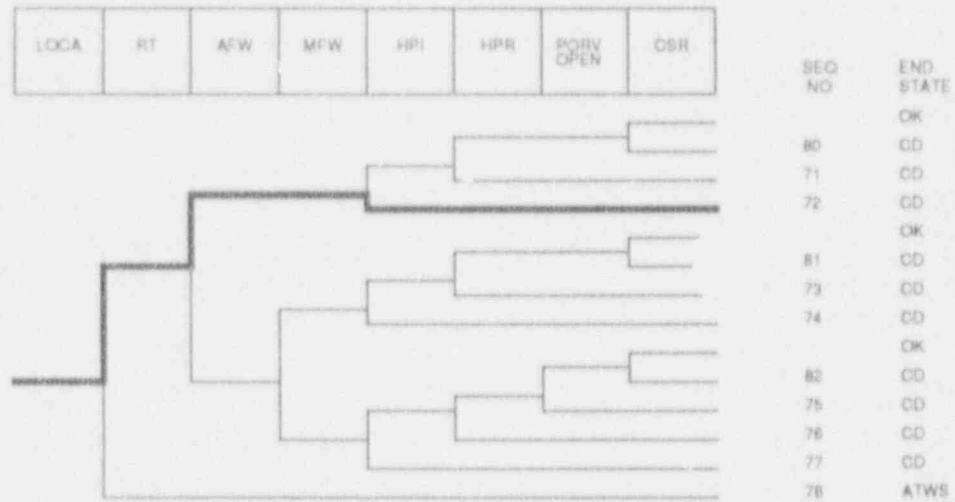
Dominant core damage sequence for LER 206/91-014

The conditional probability of subsequent core damage estimated for this event is  $2.1 \times 10^{-6}$ . The dominant core damage sequence, highlighted on the following event tree, involves a postulated LOCA with successful reactor trip and auxiliary feedwater initiation with a failure of HPI.

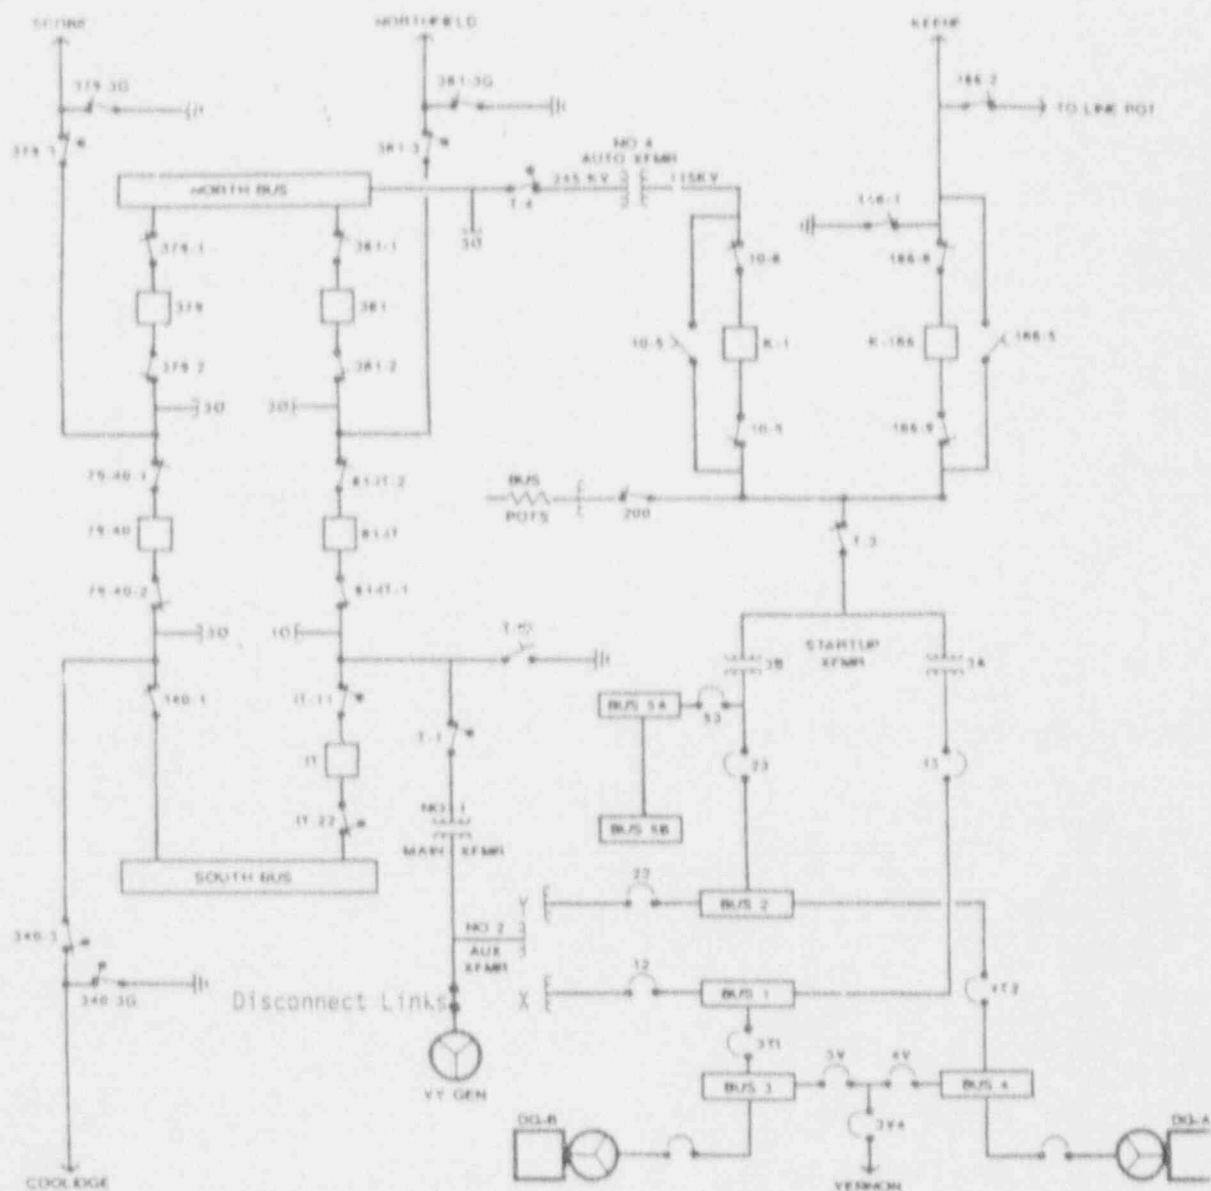
Figure 1. Vermont Yankee AC power system

A loss of offsite power (LOOP) occurred at Vermont Yankee during switchyard maintenance activities. Both emergency diesel generators (EDGs) started and provided power to their respective safety-related buses. Recovery of offsite power, which took ~13 h, was complicated by communications and organizational difficulties and travel time for support personnel. The conditional core damage probability estimated for this event is  $2.9 \times 10^{-4}$ . The relative significance of the event compared to other postulated events at Vermont Yankee is shown below.

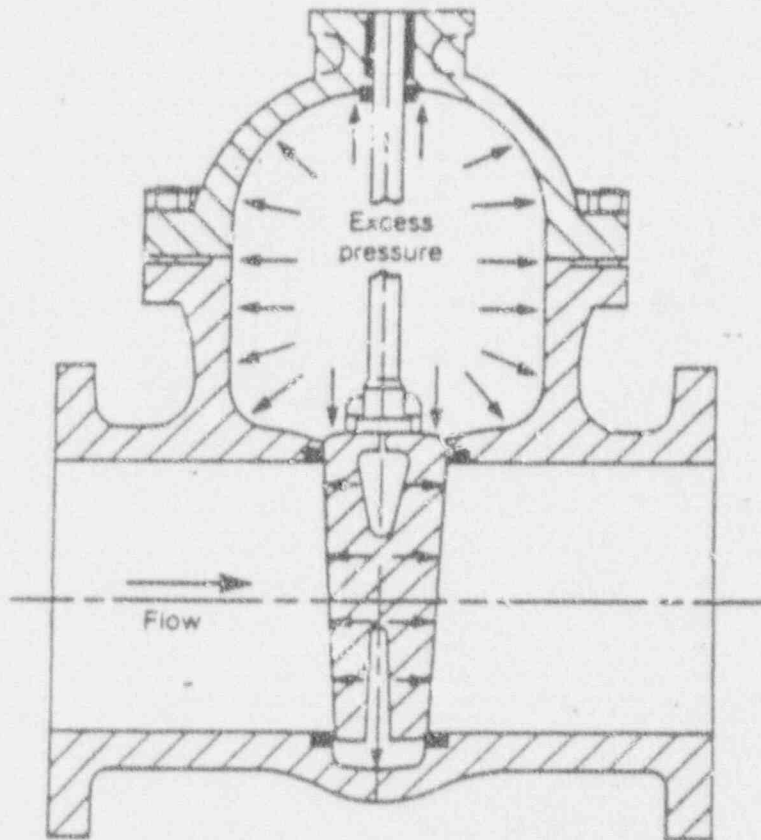
Figure 1. Hydraulic pressure locking phenomenon

Based on leak rate testing results, two of the four valves could fail to open if the reactor vessel was rapidly depressurized as it would be following a large-break loss-of-coolant accident (LOCA). The conditional core damage probability for this event is estimated to be  $9.5 \times 10^{-5}$ . The relative significance of the event compared to other postulated events at Fitzpatrick is shown below.
