ORIGINAL
UNITED STATES
NUCLEAR REGULATORY COMMISSION

LONG ISLAND LIGHTING COMPANY
(Shoreham Nuclear Power Station)

50-322-1 (OL)

DATE: MONDAY, OCTOBER 22, 1984

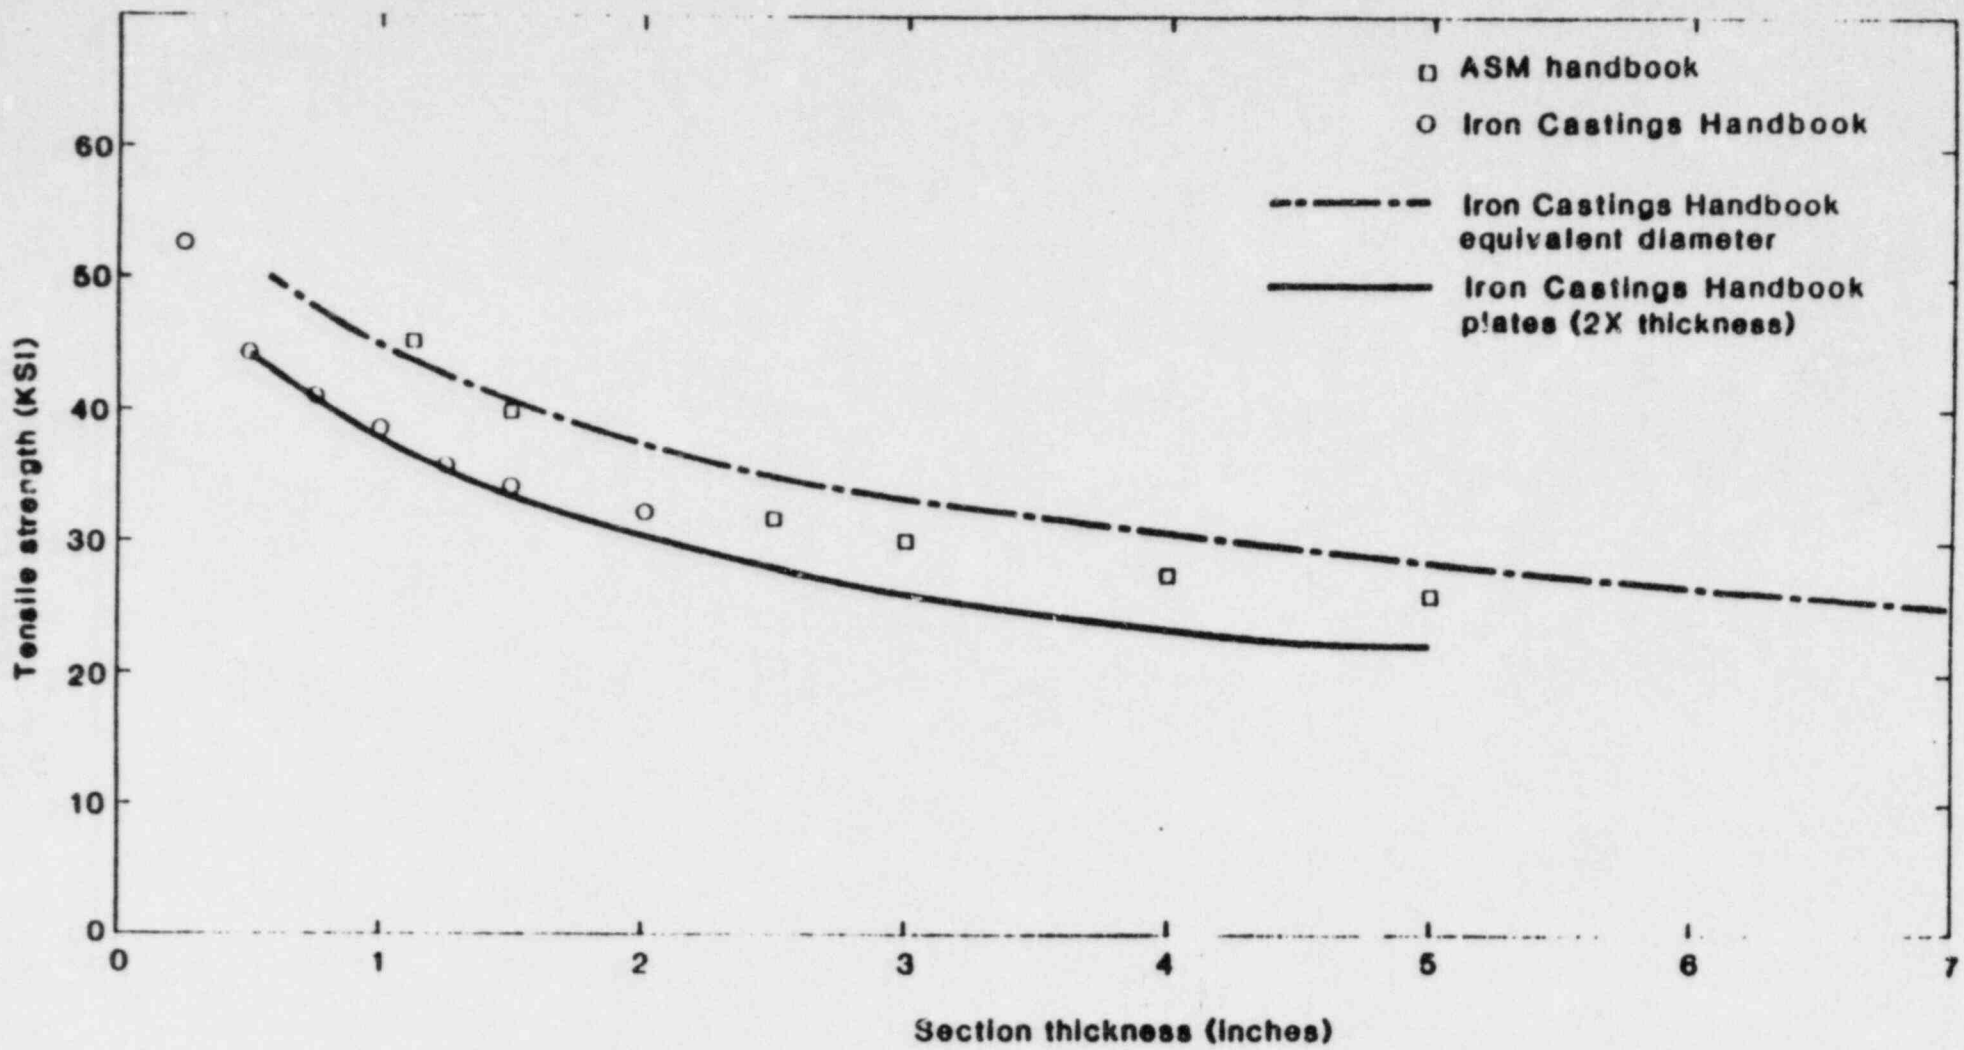
B-12

Effect of section thickness on the tensile strength of gray cast iron.

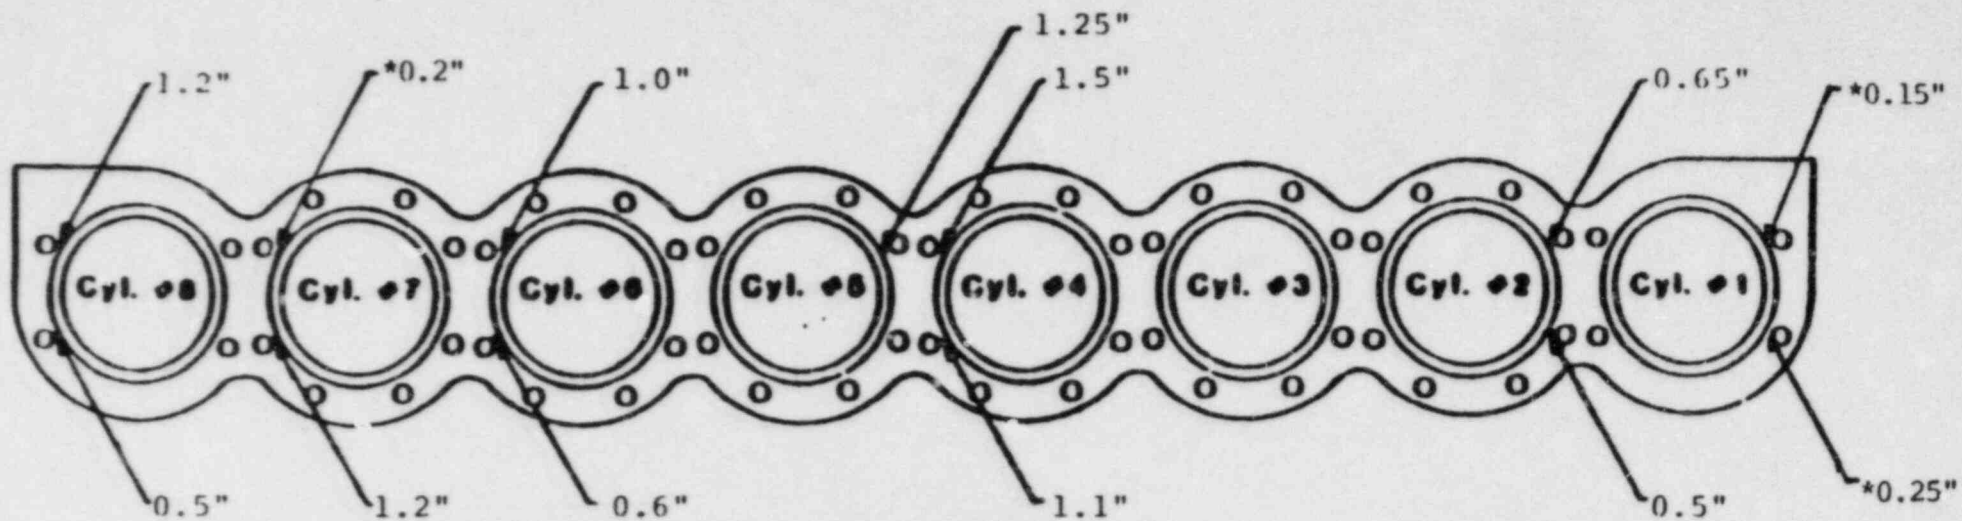
B-16

Yes. Ligament cracks were discovered in the blocks of all three engines. These cracks extended from the cylinder head stud holes to cylinder liner counterbore on EDG 101, EDG 102 and EDG 103.

A. (Wells, Youngling, Seaman, Schuster) The ligament cracks appeared to extend from the block top surface downward. Sixty-seven percent of the ligament cracks were between 1 and 1 1/2 inches deep with the remainder less than 1 inch deep. None of the cracks extended below the corner formed by the counterbore and the counterbore landing in either EDG 101 or EDG 102. A typical example of a cross-section of a ligament crack is shown in Exhibit B-19.

SNPS DG101 crack map.

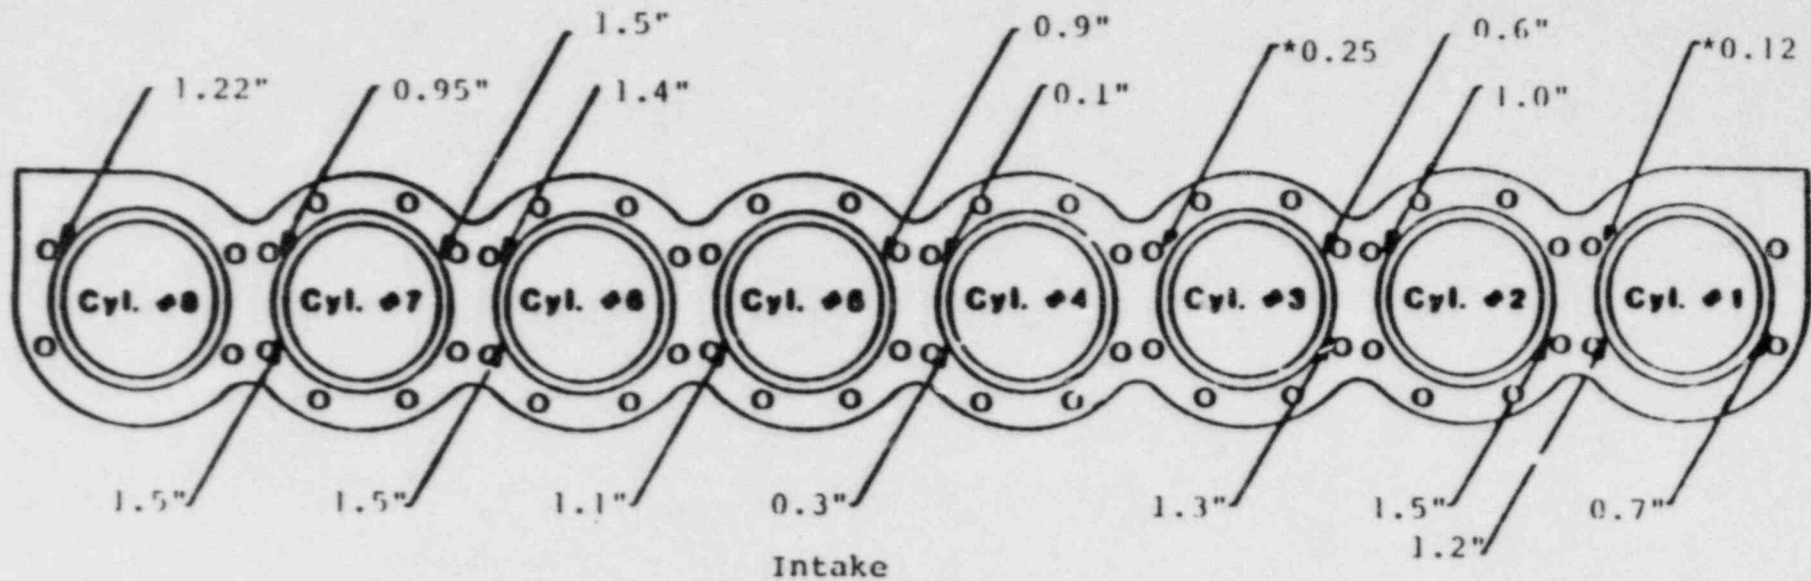
A. (Wells, Johnson, Youngling, Seaman, Schuster) The cracking was similar on EDG 101 and EDG 102. In other words, all the cracks were ligament cracks confined to the area between the cylinder bore and the stud holes and were less than 1 1/2 inches deep.

Dimensions indicate crack depth.

SNPS DG102 crack map.

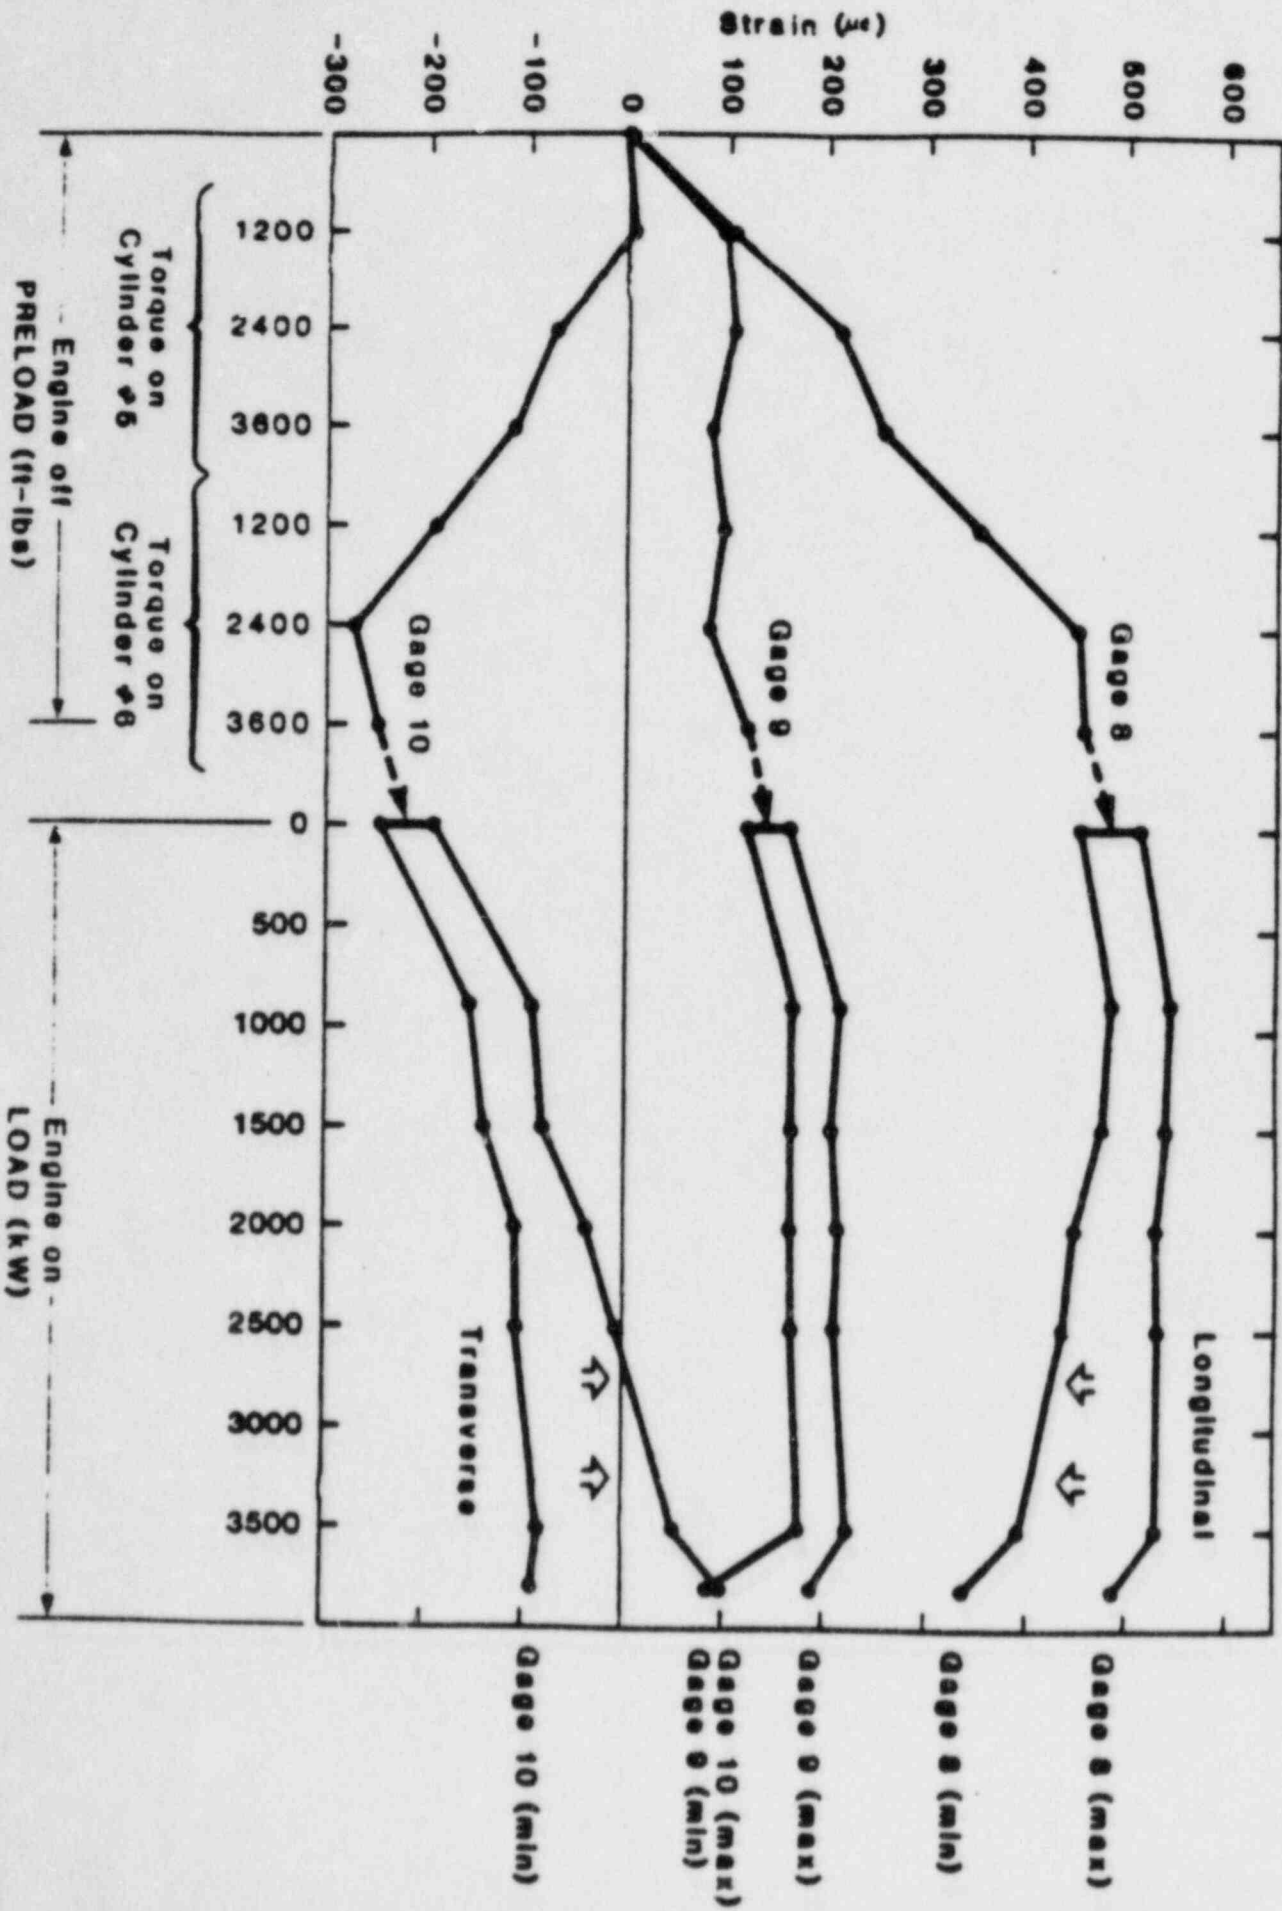
in Exhibits B-22 and B-23. As shown in the Exhibits, gages nos. 8-10, 11-13 and 3 responded to block top strains while gage no. 1 responded to the crack-mouth opening displacement of the stud-to-stud crack at the surface of the block top.

Strain vs. load for Gages 8, 9, and 10 (located on engine centerline)

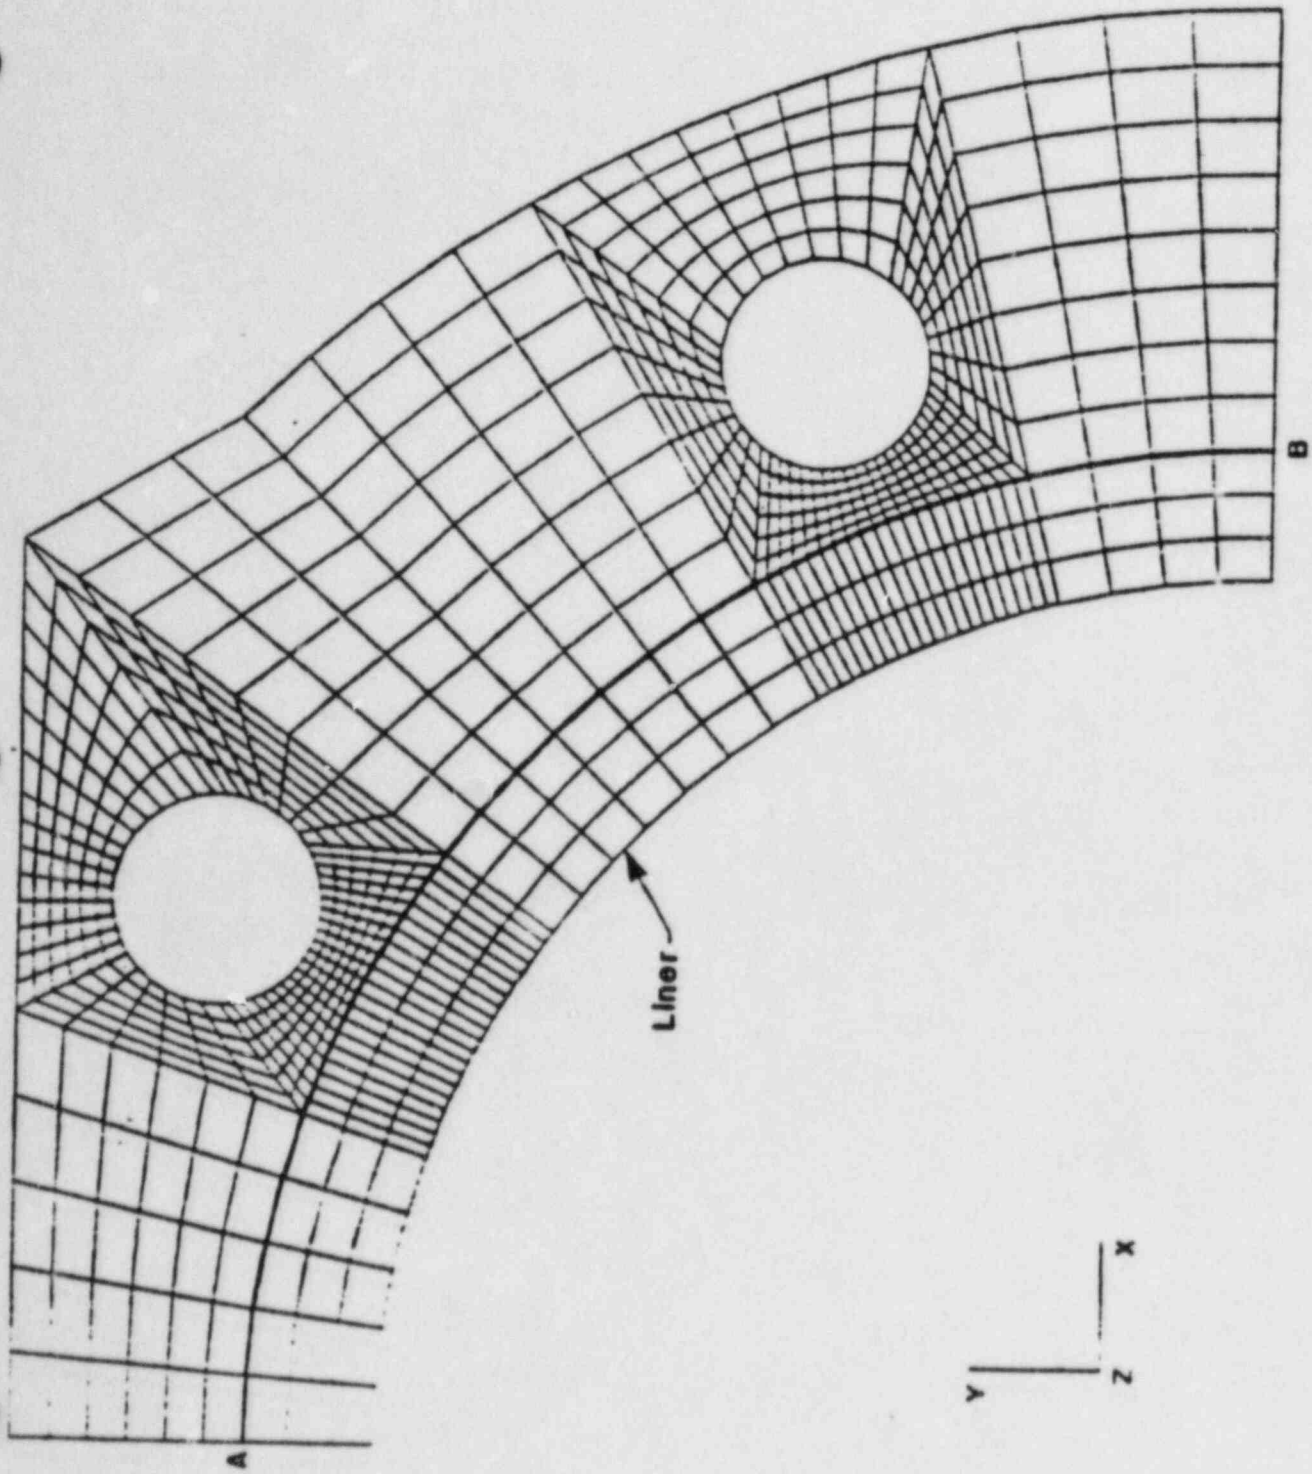
FACTORS RELATING STRESS MEASURED AT
SHOREHAM GAGE 13 to BLOCK TOP CRACK SITES

LOCATION - LOAD COMPONENT	UNCRACKED LIGAMENT	CRACKED LIGAMENT
Ligament Preload		
100% on liner 3 to 1	1.21	-
Thermal	2.94	-
Pressure	7.15	-
Stud-to-Stud Preload		
100% on liner 3 to 1	0.96	1.23
Thermal	1.99	2.05
Pressure	5.12	4.29

Good material/Poor material = 1.10
 Cracked block/uncracked block = 1.26 Thermal
 Cracked block/uncracked block = 1.06 Preload
 Cracked block/uncracked block = 1.28 Pressure

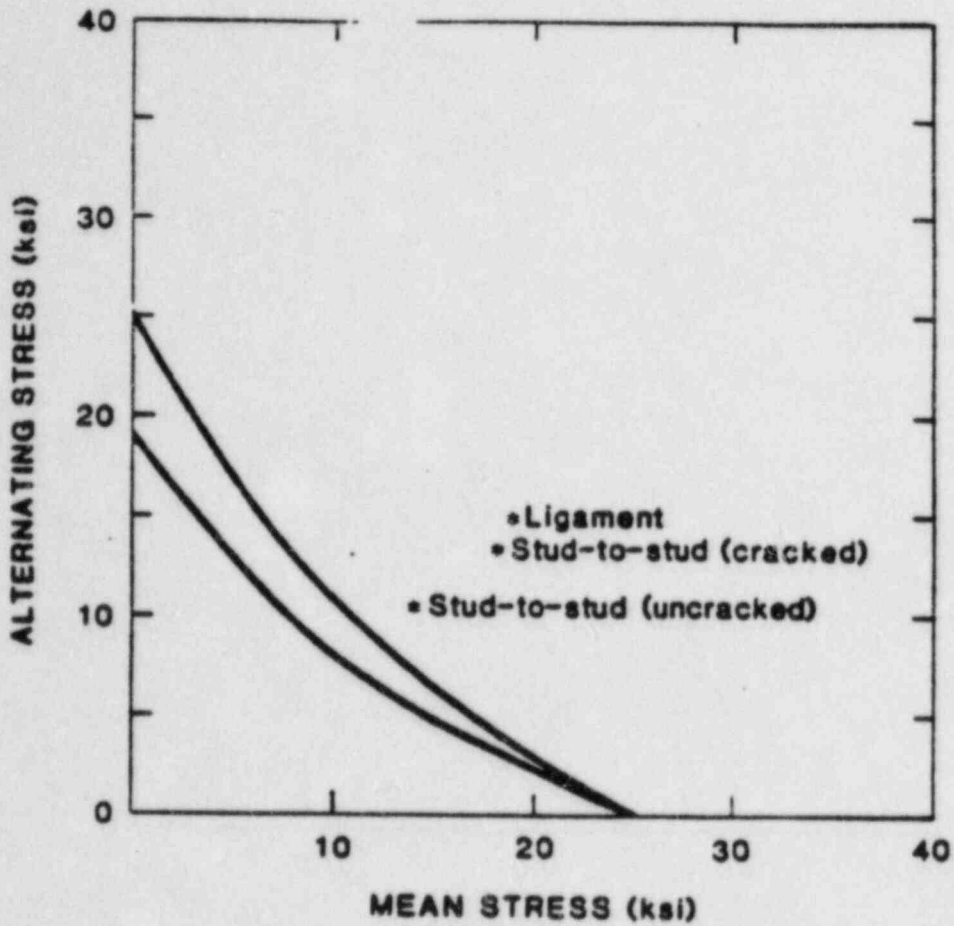
Exhibit B-49

Goodman-Smith diagram for low cycle fatigue (100 cycles) at 100% load for Shoreham engines DG101 and DG102.

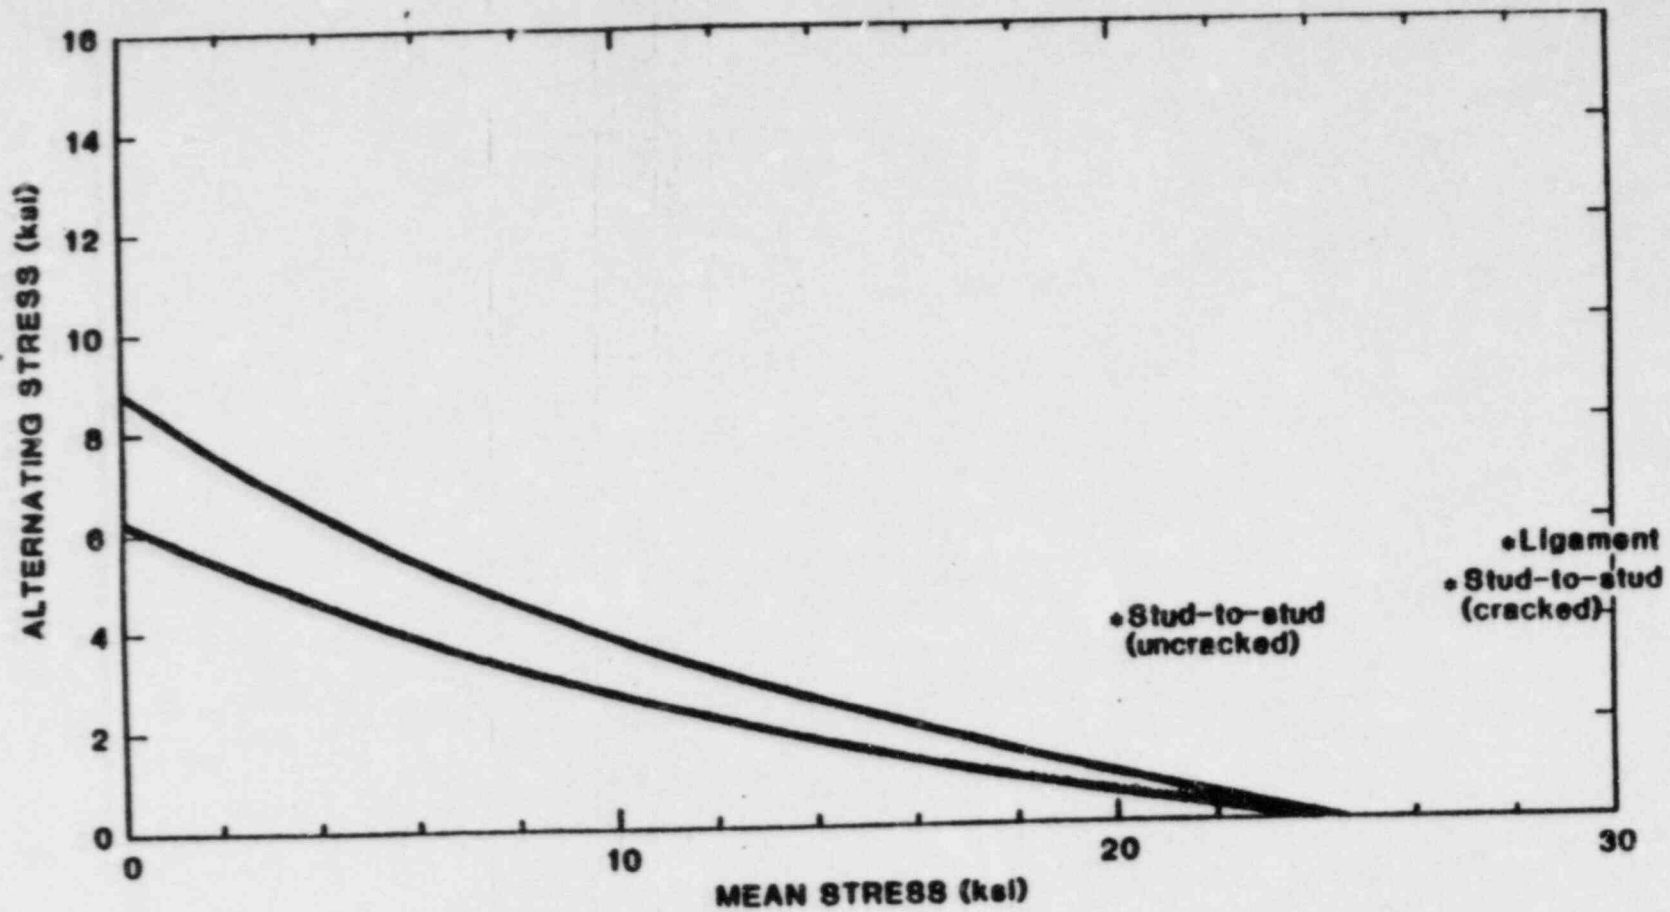
B-50

Goodman-Smith diagram for high cycle fatigue ($>10^6$ cycles) at 100% load for Shoreham engines DG101 and DG102.
