Re: Oconee Nuclear Station
Docket Nos. 50-269, -270, -287
IE Bulletin 84-03

DUKE POWER COMPANY
OCONEE NUCLEAR STATION

Response
to
IE Bulletin 84-03

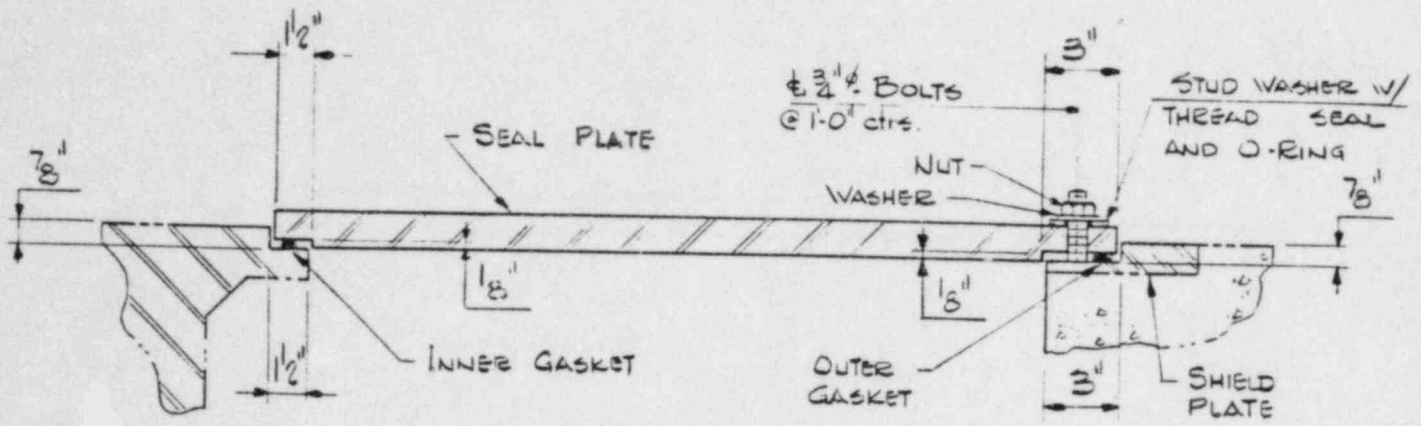
FIGURE # 1

Considering the difference in seal plate and gasket configuration between that at Oconee (Fig. 1) and that described in IEB 84-03, a gross seal failure of the magnitude experienced at Haddam Neck is not a credible event at Oconee. Correct alignment of the seal plate is assured by 4 alignment studs and 72 threaded studs. Water pressure above the seal plate, gasket sealant, the 1/8 inch recessed edges, and a final torque value of 150 ft.-lb. per nut ensure gasket stability.

A leak rate of less than 50 gpm would be expected from the Refueling Canal even in the unlikely event of a totally dislodged inner seal. Instrumentation and procedures currently in place to detect and respond to unexplained water loss in the Spent Fuel Pool and Refueling Canal would ensure that 50 gpm leak rate would be detected and mitigated.
