CALVERT CLIFFS NUCLEAR POWER PLANT  
1650 CALVERT CLIFFS PARKWAY • LUSBY, MARYLAND 20657-4702

SUBJECT: Calvert Cliffs Nuclear Power Plant  
Unit No. 2; Docket No. 50-318; License No. DPR 69  
Licensee Event Report 92-007  
Manual Trip Caused by Stuck Open 23 Moisture  
Separator/Reheater Relief Valve

**LICENSEE EVENT REPORT (LER)**

TITLE (4)  
**Manual Trip Caused by Stuck Open 23 Moisture Separator/Reheater Relief Valve**

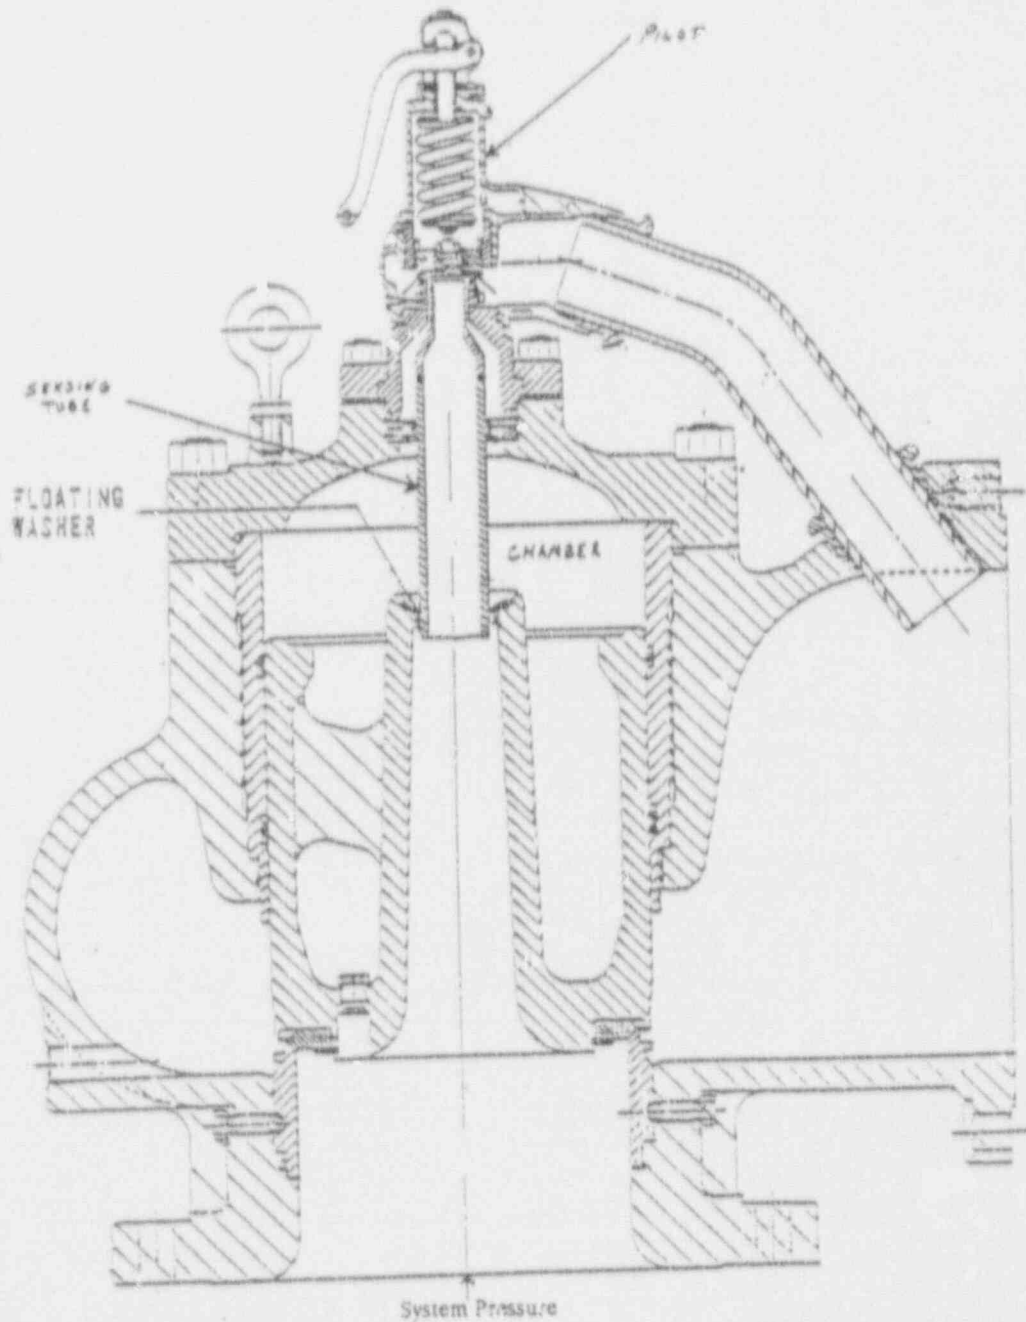
FIGURE 1

The relief valve on 23 MSR, 2-RV-4024, is a pilot operated safety relief valve (see Figure 1). The operation of the valve is as follows: System pressure (hot reheat steam) enters the main valve and flows up through the sensing tube. Steam also flows out through a clearance between the tube and a floating washer on the main valve disc into the top of the chamber to pressurize the top of the main valve disc. Additional flow occurs between the top of the sensing tube and the disc for the pilot valve, down into the top of chamber to help pressurize the top of the main valve disc. When system pressure increases and the pilot valve setpoint is reached, the pilot opens allowing pressure in the chamber to exhaust through an outlet. When pressure in the chamber decreases to approximately 58 percent of the system pressure a lifting force on the main valve disc is created causing the main valve to open.

After 2-RV-4024 lifted on September 29, 1992, the valve was opened and inspected for damage in accordance with the outstanding MO. First the pilot valve was removed and tested. Three simulated lift tests were performed and in all three the pilot relieved at approximately 127 psi, which is lower than the required 150 psi setpoint. Further inspection determined there was excessive leakage past the pilot disc. A root cause analysis performed by Plant Engineering concluded the combination of the pilot setpoint drifting low plus leakage past the pilot disc allowed excessive leakage to develop through the pilot and thus the pressure in the chamber bled off. When pressure in the chamber reached approximately 58 percent of system pressure, the main valve opened. The valve manufacturer has also confirmed that if excessive leakage exists on the pilot valve, the chamber can depressurize and allow the main valve to open.

The main valve body was also inspected for damage. Corrosion and pitting were discovered on the guide for the main plug. Additionally, excessive wear was found on the packing rings and O-rings. This condition appears to have contributed to the disc becoming stuck and unable to reseat without assistance.

- A. Immediately following the event, an engineering root cause analysis was performed by Plant Engineering and Maintenance to determine why 2-RV-4024 had lifted and failed to reseat. The valve was disassembled, inspected and completely overhauled. Both the engineering analysis and the maintenance repairs were completed prior to the restart of Unit 2.

- B. Changes will be initiated to modify the PM frequency for inspecting the MSR relief valves such that the pilots on the valves will be inspected every refueling outage versus the current interval of every two refuelings.

- C. All of the Unit 2 MSR shell-side relief valves will be inspected during the upcoming Unit 2 Spring Refueling Outage. Additionally a modification, suggested by the manufacturer, that will aid in closing the main disc will be scheduled for this outage. The existence of this potential modification was not communicated by the vendor to BC&E prior to this event.
