GPUN

EVALUATION OF POTENTIAL EFFECTS OF LOOSE

OTSG PLUGS IN THE TMI-1 RCS

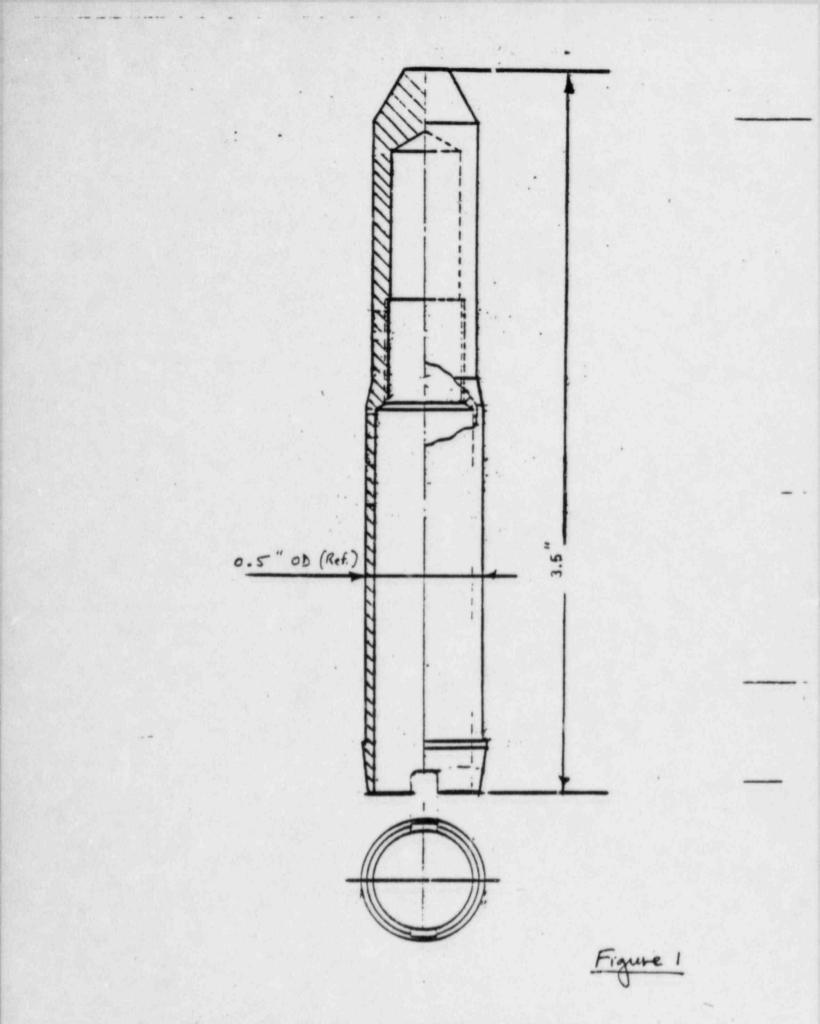
TMI-1 STEAM GENERATOR ROLLED PLUG - MODEL II

The plug design is shown in Figure 1. It is basically a thin-walled hollow cylinder of Inconel 600 material 3-1/2° long with an OD of about 1/2°; it weighs about 1-1/4 ozs. Inconel 600 is a standard primary system material. It has high strength, high ductility and high toughness properties. Hardness is in the range of RV components materials (primarily stainless steels) with which the plugs will interact.

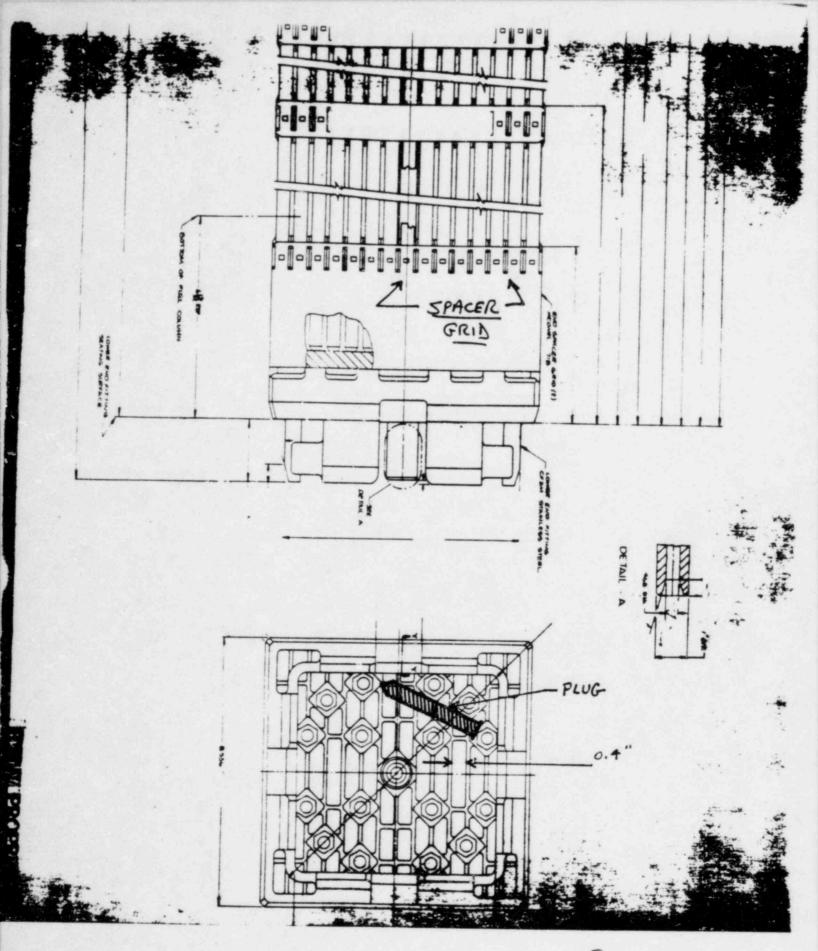
Figure 6 Mark B Fuel Assembly Lower End Fitting

6.4.3 <u>Fuel Rod Damage</u> - A more significant concern, though also unlikely to occur, is fretting damage to the fuel rods. As described above under "Flow Paths" (Section 4.0), and as shown in Figures 6 and 7, it is possible for a deformed plug (or portion of a plug) flattened along its axis to fit through the 0.4" wide slots of the lower grillage and interact with the fuel rods and lower spacer grid.

6.4.4 <u>Fuel Assembly Blockage</u> - An intact, nondeformed plug (approx. 1/2* OD) cannot fit through the 0.4* slots of the LEF. It will, therefore, cause local flow blockage. A totally flattened plug seased across the flow slots will have a similar effect. Totally flattened plugs will not actually occur, but represent the maximum area of a deformed plug. Figure 9 shows these two plug configurations to scale overlaid on the LEF flow area.
