ULNRC-2714

CALLAWAY PLANT
DOCKET NUMBER 50-483
ADDITIONAL INFORMATION REGARDING
REVISION TO TECHNICAL SPECIFICATION TABLE 3.3-4,
"ENGINEERED SAFETY FEATURES ACTUATION SYSTEM
INSTRUMENTATION TRIP SETPOINTS"

DEGRADED VOLTAGE SETPOINT REVISION AND VOLTAGE
SAFETY LIMIT ANALYSIS

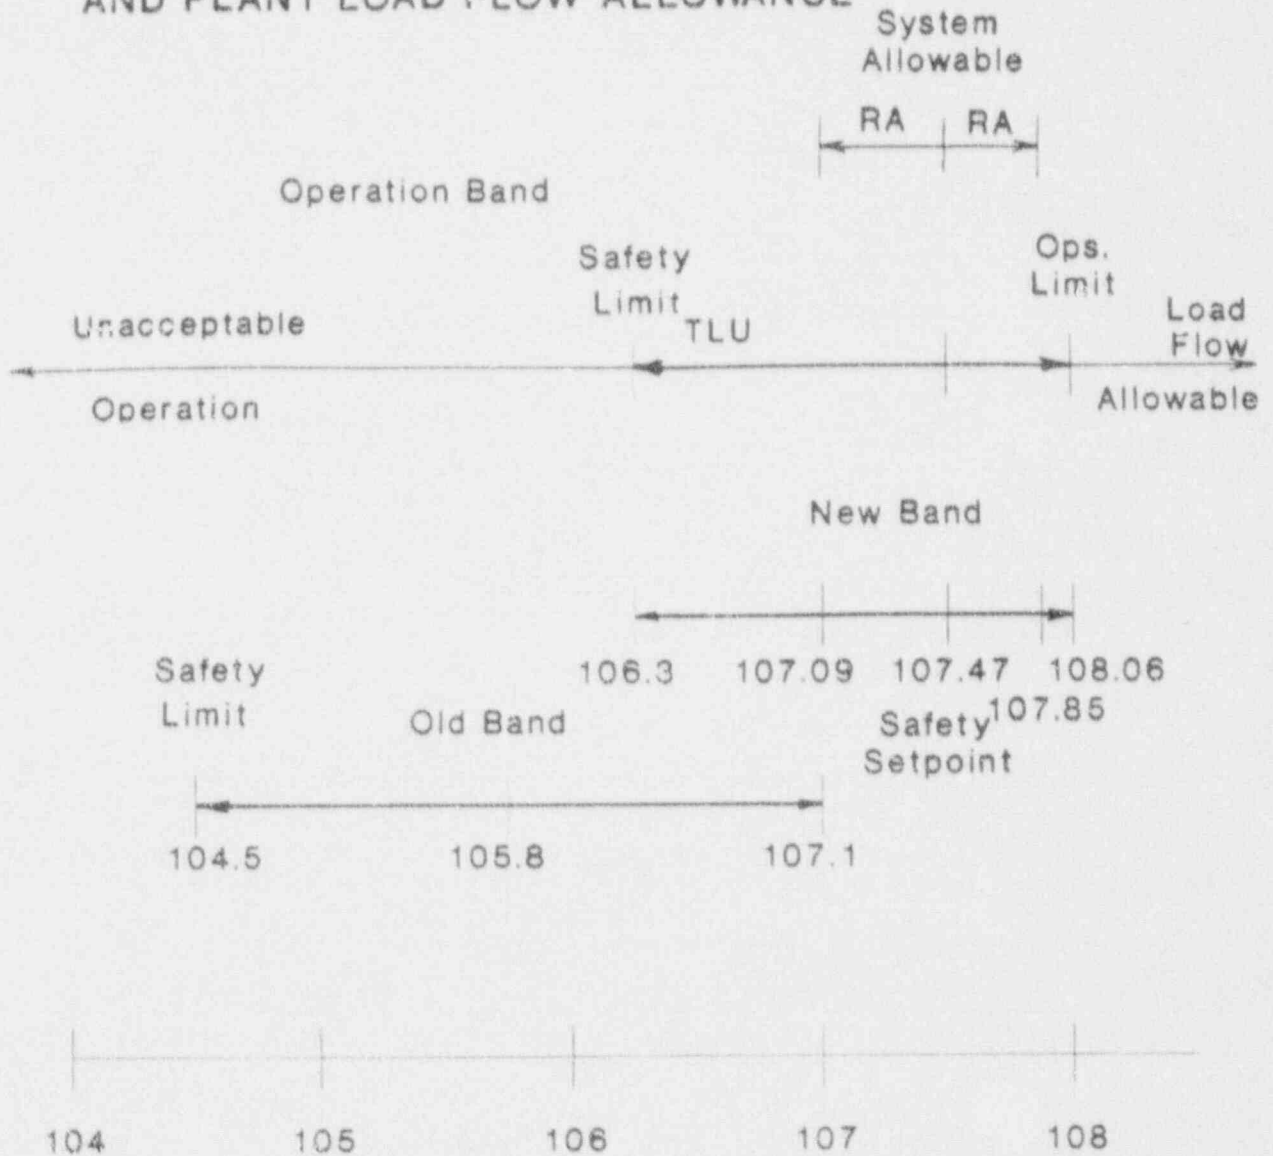
DEGRADED VOLTAGE LOOP UNCERTAINTY BREAKDOWN AND PLANT LOAD FLOW ALLOWANCE

DESIGN CHANGE CMP 91-1034 REVISES THE DEGRADED VOLTAGE SETPOINT AND THE TOLERANCE FROM 104.5 +2.6/ - 0 VOLTS TO 107.47 +/- 0.38 VOLTS. THIS CHANGE INVOLVES A CHANGE TO THE PLANT TECHNICAL SPECIFICATIONS.

- 1) A REVISION IN THE ANALYSIS OF THE LOOP TOLERANCES USING ISA STANDARD DRP 67.04. --- CALLAWAY USES PROCEDURE J-U-GEN TO PERFORM THIS ANALYSIS.
- 2) A REVISION OF THE LOWER LIMIT OF THE DEGRADED VOLTAGE VOLTAGE SETPOINT BAND. --- THIS IS CONSIDERED AS A SAFETY LIMIT. THIS VOLTAGE LIMIT IS PRODUCED USING LOAD FLOW TECHNIQUES. THE LOAD FLOW CONSERVATISMS BASED ON INITIAL DESIGN ASSUMPTIONS ARE BEING REVISED USING ACTUAL COMPONENT DATA AND OPERATIONAL CONSIDERATIONS. THE RESULTS OF THIS ANALYSIS IS USED AS THE SAFETY LIMIT.
