LOUISIANA POWER AND LIGHT COMPANY  
WATERFORD STEAM ELECTRIC STATION  
UNIT NO. 3

SUMMARY EVALUATION  
STRUCTURAL SIGNIFICANCE OF BASEMAT  
NONDESTRUCTIVE TESTING RESULTS

October 25, 1984  
Ebasco Services Incorporated  
Two World Trade Center  
New York, NY 10048

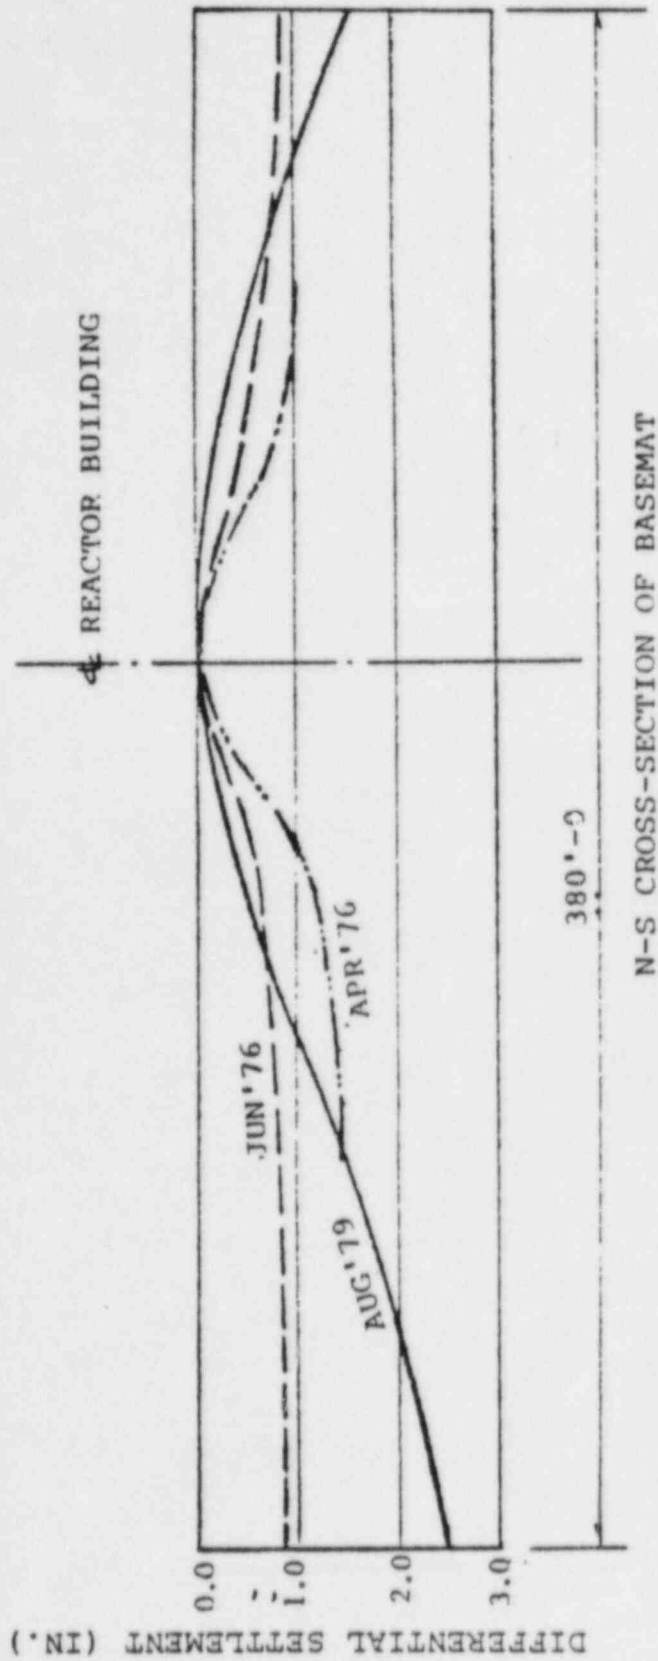
The cause of bottom hairline crack is also considered to be due to flexure of the basemat resulting from the final loadings as the superstructure was completed. This conclusion is consistent with the cracks having been formed due to readjustment of basemat convex shape as the superstructure loads were applied to a mat cambered and slightly prestressed (see Figure 2 of Reference 2 attached).

From the summary of NDT results, it is clear that the top cracks are greater in number than the bottom cracks. This reflects that the crack pattern generally followed the mat flexure, which was found to be predominantly convex shape throughout the construction stages. The top cracks are located primarily in an east-west band centered on the RCB centerline. This matched closely the area of maximum convex flexure of the basemat in the early stages of construction as shown on Figure 2.

WATERFORD SES UNIT NO. 3  
BASEMAT CURVATURE
