LICENSEE EVENT REPORT (LER)

FACILITY NAME (1) Catawba Nuclear Station, Unit 1						DOCKET NUMBER (2) 0 5 0 0 0 4 1 3			PAGE (3) 1 OF 0 4	
--	--	--	--	--	--	--------------------------------------	--	--	----------------------	--

TITLE (4)  
Ice Condenser Lower Inlet Doors Blocked Closed

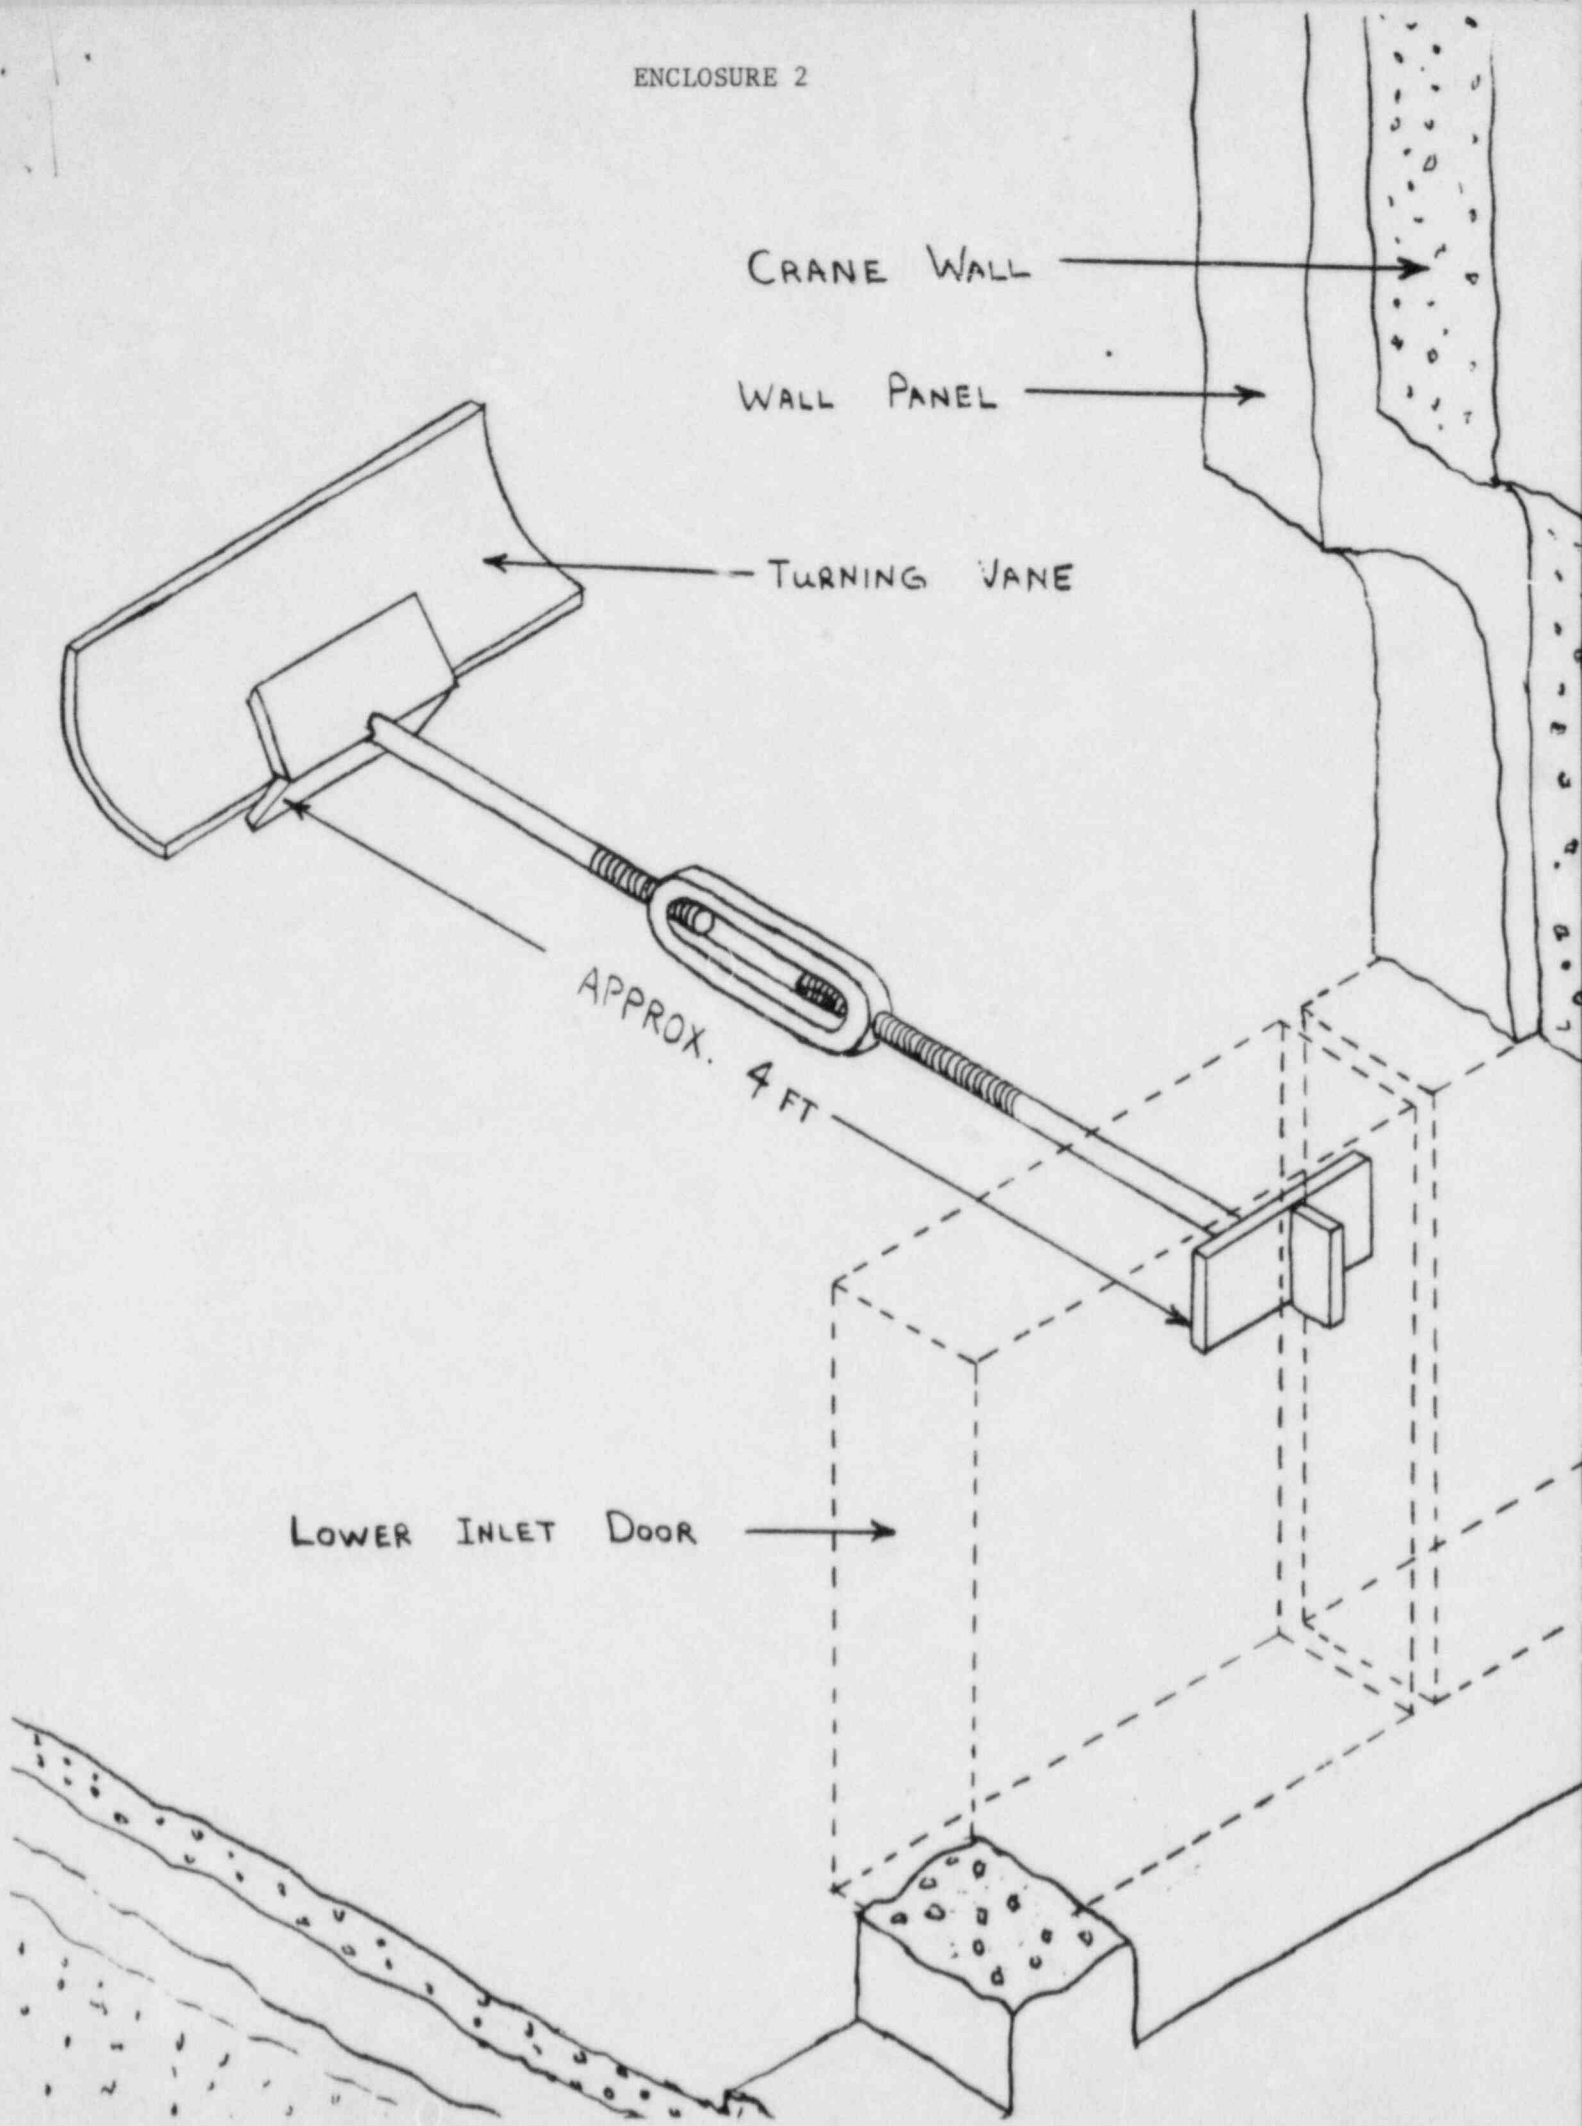
ENCLOSURE 2

After entering Mode 5 (Cold Shutdown) and prior to entering Mode 6 (Refueling) the Ice Condenser Lower Inlet Doors are physically blocked closed to ensure that the Lower Inlet Doors do not inadvertently open (see Enclosure 2).
