PROFESSIONAL LOSS CONTROL, INC.

EVALUATION  
OF  
FIRE DOORS 3-20 AND 3-13  
AT  
FERMI 2  
DETROIT EDISON CO.

Date Submitted: January 31, 1985

Prepared by: Robert J. O'Laughlin, P.E., CSP  
Senior Fire Protection Engineer  
Professional Loss Control, Inc.

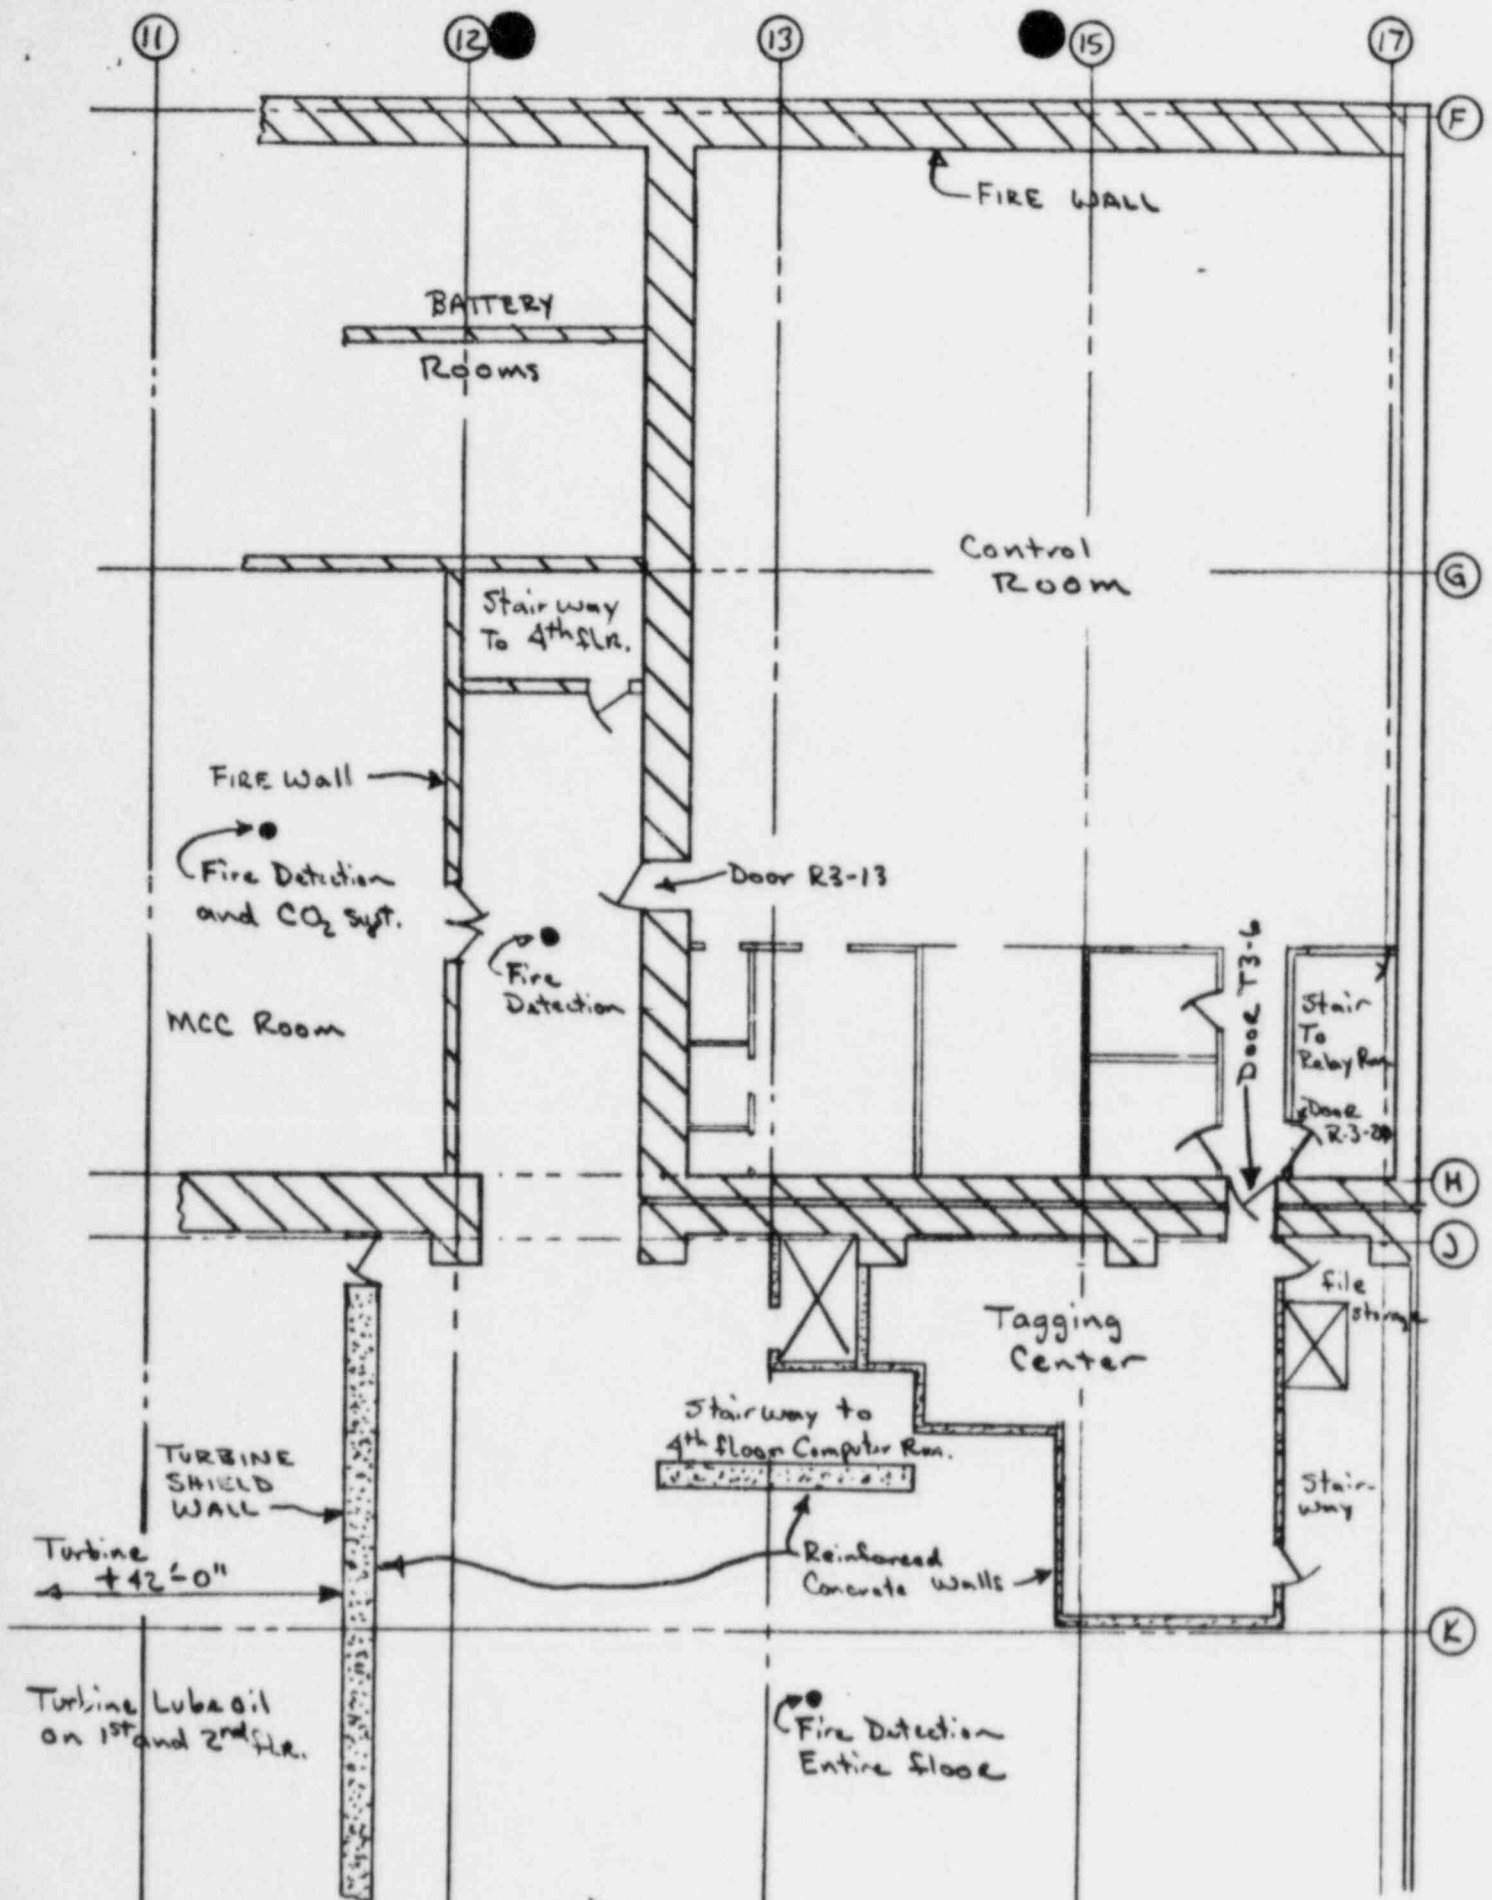
FIGURE 1

Door R3-20 separates the control room from the stairwell in the northeast corner of the control room. The stairwell construction has a two hour fire resistance. The control room is enclosed in a three hour fire resistive envelope except the north exterior wall. (Refer to Sketch No. 1).

Door R3-13 separates the control room from the Turbine Bldg. extension, floor elevation 643'-6". This security door is installed in a 3 hour fire resistance wall on the south side of the control room. This door is located approximately 25 ft from the main Turbine Building floor. (Refer to sketch No. 1).
