WOLF CREEK

Reference: Letter dated March 7, 1996, from J. L. Callan NRC,
to N. S. Carns WCNOG
Subject: Docket No. 50-482: Wolf Creek Generating Station Icing
Event Restart Issues

Reply to Enclosure 1
Wolf Creek Restart Issues

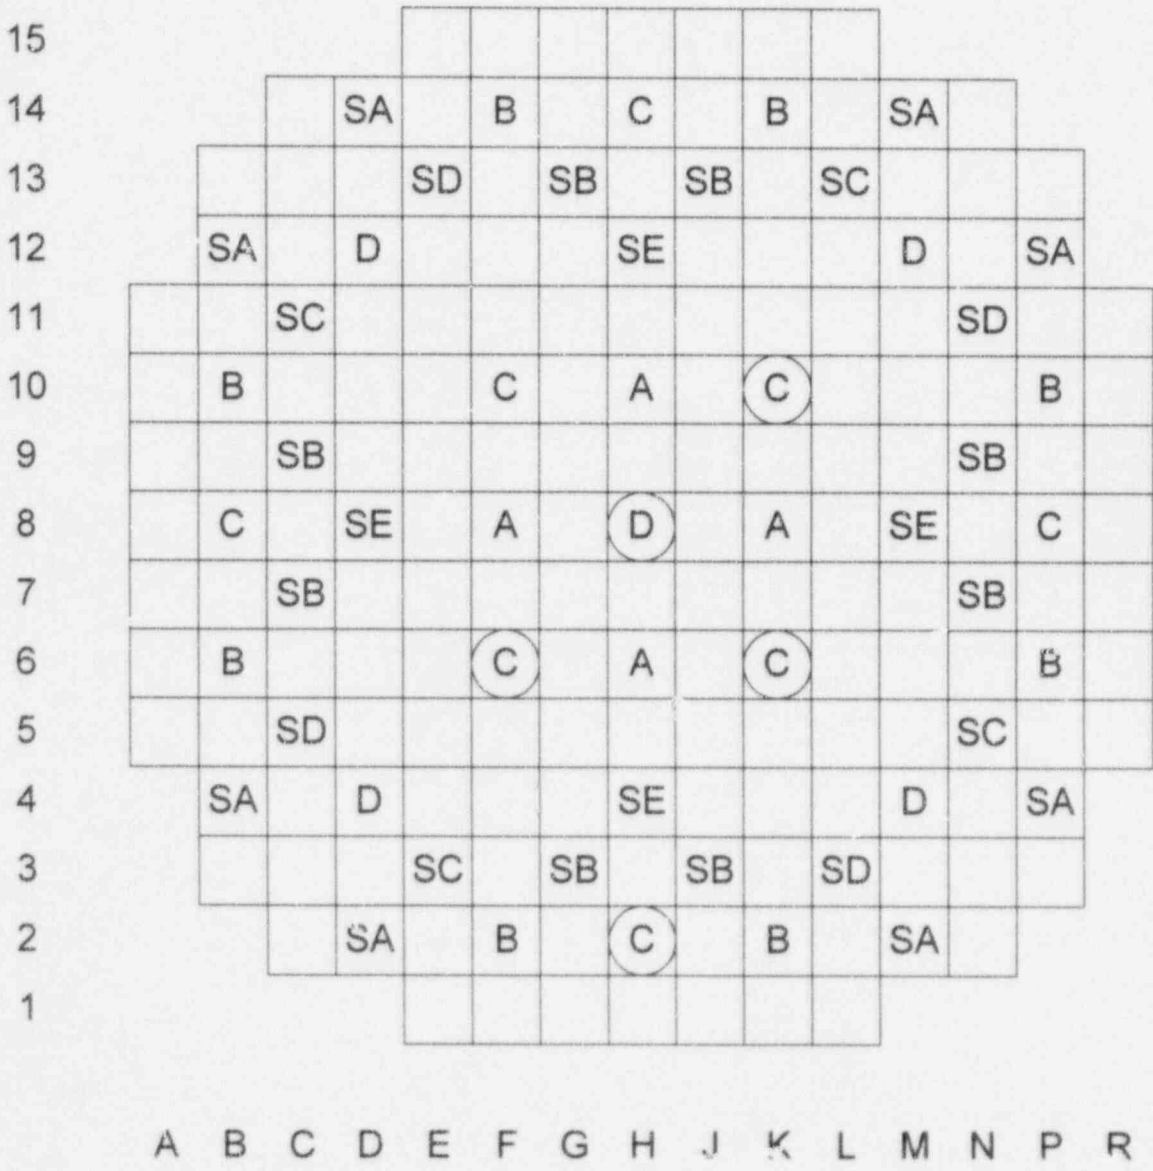
Figure 1-1 - Locations of Rodded Core Locations at WCGS

There were five RCCA's which failed to fully insert. The location of these assemblies is indicated in Figure 1-1 (see page 23). The following fuel assemblies were involved.

The tests and inspections performed indicate that an interference between the control rods and the fuel assembly, which manifested itself in incomplete rod insertion, originated in the fuel assembly. The fuel assemblies affected were thrice burned assemblies with exposures exceeding 49,000 MWD/MTU.

The Cycle 9 loading pattern and associated reload design were developed with direct intent to mitigate each of the root causes under consideration. The loading pattern was redesigned with the express intent of lowering the burnup of all assemblies beneath control rods. This is displayed in the table below:
