January 24, 1985  
PY-CEI/NRR-0173L

Perry Nuclear Power Plant  
Docket Nos. 50-440; 50-441  
IDI Inspection 84-29 Response

TABLE OF CONTENTS

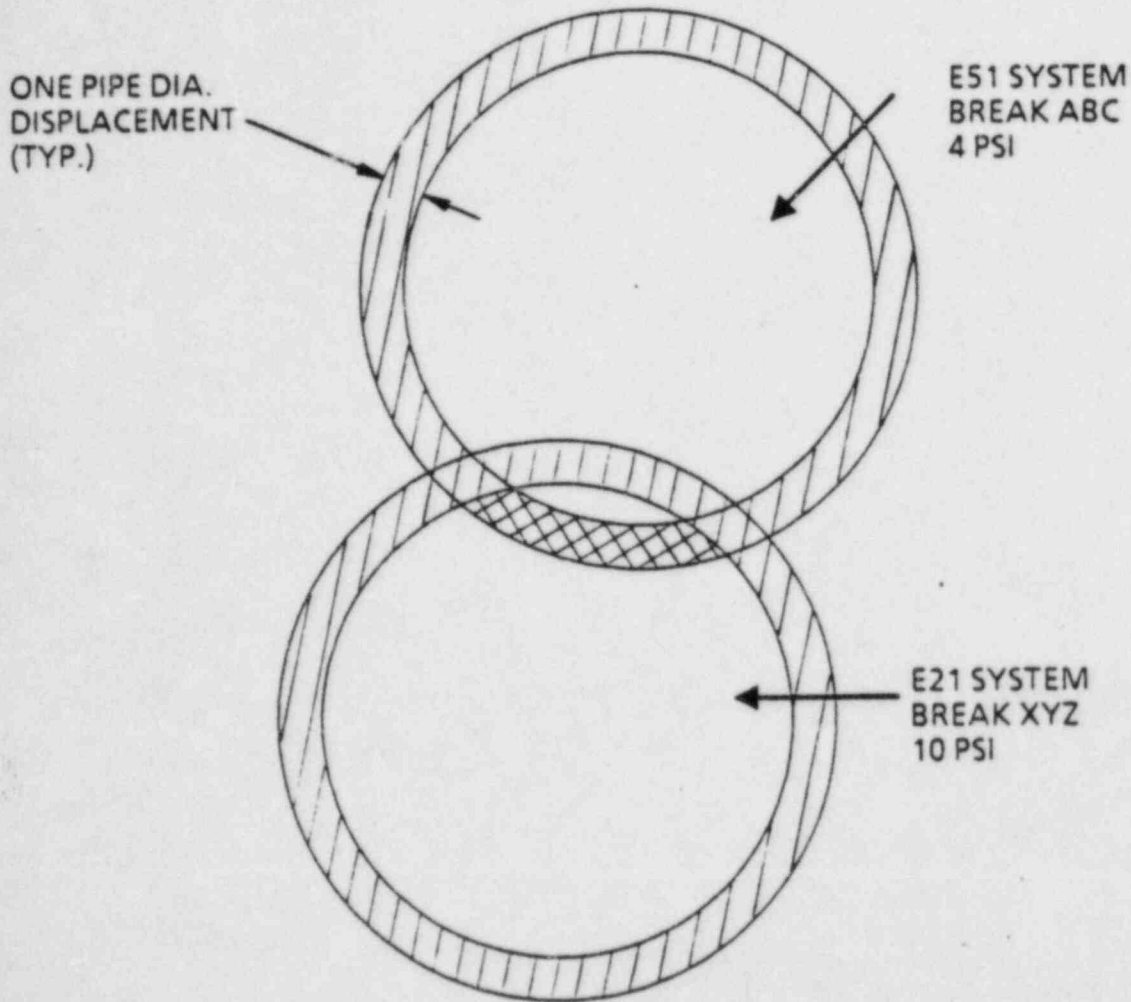
JET IMPINGEMENT INCREASE ENVELOPE DUE TO PIPING DISPLACEMENT (AS CURRENTLY EXISTS ON DRAWINGS).

However, in response to this item, all the Jet Study drawings will be reviewed to identify any safety-related targets located in discontinued band zones not previously identified. This corrective action will be completed by February 1, 1985. For the reasons stated above, it is not expected that any new targets will be identified.
