LICENSEE EVENT REPORT (LER)

FACILITY NAME (1) Sequoyah, Unit 1	DOCKET NUMBER (2) 0 5 0 0 0 3 2 7	PAGE (3) 1 OF 0 7
---------------------------------------	--------------------------------------	----------------------

TITLE (4)  
Thimble Tube Ejection, Revision 1

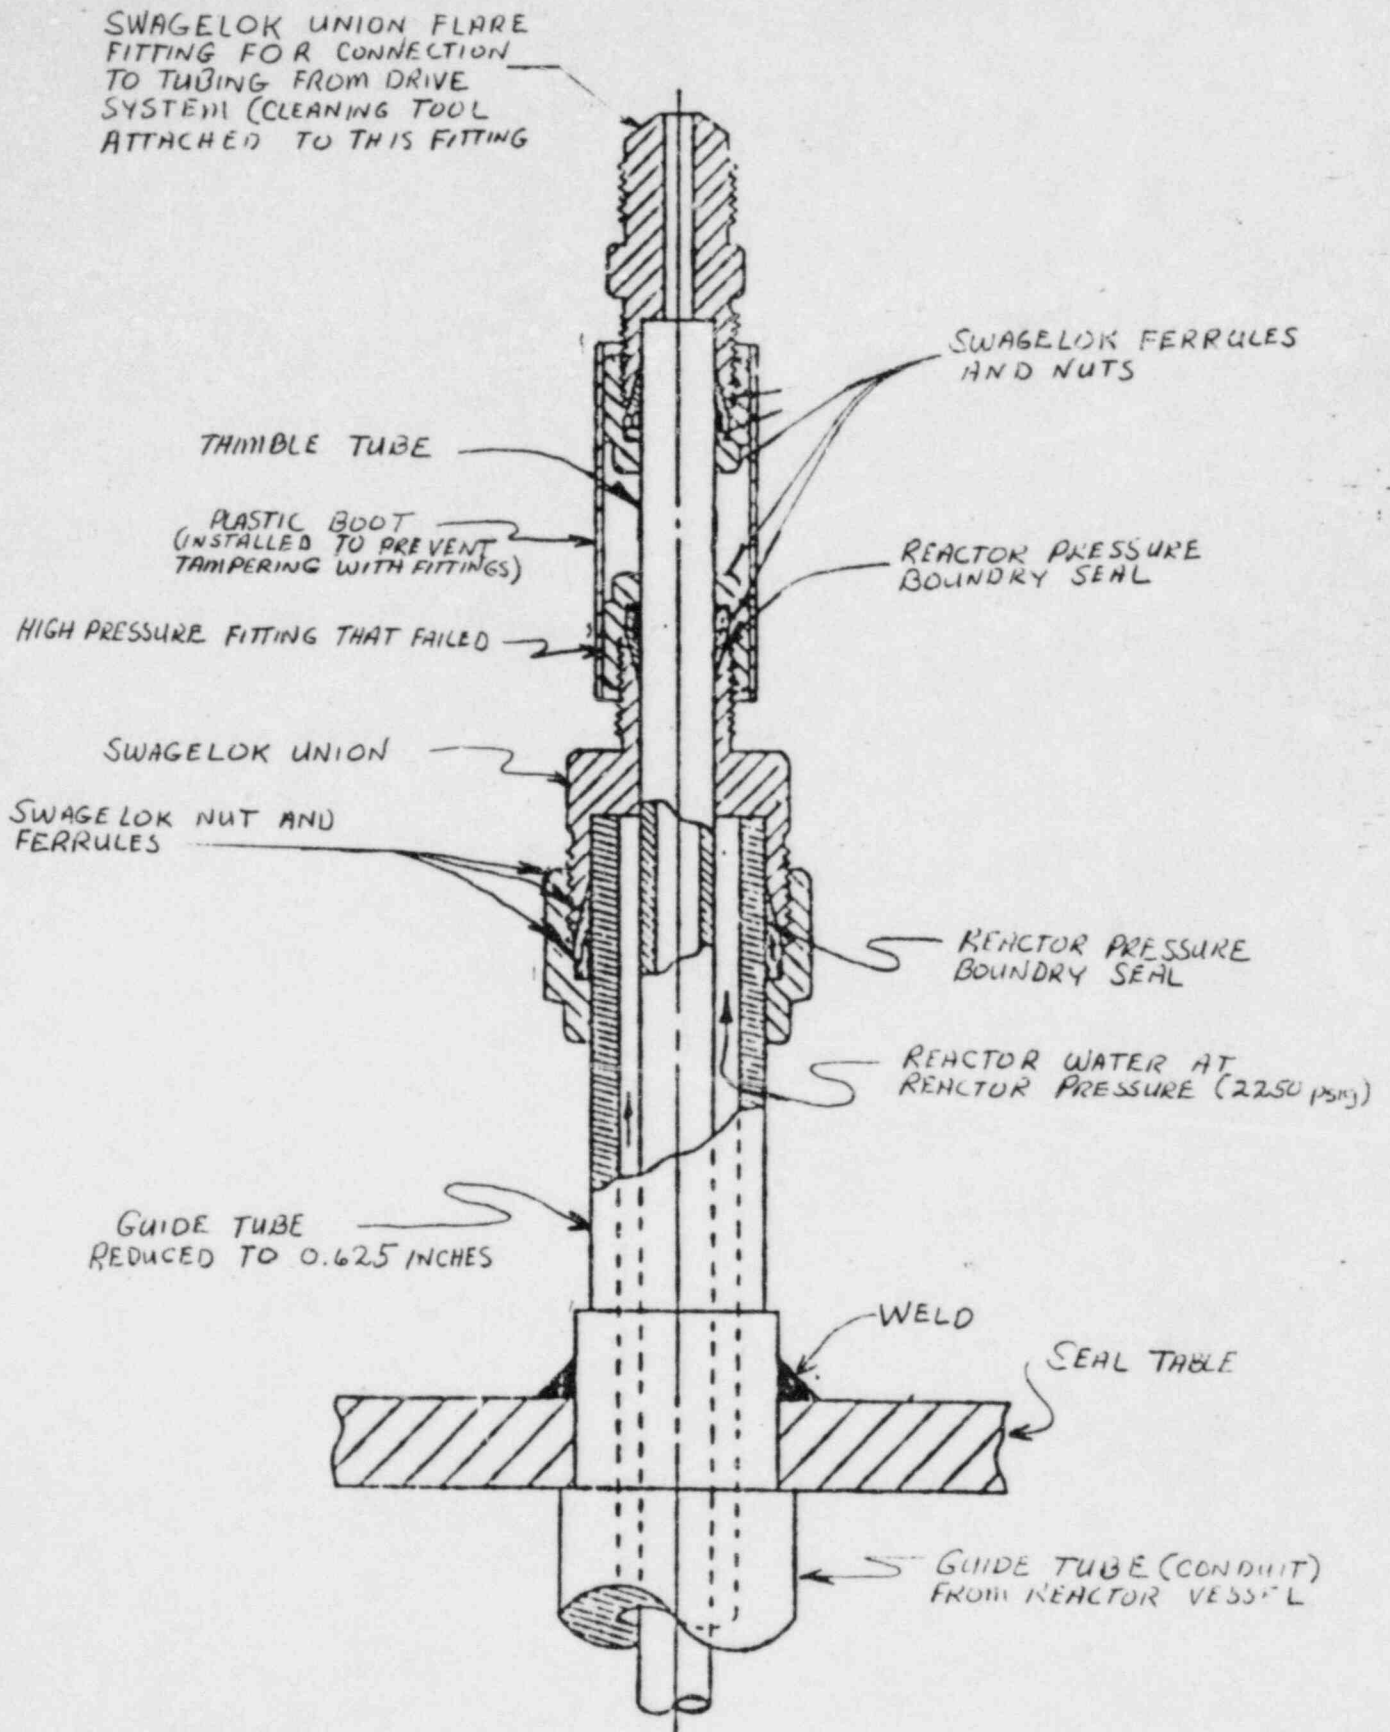
FIGURE 5

Although the ferrule was found cracked circumferentially approximately 180 degrees on the inside diameter, the relative motion by the ejected tube and fitting would have caused the crack to close if it existed prior to the event.

THIMBLE TUBE MECHANICAL SEALS

NOTE: THE FITTING INVOLVED IN THIS INCIDENT CONTAINED A GYROLOK FERRULE ASSEMBLY CONSISTING OF TWO PIECES (SEE FIGURES 1, 2, 5, AND 6 OF ATTACHMENT 1 FOR MORE DETAIL)

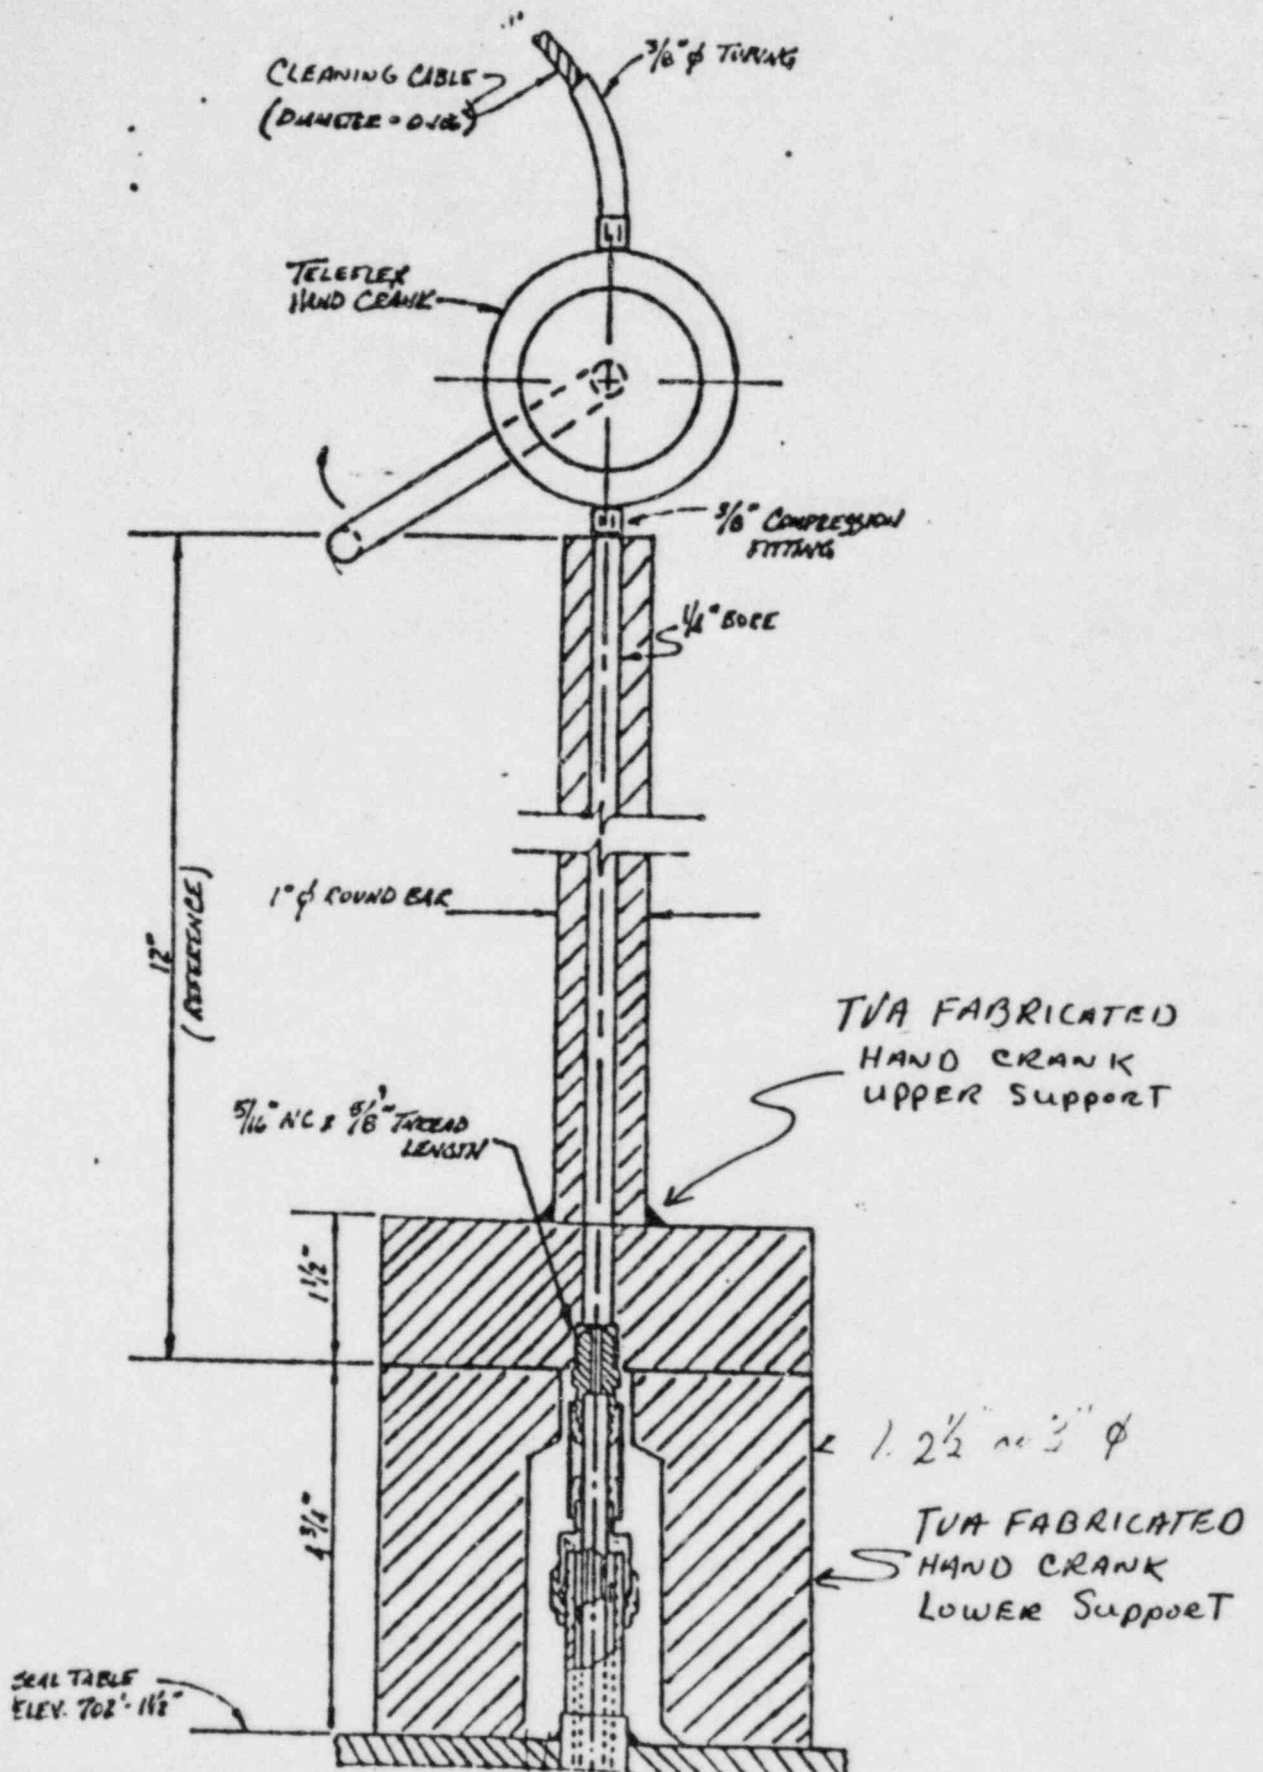
FIGURE 12 A

- Cleaning fixture imposed unusual forces on the assembly. This appears to be the most probable cause of the failure from the tests performed on the mock-up. Three fittings were failed by a person pushing on the handle of the cleaning fixture mock-up. The failed mock-up tubes were similar in appearance to the actual failed tube and fitting. Strain gauges were installed on the mock-up tube and a measured force was applied to the mock-up handle. A plot was made using applied force versus strain. Tube strains of approximately 1000 strain units were noted just due to installation of the cleaning tool. Evaluation of the plot showed some slippage at 30 lbs. applied force. Some leakage appeared at 140 lbs. force and separation occurred at 250 lbs. force.

The cleaning tool base support was modified and a temporary base was constructed and used without a technical evaluation of the effect on the mechanical seals. No testing was performed before use. Use of the tool and its support was determined during post-accident testing to impose forces of considerable magnitude on the mechanical seals and those forces were found to cause strain sufficient that the thimble tube separated from the mechanical seal.

DRYBRUSHING CLEANING TOOL (TELEFLUX SUPPLIED HAND CRANK) AND TVA  
 FABRICATED HANDCRANK UPPER AND LOWER SUPPORT PIECES IN USE WHEN THE  
 THIMBLE TUBE WAS EJECTED

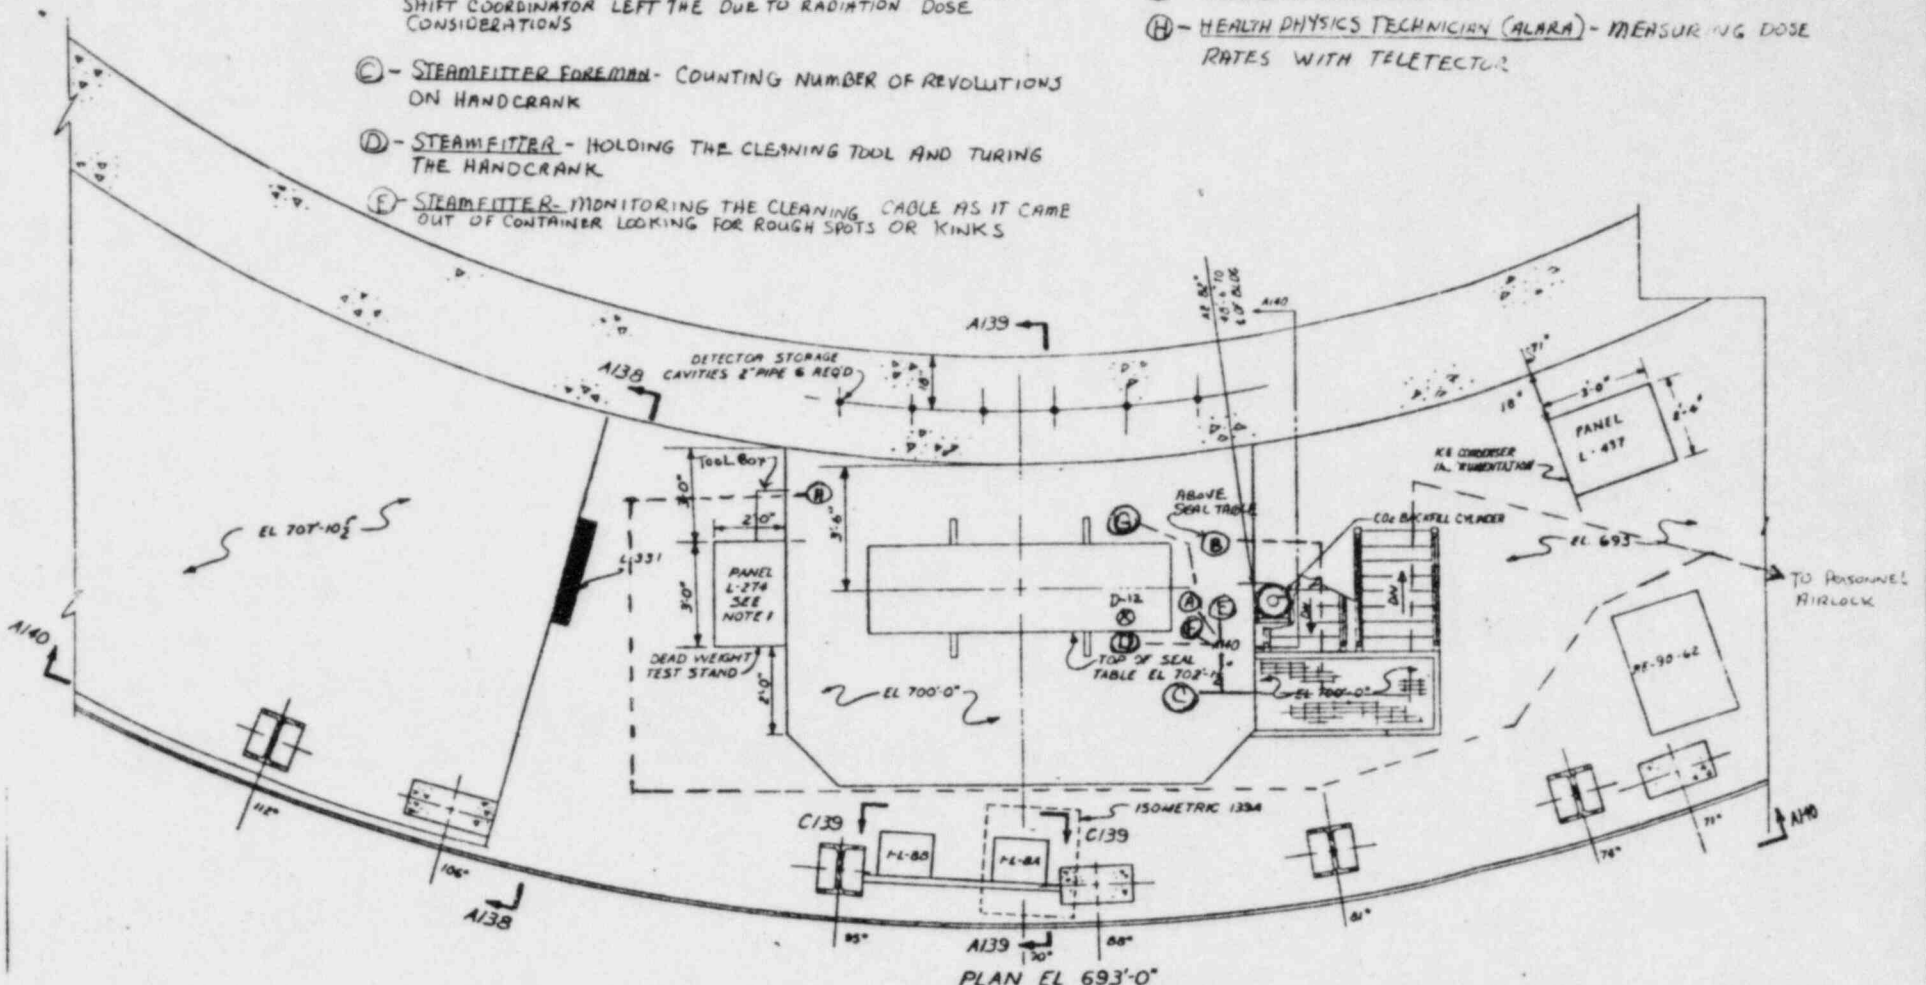
FIGURE 13A

- Ⓐ - EVENING SHIFT COORDINATOR - DIRECTING CLEANING ACTIVITIES
- Ⓑ - MECHANICAL GENERAL FOREMAN - OBSERVER, WOULD ASSUME THE ROLE OF DIRECTING CLEANING OPERATION IF THE EVENING SHIFT COORDINATOR LEFT THE DUE TO RADIATION DOSE CONSIDERATIONS
- Ⓒ - STEAMFITTER FOREMAN - COUNTING NUMBER OF REVOLUTIONS ON HANDCRANK
- Ⓓ - STEAMFITTER - HOLDING THE CLEANING TOOL AND TURNING THE HANDCRANK
- Ⓔ - STEAMFITTER - MONITORING THE CLEANING CABLE AS IT CAME OUT OF CONTAINER LOOKING FOR ROUGH SPOTS OR KINKS

- Ⓕ - STEAMFITTER - FEEDING CABLE INTO THE GUIDE TUBE ON THE CLEANING TOOL
- Ⓖ - HEALTH PHYSICS TECHNICIAN - MEASURING DOSE RATES
- Ⓗ - HEALTH PHYSICS TECHNICIAN (ALARA) - MEASURING DOSE RATES WITH TELETECTOR

LOCATION OF WORKERS WHEN THE INCIDENT OCCURRED AND EGRESS ROUTES OUT OF THE INSTRUMENT ROOM

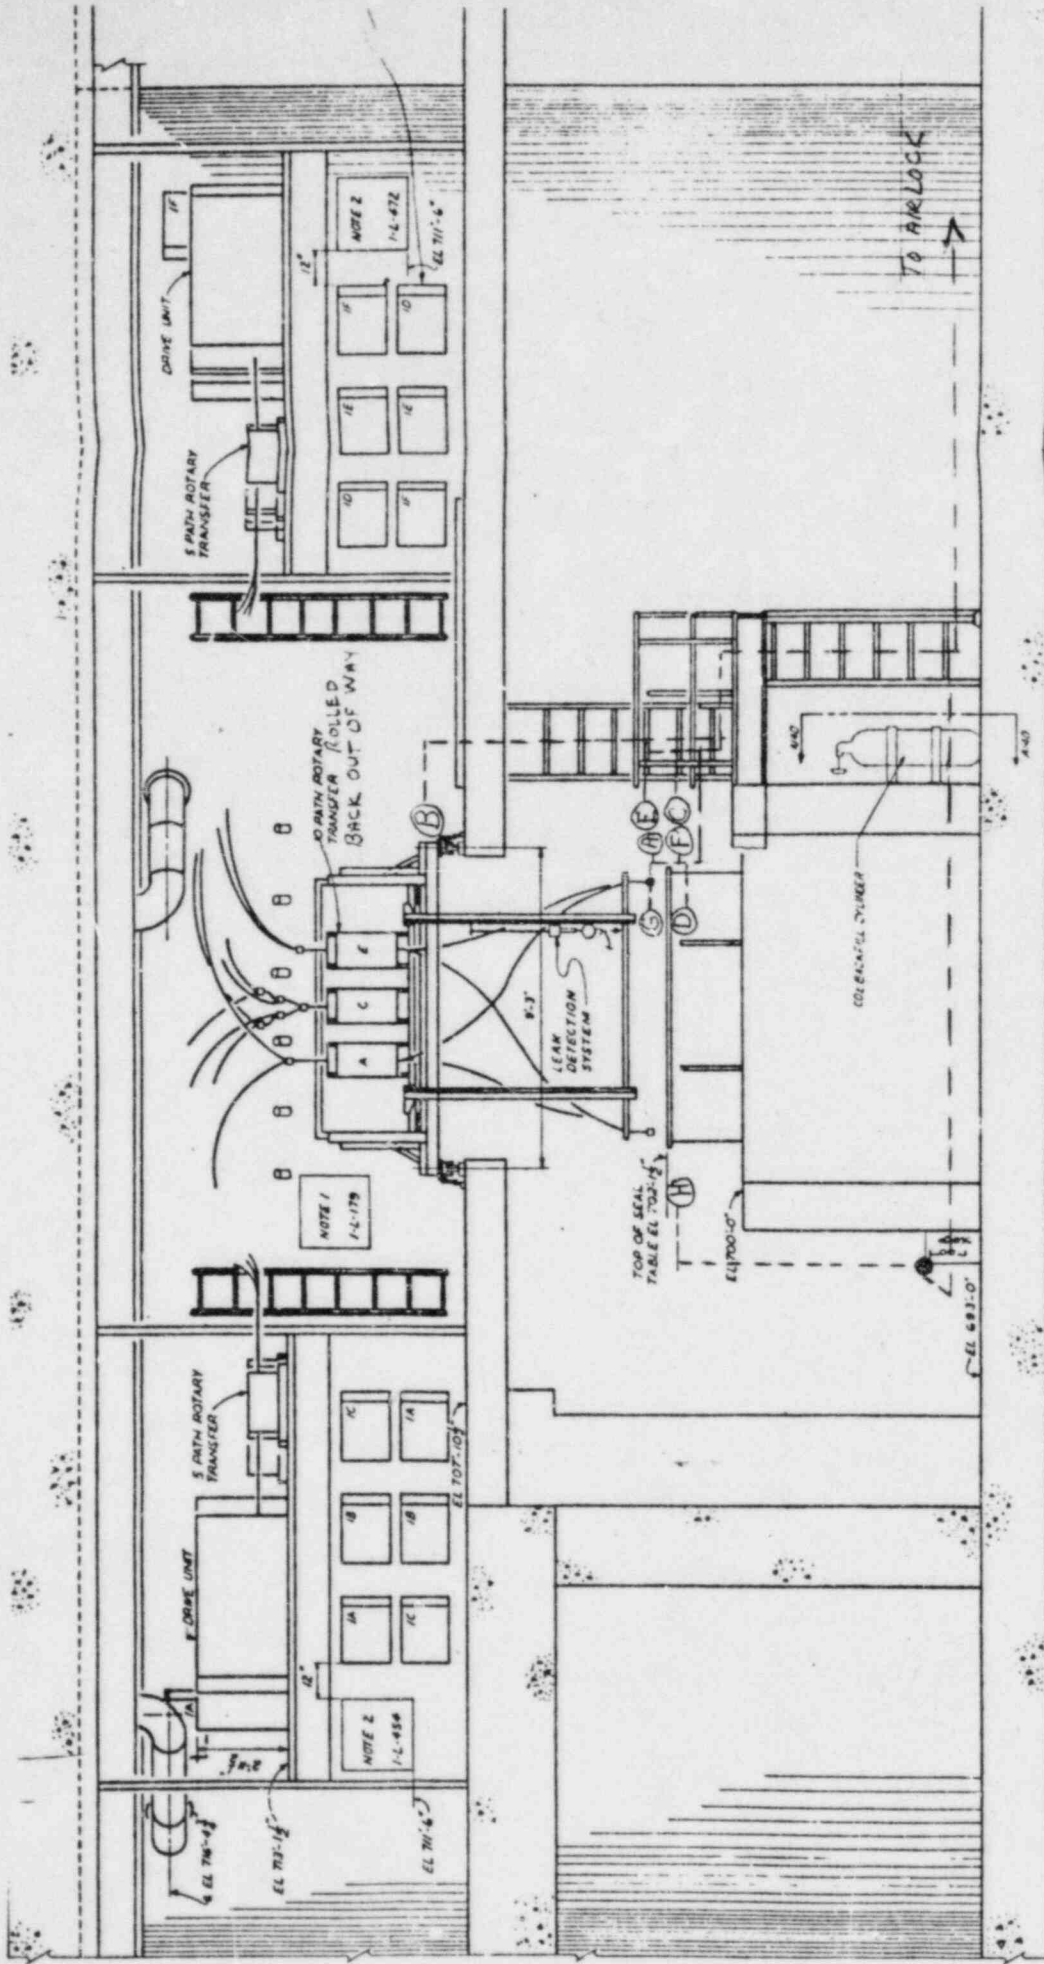
LOCATION OF WORKERS WHEN INCIDENT  
 OCCURRED AND EGRESS ROUTES  
 FIGURE 13B

NOTE 3 (H) FLIPPED OR FELL OVER  
 HAMMOCK HIT TOOL BOX, AND RAN  
 TO THE AIRLOCK

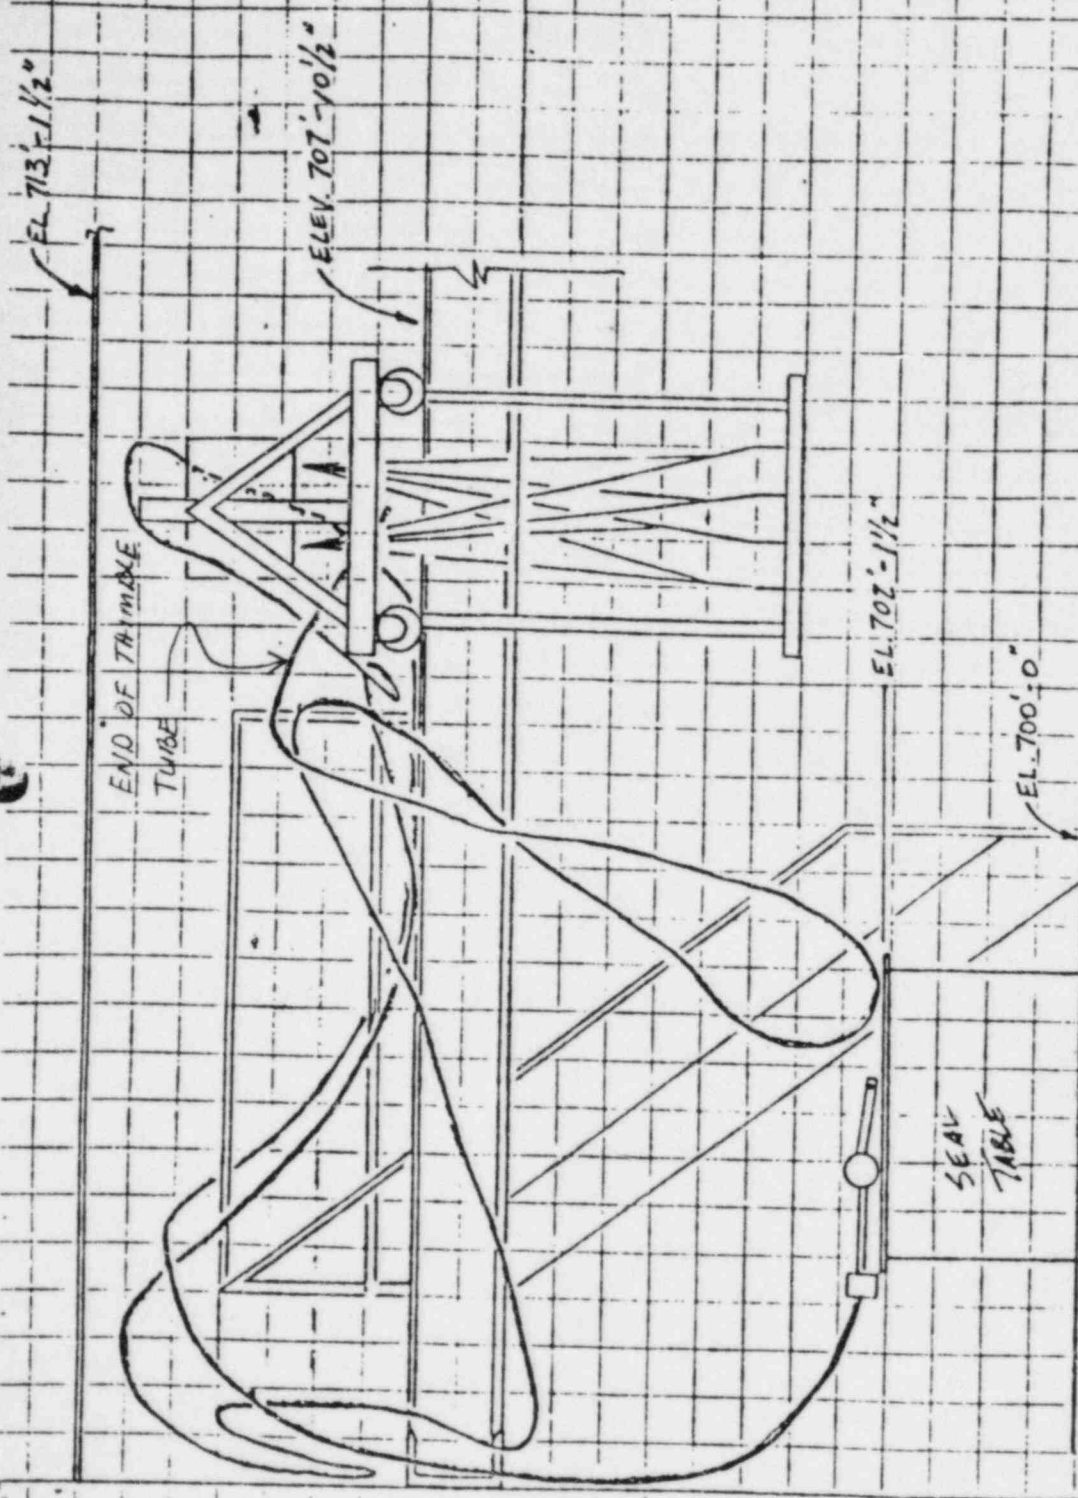
REPRODUCED DRAWING OF EJECTED THIMBLE TUBE  
FIGURE 15

At approximately 0900 CST, four personnel entered the seal table area to observe the general condition of the area. Personnel reported the thimble tube to be completely ejected from the guide tube and twisted throughout the room. A small, steady stream of water was flowing from the guide tube at the seal table as a result of the pressure from the nitrogen blanket in the pressurizer. Radiation surveys indicated levels of 2-3 rem at the entrance to the seal table area, 200-300 rem at the end of the tube closest to the seal table, and greater than 1000 rem in the center of the ejected tube.
