Northern States Power Company

MONTICELLO NUCLEAR GENERATING PLANT
Docket No. 50-263 License No. DPR-22
LER 96-002

Emergency Diesel Generator Operability Concerns Due to
Missing Fastener in Voltage Regulator

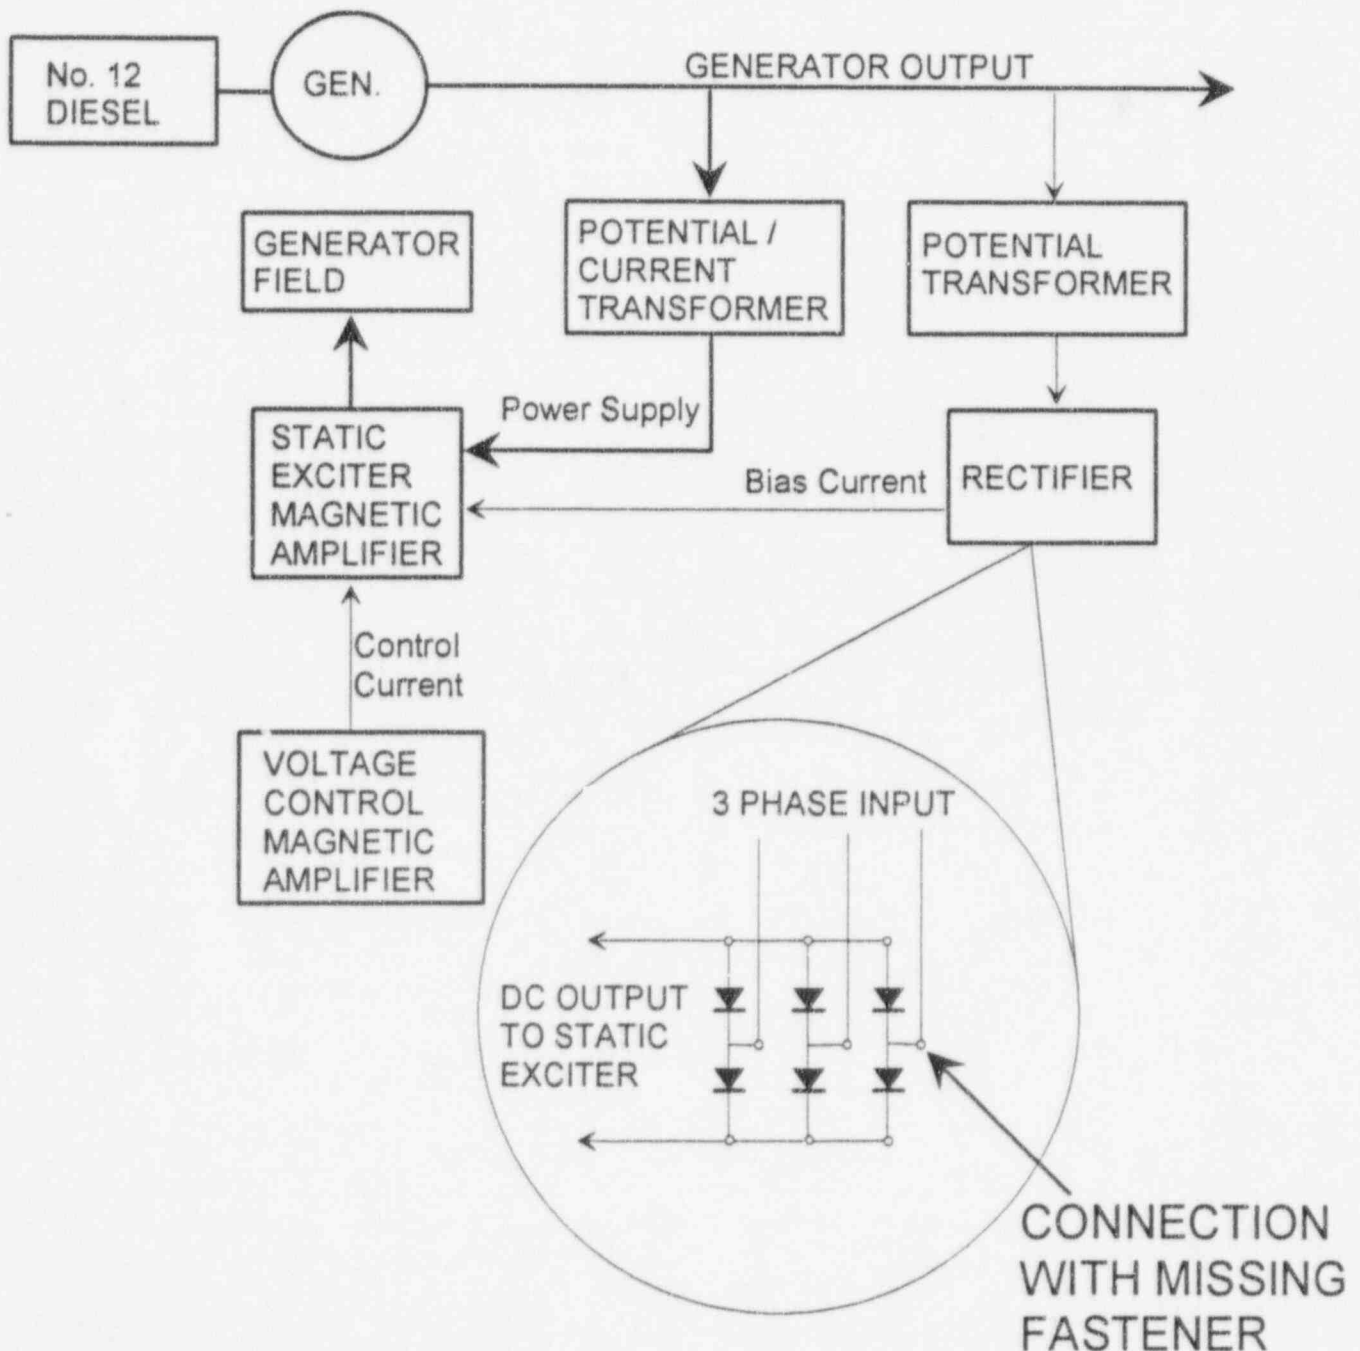
EMERGENCY DIESEL GENERATOR VOLTAGE CONTROL (SIMPLIFIED)

While at 83% power on March 8, 1996, system engineers found a wire in the No. 12 Emergency Diesel Generator (EIS System Code: EK) voltage regulator (EIS Component Code: EC) not properly secured. The wire provides the electrical connection between a potential transformer and a rectifier in the voltage regulator (see attached figure). The wire was promptly secured and the emergency diesel generator (No. 12) was successfully tested. The unaffected redundant emergency diesel generator (No. 11) was also successfully tested.

The wire had a lug on it and the rectifier terminal connection is a metal tab with a hole for the bolt to penetrate. No bolt or nut was present at the connection. The wire was found with the lug in contact with the rectifier terminal and held against the terminal by spring tension in the wire. However, continuous contact between the lug and the terminal during a seismic event could not be assured.

1. The wire lug was secured to the terminal promptly, following identification.
2. Both Emergency Diesel Generators were tested and determined to be fully operable.
3. The cabinet with the loose fastener was visually inspected for other loose fasteners; none were found. The similar panel for the No. 11 Emergency Diesel Generator was also visually inspected and no problems were found.
4. The periodic electrical connection inspection procedures will be revised to provide additional guidance for personnel performing the inspections. Past inspections have been comprehensive, however, this change will clarify the requirement to inspect for missing fasteners.
