LICENSEE EVENT REPORT (LER)

FACILITY NAME (1) BYRON, UNIT 1	DOCKET NUMBER (2) 0 5 0 0 0 4 5 4 1	PAGE (3) OF 0 4
---	---	---------------------------

TITLE (4)
INOPERABILITY OF BOTH SI TRAINS

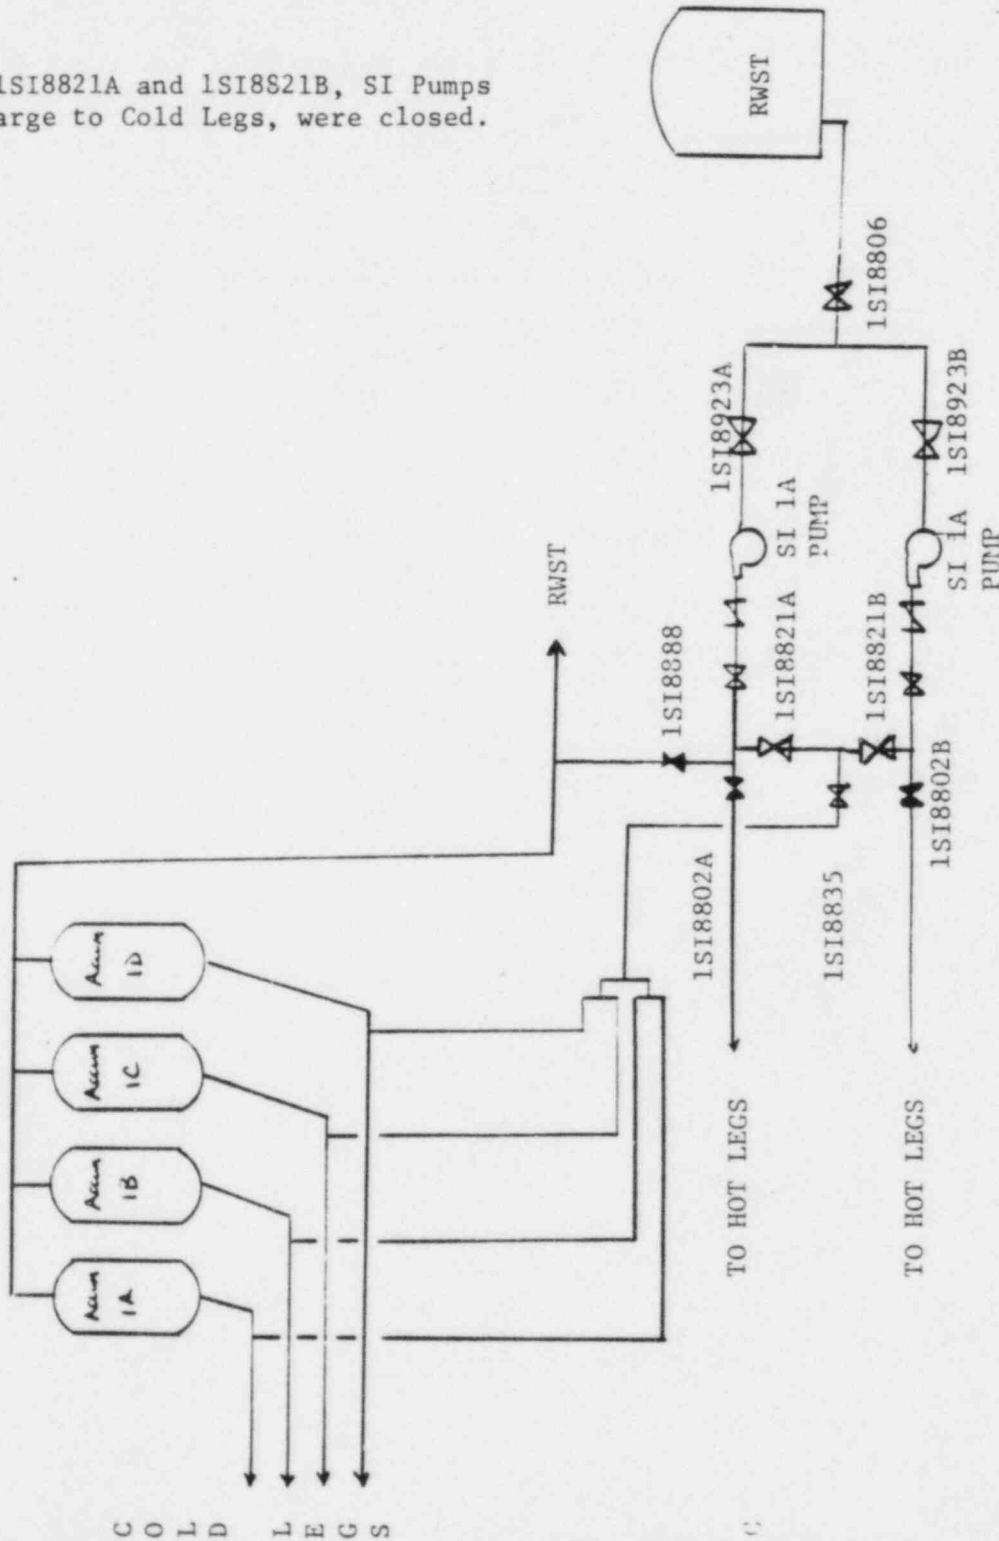
ILLUSTRATION OF SI INOPERABILITY EVENT

The operator, concerned with the possibility of overpressurizing the RCS, closed both discharge lines crosstie isolation valves whereas the procedure stated to close only the A train isolation valve. The Main Body of the procedure was technically correct for the given conditions, so the deviation resulted from the procedure not being followed. The procedure was very restrictive allowing only the SI A pump to be used for raising the Accumulator level.

Both 1SI8821A and 1SI8821B, SI Pumps Discharge to Cold Legs, were closed.

A temporary Procedure Change Request was immediately initiated to change the procedure to provide awareness of Technical Specifications LCO violations. The procedure has been since permanently revised to allow the use of either SI pump depending on the plant conditions. The procedure states under what conditions each pump can and/or must be used to prevent another LCO violation. In addition, the control board mimic of the Safety Injection System was reviewed and verified to be correct.
