U. S. ATOMIC ENERGY COMMISSION  
DIRECTORATE OF REGULATORY OPERATIONS  
REGION I

RO Inspection Report No.: 50-219/73-11

Licensee: Jersey Central Power & Light Company

Location: Oyster Creek, Forked River, N.J.

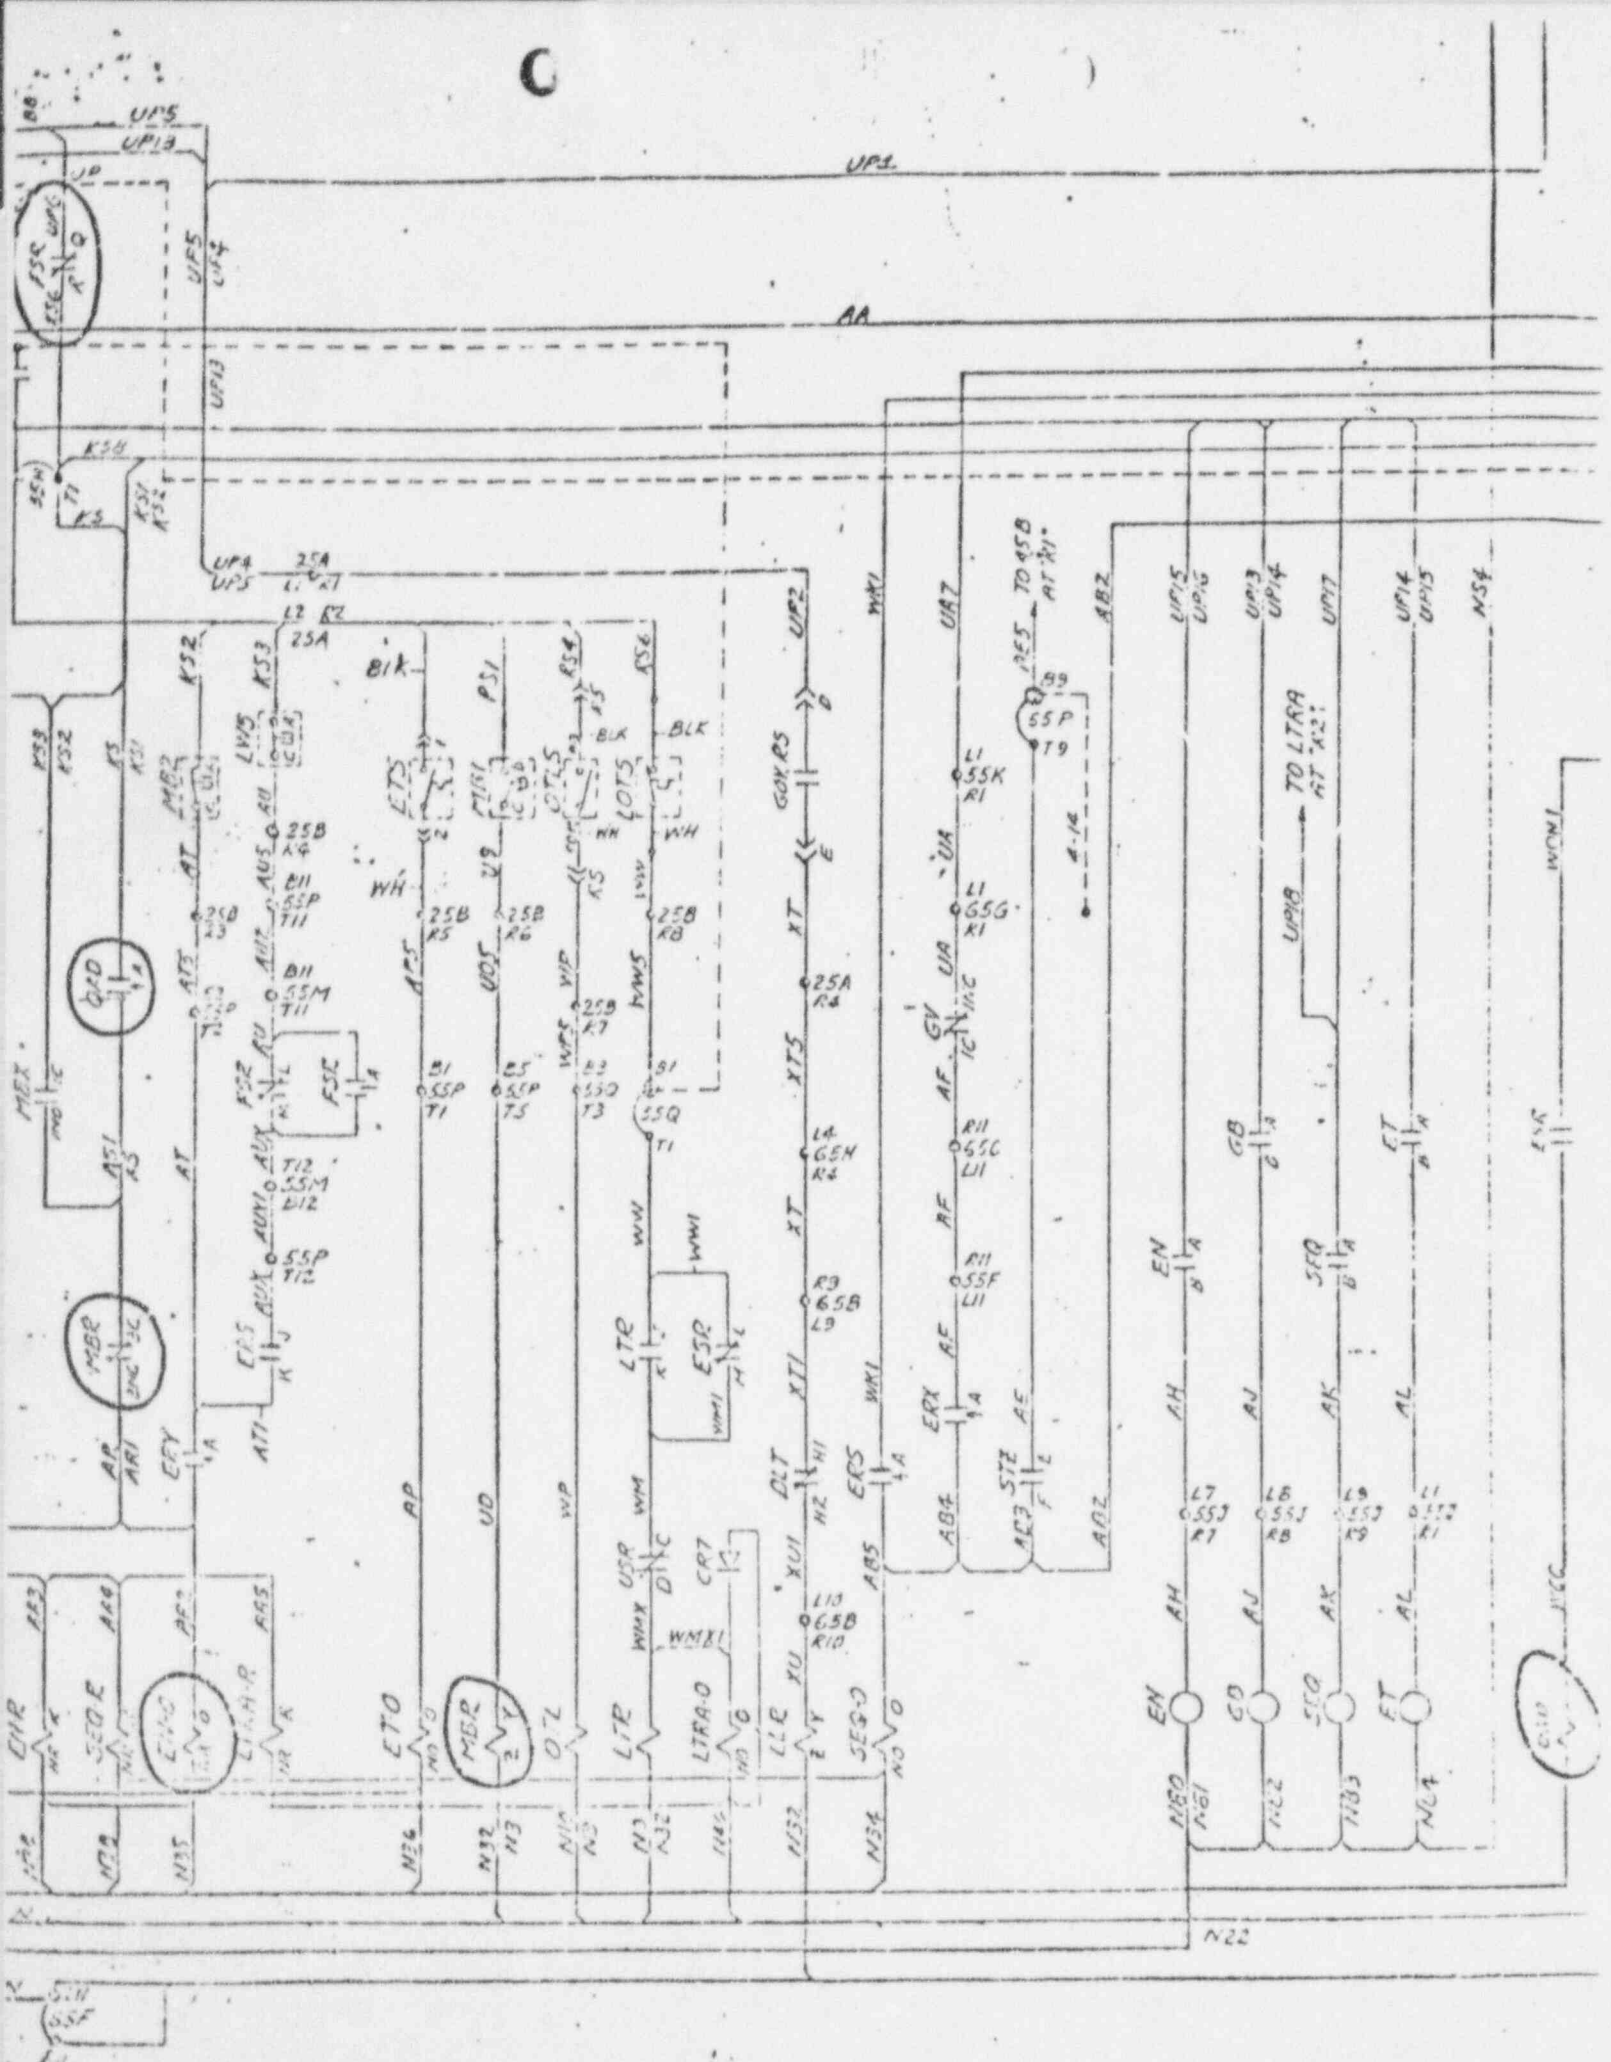
CONTROL SCHEMATIC FOR EMERGENCY DIESEL GENERATOR

The problem experienced with the diesel generators was identified to be as a result of relay contact actuation which is inherent in the design of the circuit (see Figure 1). When the unit is initiated in the "fast start" mode, power to the engine fault circuit is cut off. With the unit at speed, the OAD relay is energized closing contacts in the engine "lockout" circuit. Under normal conditions, the bearing oil pressure switch would be closed, enabling the MBR relay to be energized, opening a contact in the engine "lockout" circuit. However, that relay could not be energized due to the opened "fast start" relay contacts and consequently the bearing oil pressure contacts remained closed. When the unit was secured, the "fast start" relay was deenergized, closing the "fast start" relay contacts. Before the MBR relay could be energized and its respective contacts opened in the engine "lockout" circuit, the "lockout" relay was actuated which prevented a subsequent start. The engines would remain locked out until the relays could be manually reset locally, as was the case.

1. Prepare procedures, in conjunction with the Relay Department, for all Relay Department work in the Oyster Creek plant. All work in the future will be coordinated with the shift foreman.
2. Prepare a design change to the diesel generator logic circuits to prevent lockout following shutdown of the diesel. General Motors will be contacted for recommendations.
3. Review and revise Procedure No. 511 "Loss of Feedwater System" as required.
