RO INSPECTION REPORT NO. 50-219/73-15
JERSEY CENTRAL POWER AND LIGHT COMPANY

OYSTER CREEK DIESEL GENERATOR RESTART PROBLEMS - DOCKET NO. 50-219

DETAILS

Section II - Diesel Generator Circuit Modifications (V. Thomas)

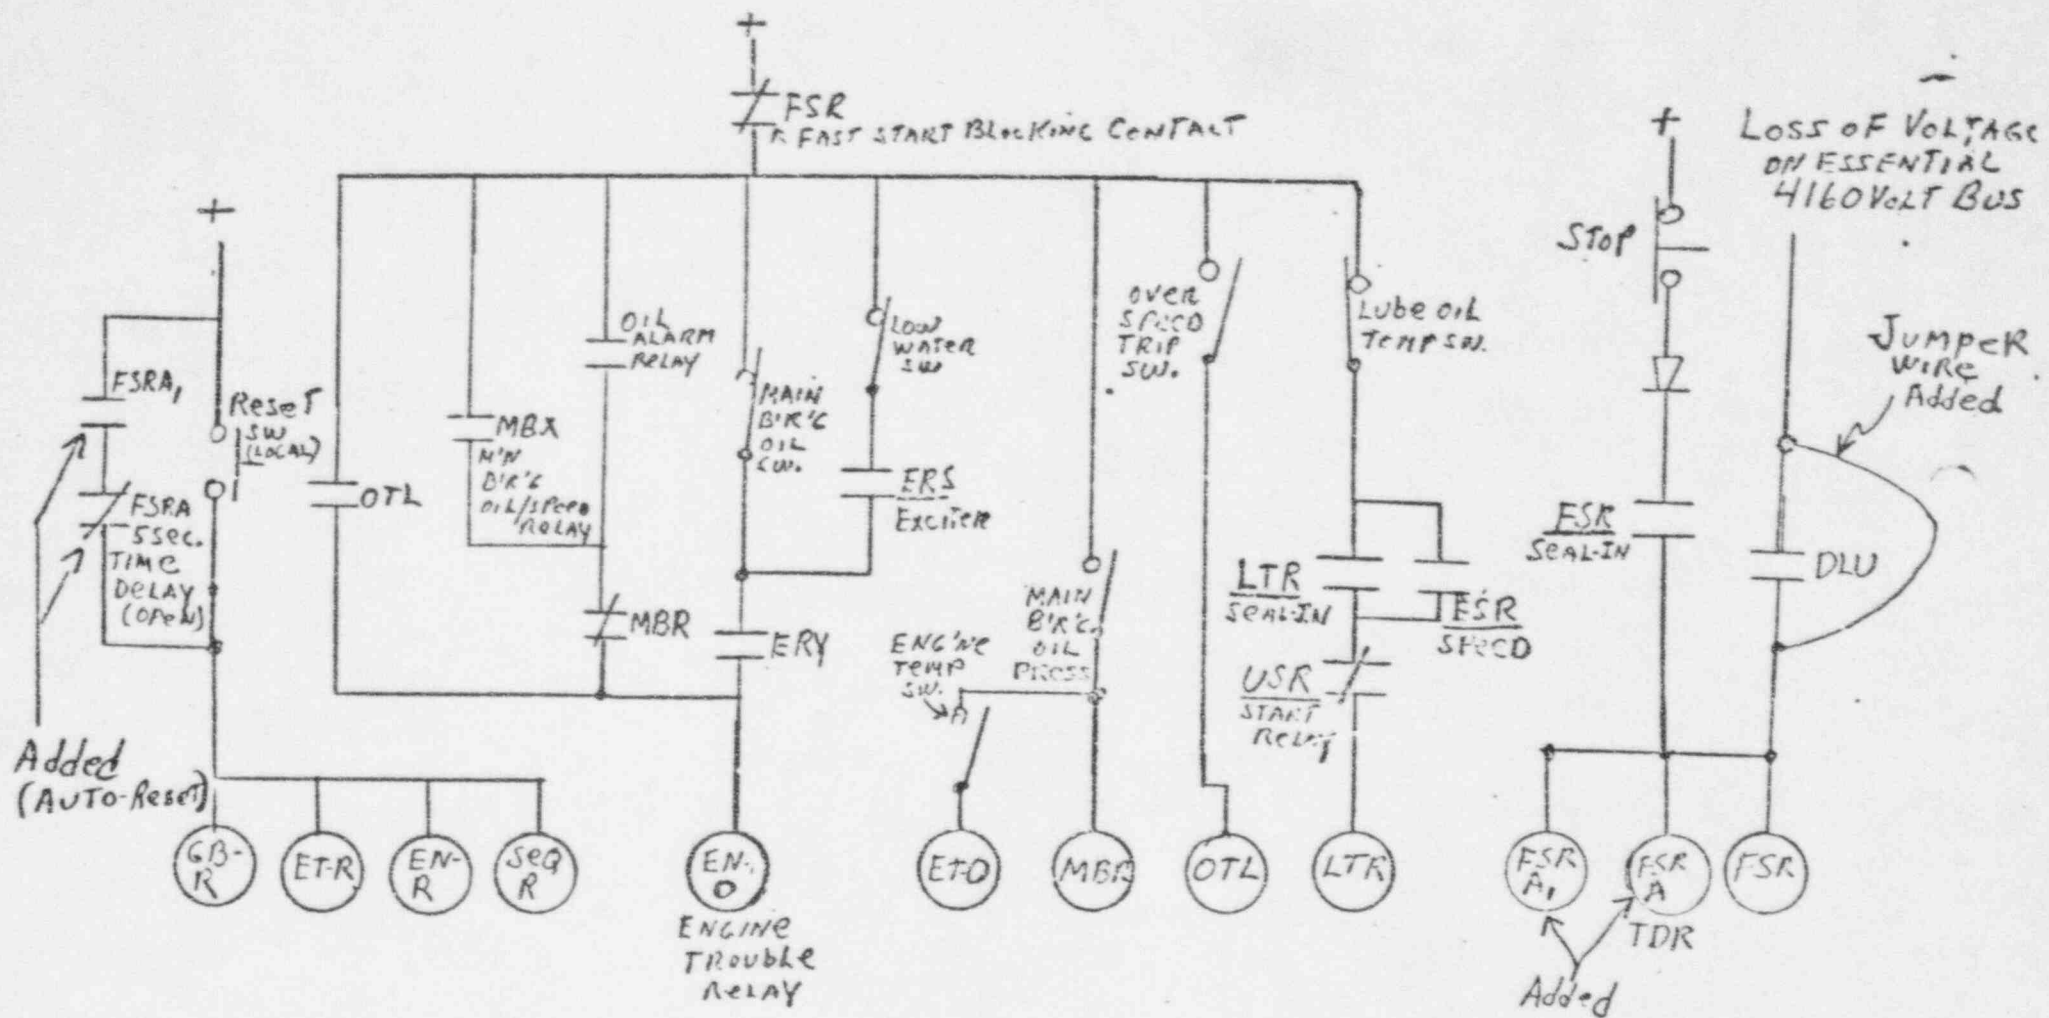
TYPICAL
 DIESEL GENERATOR CIRCUIT (PARTIAL)
 MODIFICATION

The licensee stated that subsequent to the problem experienced with the diesel generators during the recent loss of power event, investigation into the matter resulted in modifications of the diesel unit's fast-start, and restart circuitry. These corrective measures are discussed below and are also shown on Figure 1, a simplified schematic of the diesel generator's starting circuitry.

The corrective measures taken by the licensee involved the installation of two relays and a jumper wire. The two "fast-start" auxiliary relays identified as FSRA (time delay) and FSRA₁ (instantaneous), are installed parallel to the existing "fast-start" relay (FSR). The jumper wire is installed around the set of contacts of the "dead-line" (DLU) relay. In effect, these modifications now permit the FSR, FSRA, and FSRA₁ relays to be energized simultaneously upon loss of power to any essential 4160 volt bus even though an engine-fault is present. This automatic reset feature is made possible because of the following additional circuit changes:

1. A set of contacts from each new relay, FSRA and FSRA₁, is now installed in a series parallel circuit arrangement (see Figure 1) around the existing local reset button that is wired in the diesel generator's engine-fault reset circuitry.

2. The set of contacts from the FSRA relay has a five second time delay "to open" feature while the other set of contacts from the FSAR₁ relay has an instantaneous "to close" feature. This mode of contact operation occurs only when FSRA and FSRA₁ relays are energized.

In summary, the contact operation combined with the circuit arrangement as discussed now provided the licensee with a "built-in" automatic five second reset feature to clear any engine-fault during a diesel generator fast-start situation. There is no longer a need to manually reset the machine to obtain a "fast-start" following a manual shutdown of the unit. It is well to note, however, that the auto-reset feature has no effect during manual operation of the diesel generator. In manual operation, local reset action following unit shutdown is still required.

The licensee also stated that the above modifications were reviewed by the Plant Operations Review Committee (PORC) as required, and the proposed fix was found to be acceptable. The modifications were completed by October 1, 1973. Subsequently, the diesel unit's automatic start circuitry was successfully tested in that, the unit properly responded to a fast-start condition while an engine fault existed.

Our review of the above circuit modifications revealed that these corrective actions have been completed. We also reviewed the licensee's abnormal occurrence report, and his test procedures of the diesel unit following the above modifications, and no items of discrepancy were noted.
