Subject: Abnormal Occurrence Report 73-17

Subject: Oyster Creek Station
Docket No. 50-219
Hydraulic Shock and Sway Arrestor Failure

OYSTER CREEK
NUCLEAR GENERATING STATION
DPR-16

SUMMARY REPORT ON
SNUBBER REPAIR ACTIVITIES
DURING SPRING 1973
REFUELING OUTAGE

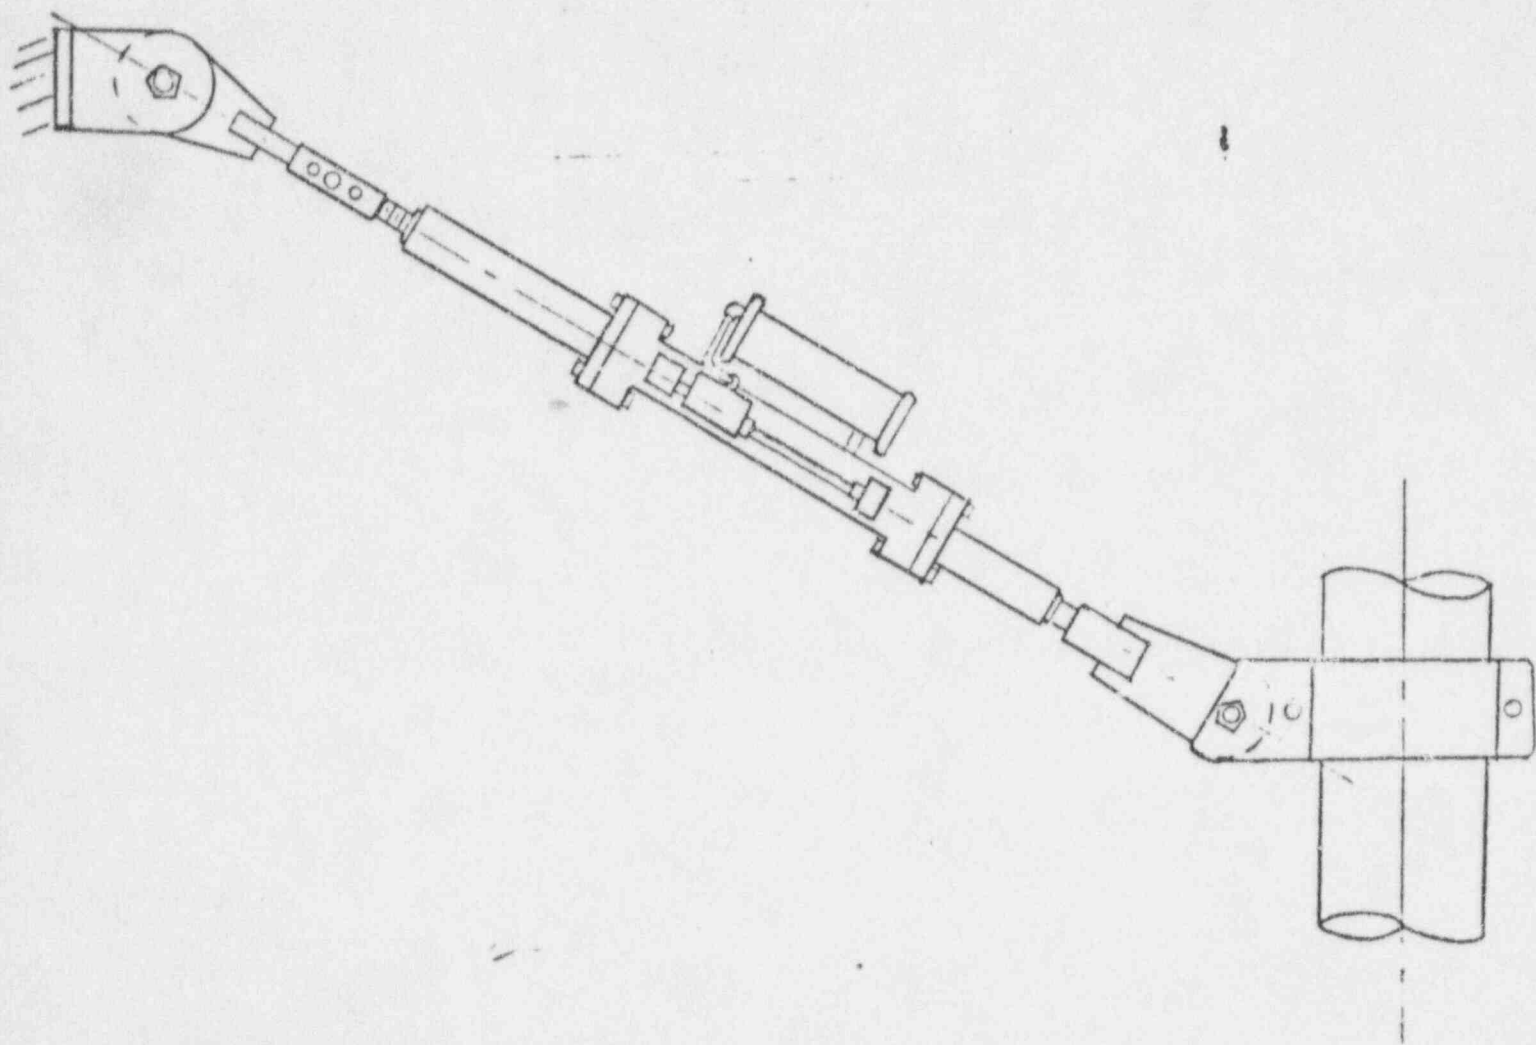
FIGURE I

THE HYDRAULIC SHOCK AND SWAY ARRESTOR (HSSA) UNIT (ILLUSTRATED IN FIGURE ONE) IS USED TO PROTECT PIPING SYSTEMS AND EQUIPMENT PIECES SUBJECT TO POSSIBLE DAMAGE FROM SHOCKS OR VIBRATION. IN EFFECT, THE ARRESTOR BECOMES A RIGID STRUCTURAL MEMBER UNDER IMPACTIVE LOADING CONDITIONS. IN DOING THIS IT IS CAPABLE OF TRANSFERRING LOADS FROM THE PIPING OR EQUIPMENT PROTECTED TO RIGID STRUCTURAL MEMBERS. THE ARRESTOR IS FURTHER DESIGNED TO ACCOMMODATE NORMAL THERMAL MOVEMENT OF THE EQUIPMENT PROTECTED WITH A MINIMUM OF RESISTANCE.

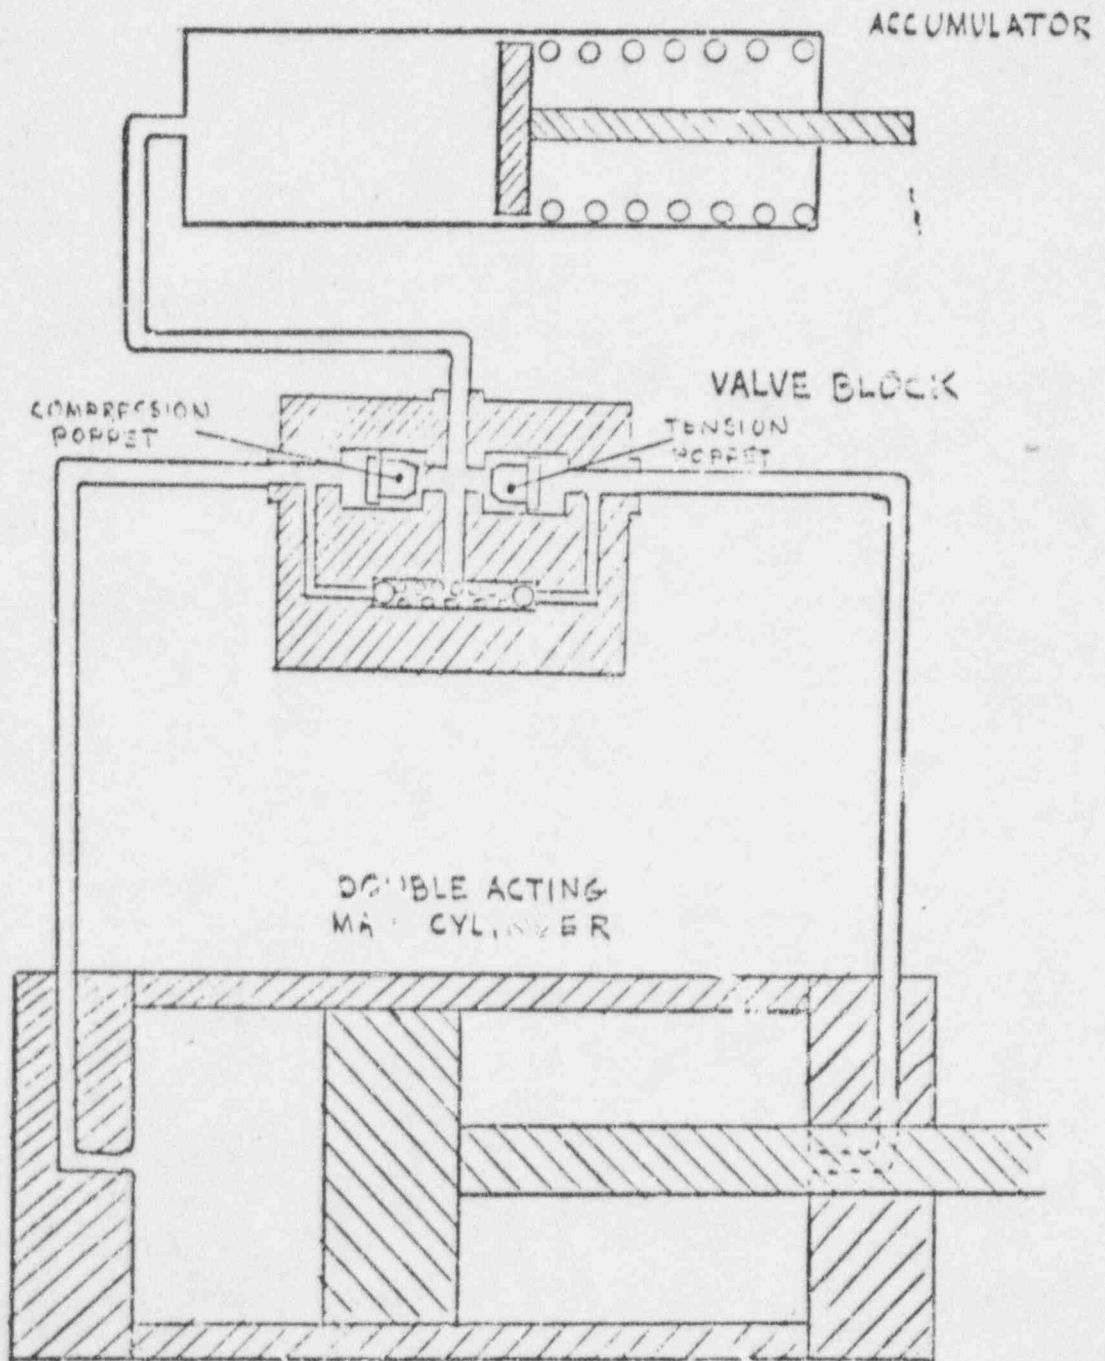
FIGURE II

THE UNIT CONSISTS OF A DOUBLE ACTING PISTON CYLINDER ARRANGEMENT, AN EXTERNAL VALVE BLOCK AND A SPRING LOADED ACCUMULATOR ASSEMBLY (SEE FIGURE II).
