Subject: Oyster Creek Station
Docket No. 50-219
Valve Malfunctions

ATTACHEMNT I

Failure of the "D" Electromatic Relief Valve to reseal after performing its protective function is considered to be an abnormal occurrence as defined in the Technical Specifications, Paragraph 1.15.F.

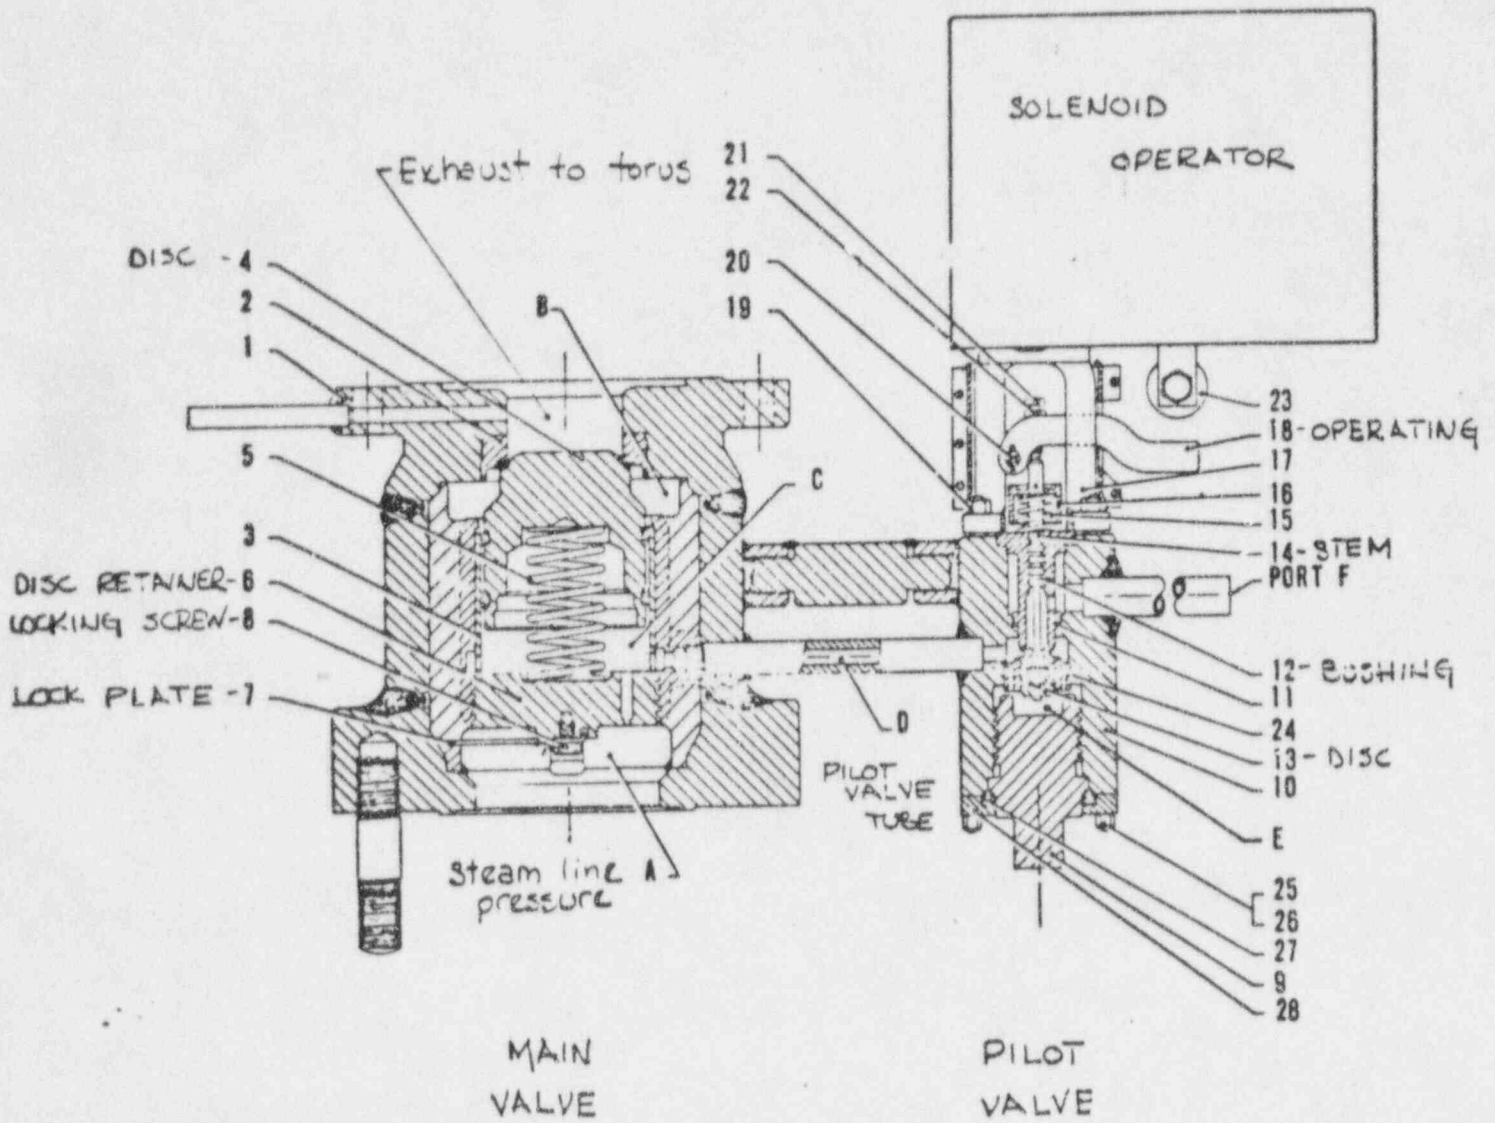
FIGURE 1

Figure 1 attached identifies the valve parts under discussion.

Further investigation revealed that a piece of thread material from the disc retainer of the main valve had blown through the pilot valve tube. During the valve actuation it became lodged between the pilot valve seat and disc, thus the pilot valve was not able to fully close which, in turn, maintained the main valve in an open position.

It was also noted that the tie wire, lock screw and lock arm were missing from the disc retainer. Since the lock arm and screw were missing from the "D" valve, the remaining 4 relief valves were removed for inspection. As a result of this inspection, it was found that a small tab from the lock arm of the "B" relief valve had also broken off. Similar parts for the other 3 valves were found to be in place and secure. In addition, it was observed that the valve operator's spring guide for the "E" relief valve was misaligned, thus causing the solenoid plunger to be restricted in its upward travel.

In order to prevent recurrence of lock arm failures, these components were removed from all relief valve assemblies. A new method of preventing disc retainer rotation was installed. This method consists of pinning the disc retainer to the cage. Dresser Company, manufacturer of the valves, was contacted concerning this repair and approved same, taking into consideration that the installation of a set screw can in no way cause the clearance between the threads to increase. All other lead threads on each disc retainer were examined and feathered edges removed as necessary. The spring guides for the "E" valve were realigned and the solenoid plunger was checked for freedom of movement.
