JERSEY CENTRAL POWER & LIGHT COMPANY, DOCKET NO. 50-219  
PRELIMINARY SUMMARY REPORT ON SNUBBER REPAIR ACTIVITIES DURING  
SPRING 1973 REFUELING OUTAGE

Subject: Oyster Creek Station  
Docket No. 50-219  
Reactor Coolant System Leakage

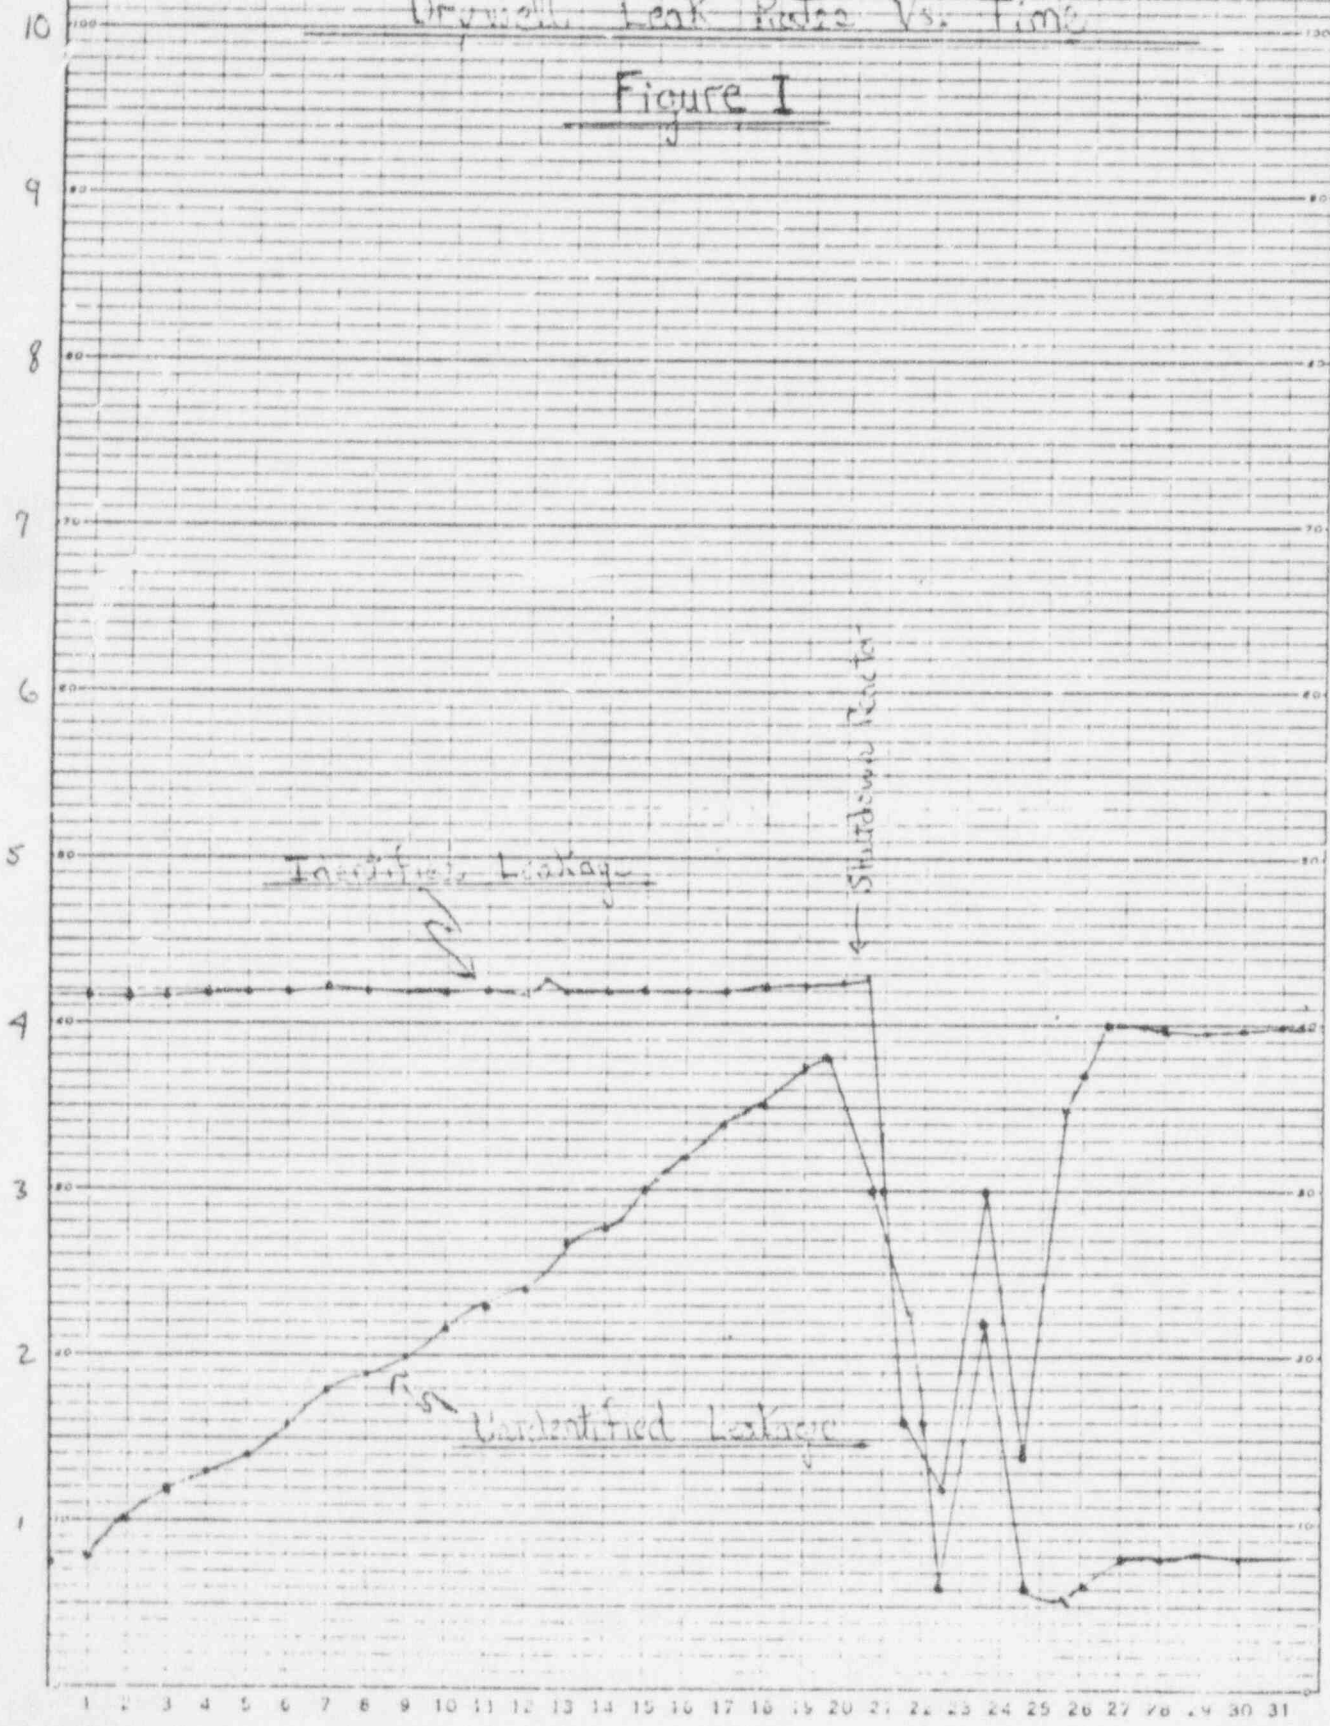
## Figure I

As indicated in Figure 1, attached, an increasing rate of leakage into the drywell sump began to occur on July 1, 1973 and continued through July 19, 1973, reaching a peak of approximately 3.02 gpm when averaged over 24 hours. As shown in Figure 2, attached, a plot of absorption pool (torus) water level developed on July 23, 1973 over the same period indicated the level to be increasing starting about July 11, 1973. It is now estimated that the unexplained leak rate increased to >5.0 gpm at some time during July 17, 1973 and continued to be above the 5.0 gpm limit until the plant was shut down and depressurized on July 21, 1973.

# Drywell Leak Rates Vs. Time

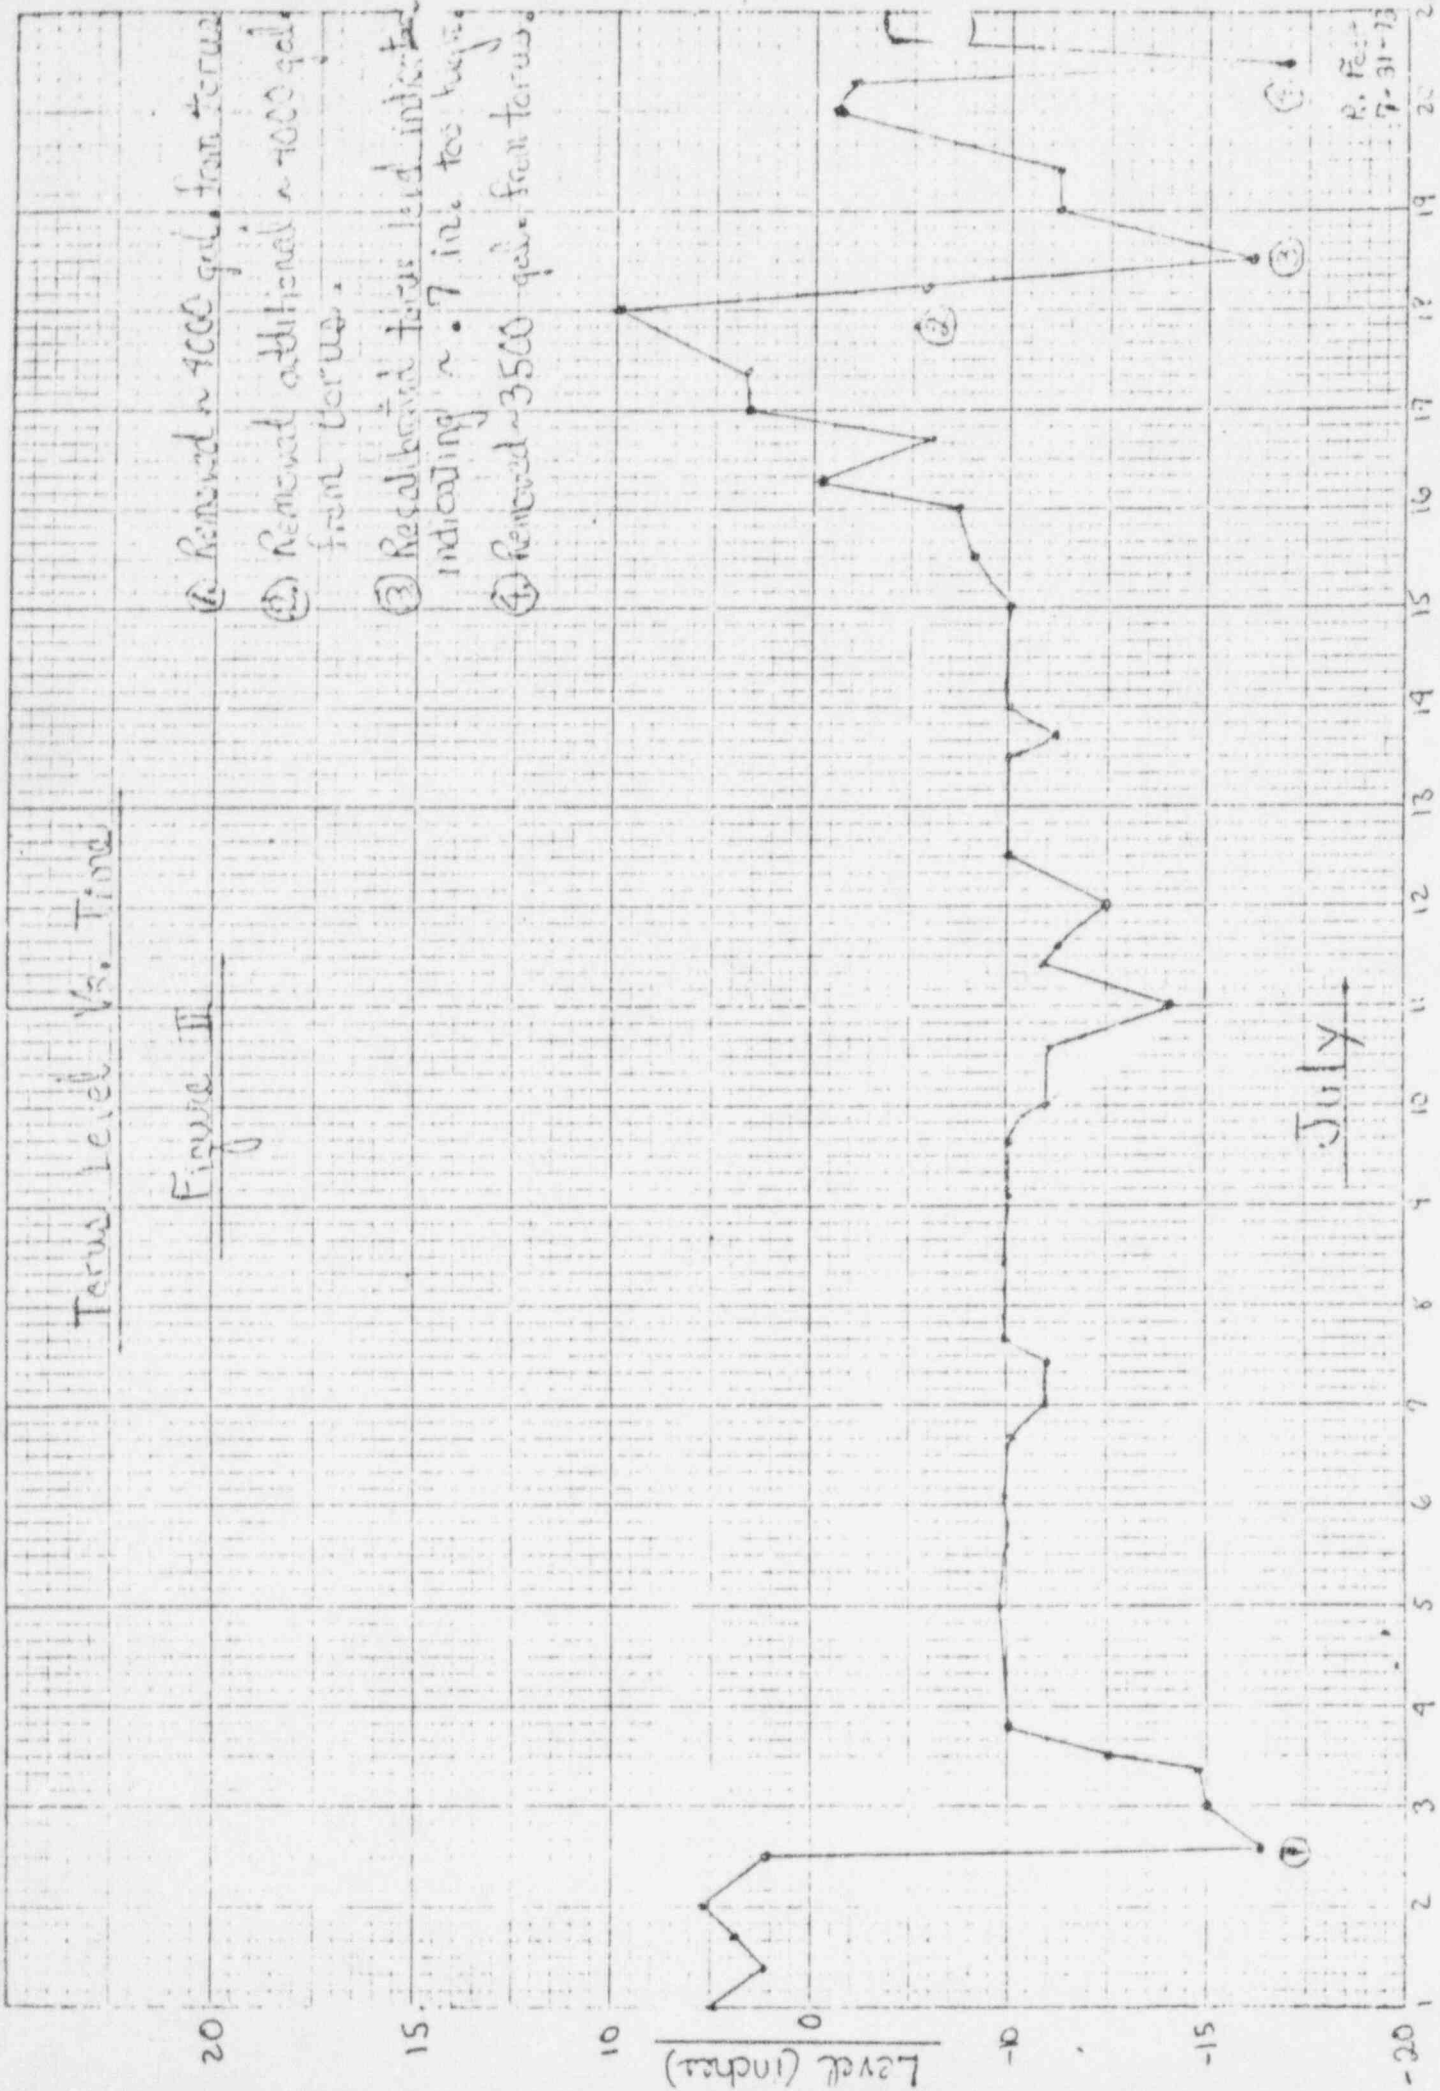
Figure III

Torus Level Vs. Time

- ① Removed ~ 4000 gal. from torus.
- ② Removed additional ~ 4000 gal. from torus.
- ③ Re-calibrated torus lid indicator indicating ~ 7 in. too high.
- ④ Removed ~ 3500 gal. from torus.
