PRELIMINARY  
SUMMARY REPORT ON  
SNUBBER REPAIR ACTIVITIES  
DURING SPRING 1973  
REFUELING OUTAGE

Subject: Abnormal Occurrence Report 73-14.

Report No. 73-14

SUBJECT: Violation of the Technical Specification, paragraph 3.3D, Reactor Coolant System Leakage. Operation of the reactor at power continued when it was not recognized that an increasing Absorption Pool Level combined with the rate of leakage into the Drywell Sump resulted in an "unexplained" leak rate in excess of 5 gpm.

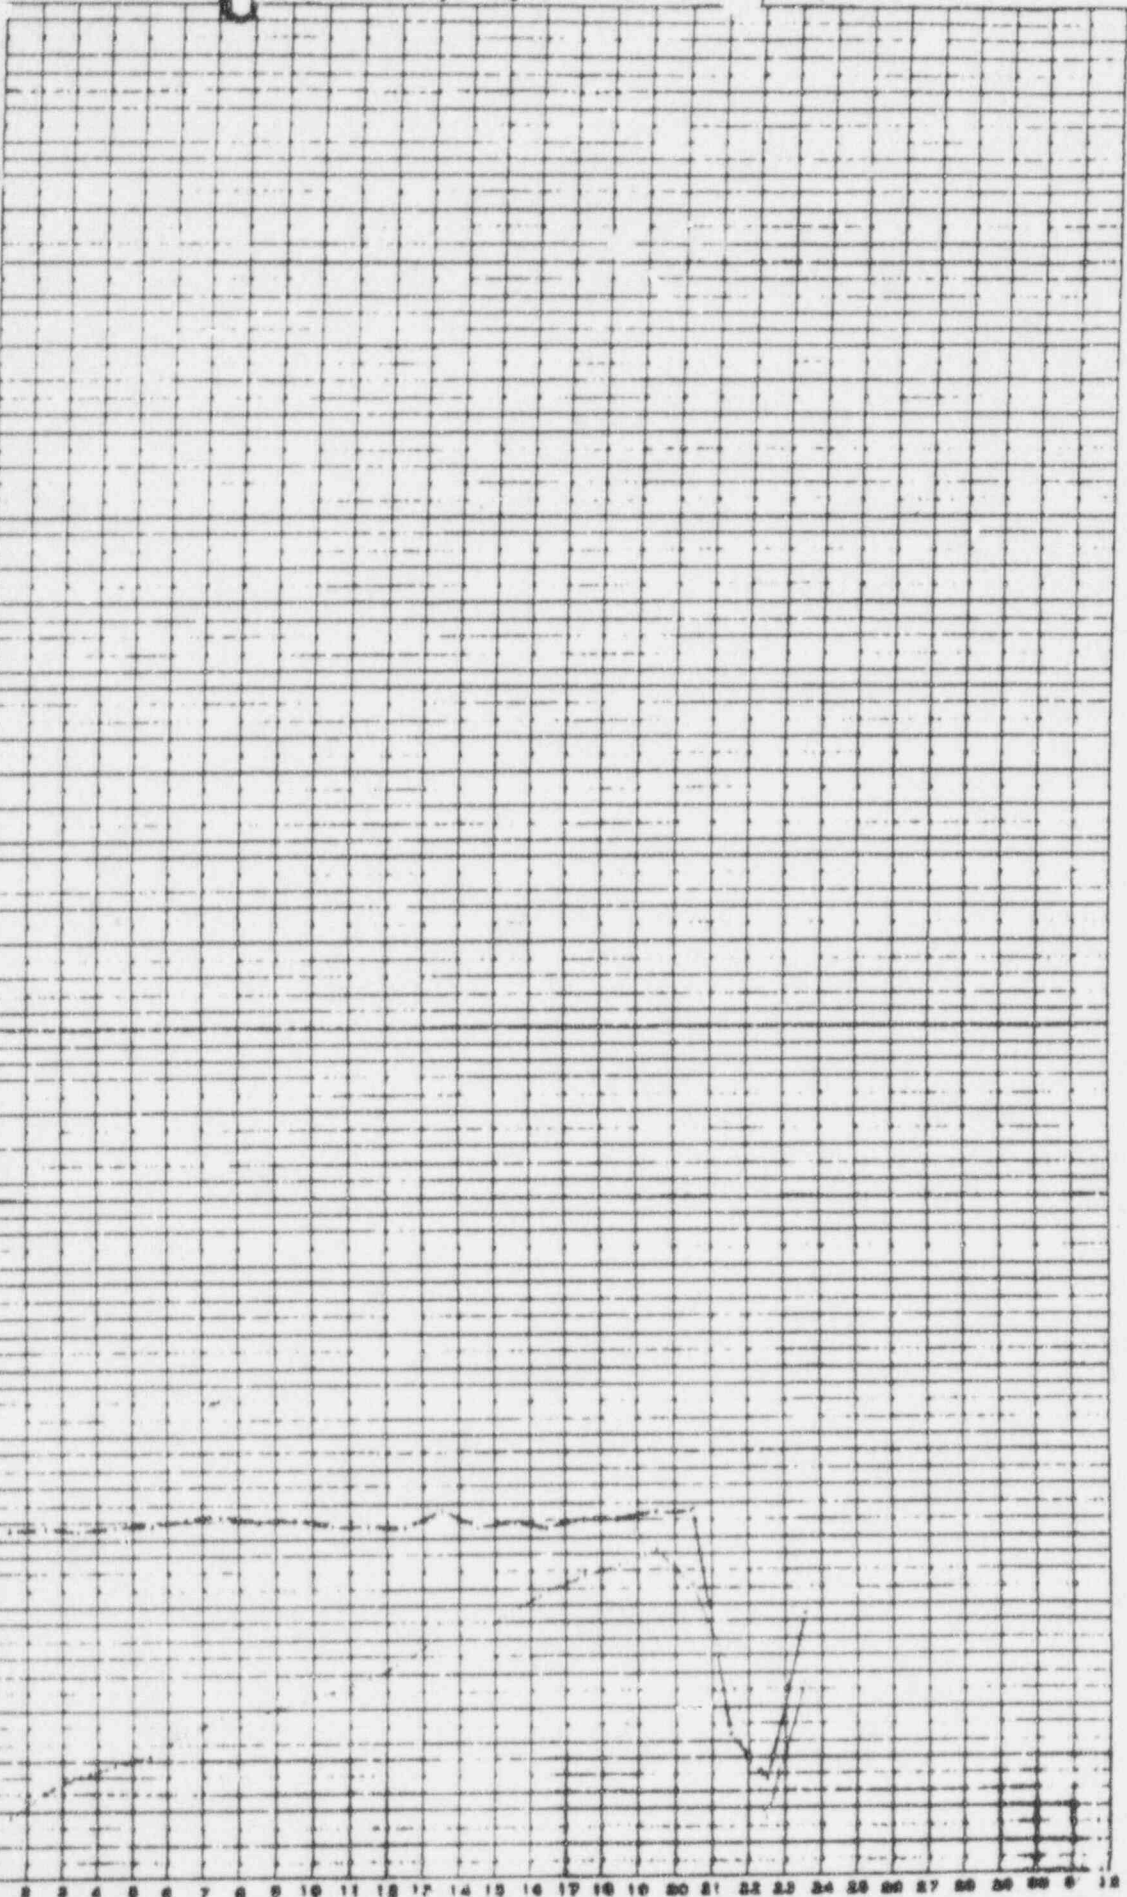
As indicated in Figure I, attached, an increasing rate of leakage into the Drywell Sump began to occur on July 1, 1973 and continued through July 19, 1973, reaching a peak of approximately 3.92 gpm when averaged over 24 hours. As shown in Figure 2, attached, a plot of Absorption Pool (Torus) water level developed on July 23, 1973 over the same period indicated the level to be increasing starting about July 11, 1973. It is now estimated that the unexplained leak rate increased to >5.0 gpm at some time during July 17, 1973 and continued to be above the 5.0 gpm limit until the plant was shutdown and depressurized on July 21, 1973.

CAUSE: The cause was found to be a feed water leak around one of the feed-water check valve hinge pin seal plugs, which due to its position and the manner in which the water was spraying, resulted in leakage to both the Drywell floor and the Torus. Valve data is as follows:

The erosion of the seating surface on the valve body was machined out, minimum wall thickness checked to be satisfactory, and the plug adapted to fit. A successful leak test was conducted at operating pressure on \_\_\_\_\_ and the plant returned to service.

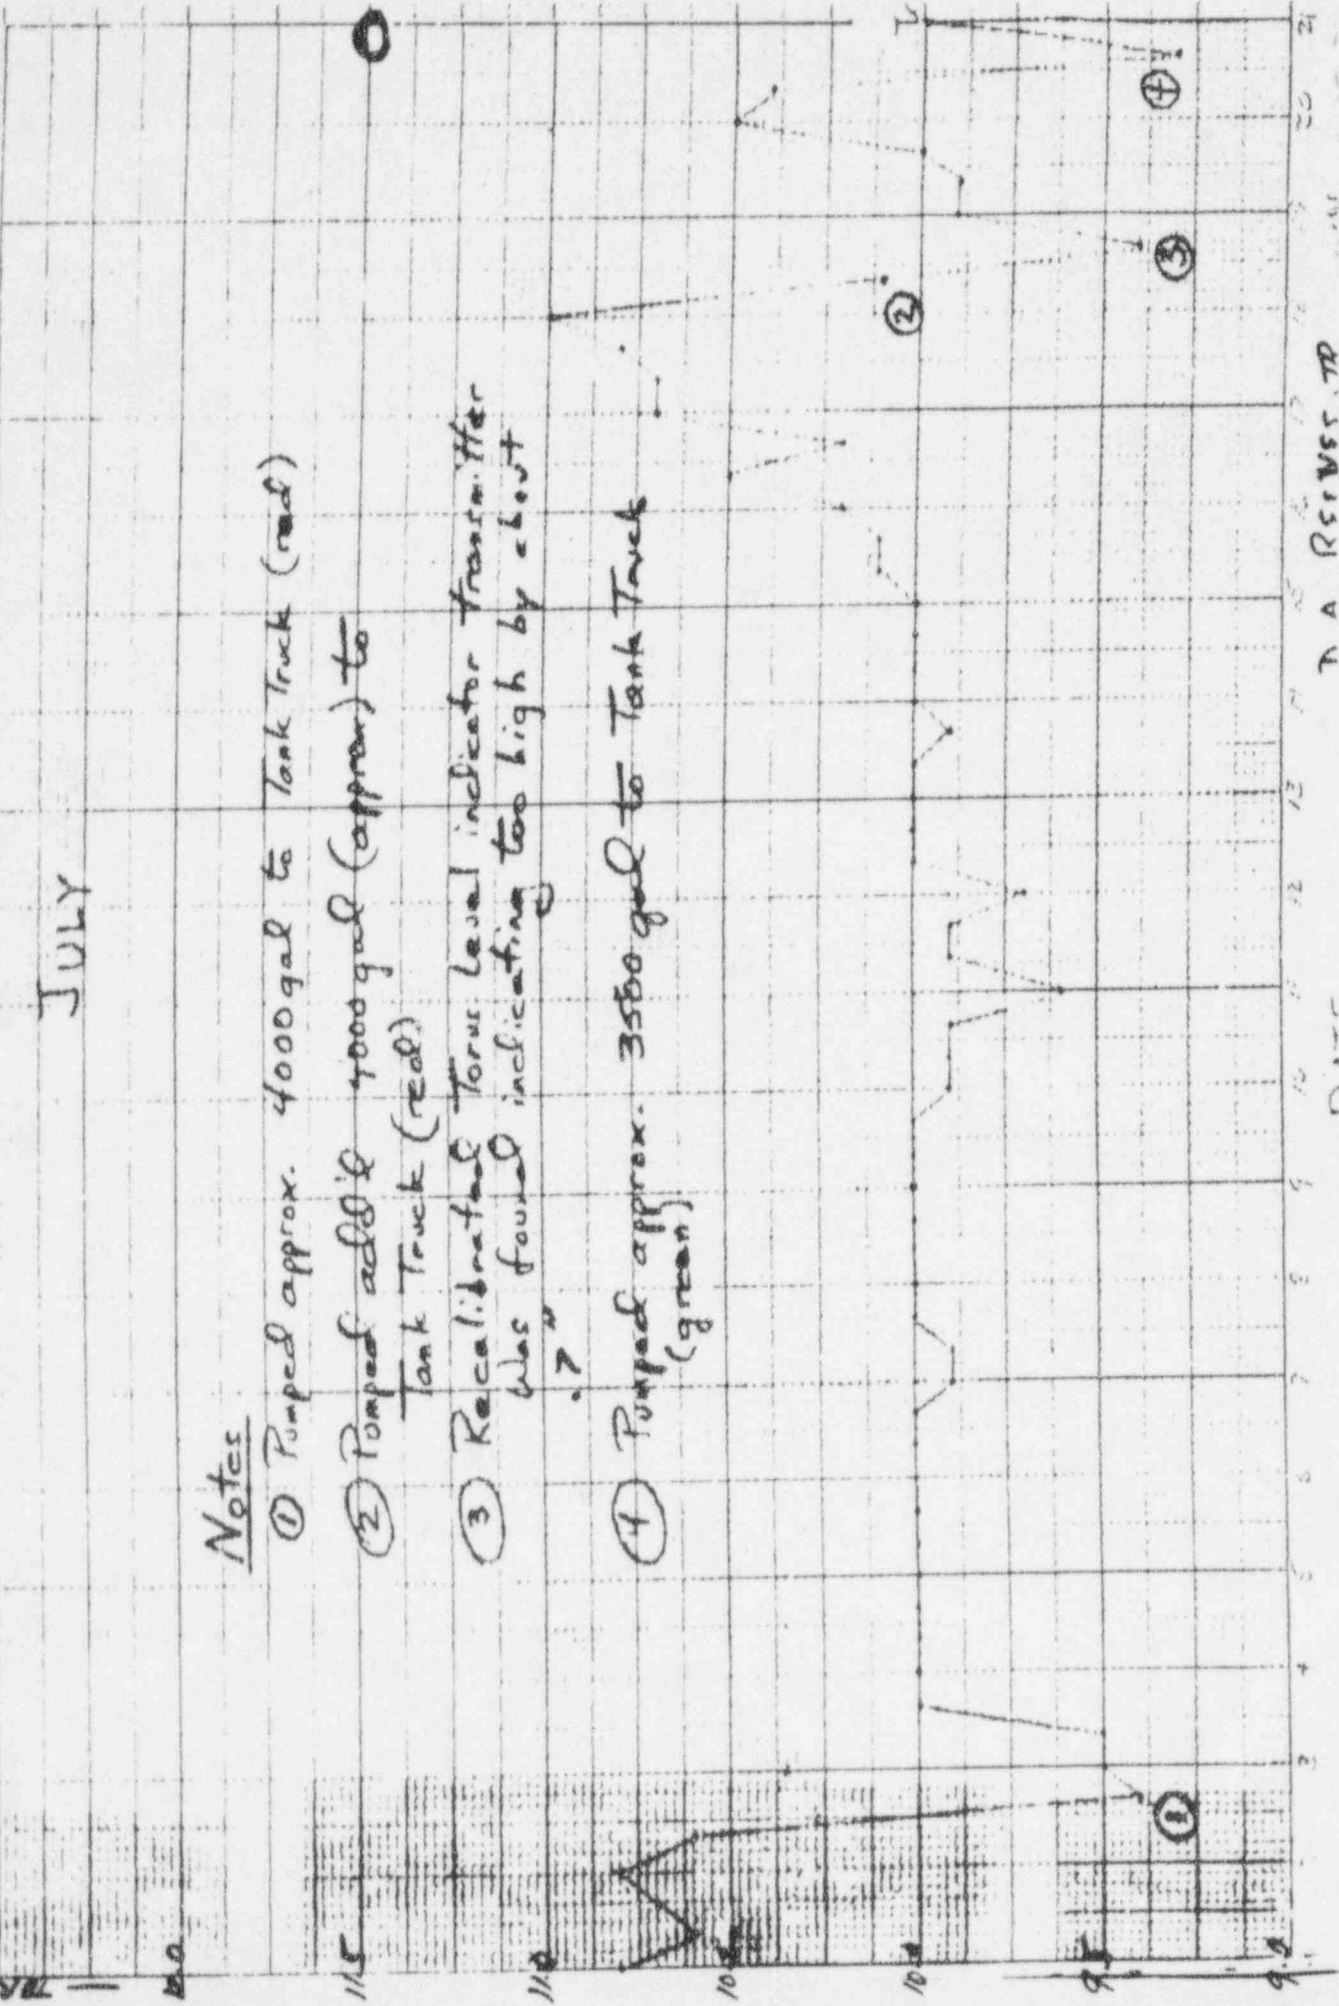
# DATE VS TORUS LEVEL JULY

- ① Pumped approx. 4000 gal to tank truck (read)
- ② Pumped add'l 4000 gal (approx) to Tank Truck (red)
- ③ Recalibrated Torus level indicator transmitter was found indicating too high by about .7"
- ④ Pumped approx. 3500 gal to Tank Truck (green)
