U. S. ATOMIC ENERGY COMMISSION
DIRECTORATE OF REGULATORY OPERATIONS

RO Inspection Report No.: 50-219/73-04 Docket No.: 50-219
Licensee: Jersey Central Power & Light Co. License No.: DPR-16
Oyster Creek Priority: _____
_____ Category: C
Location: Forked River, New Jersey

Type of Inspection: Special

Dates of Inspection: March 13, 1973

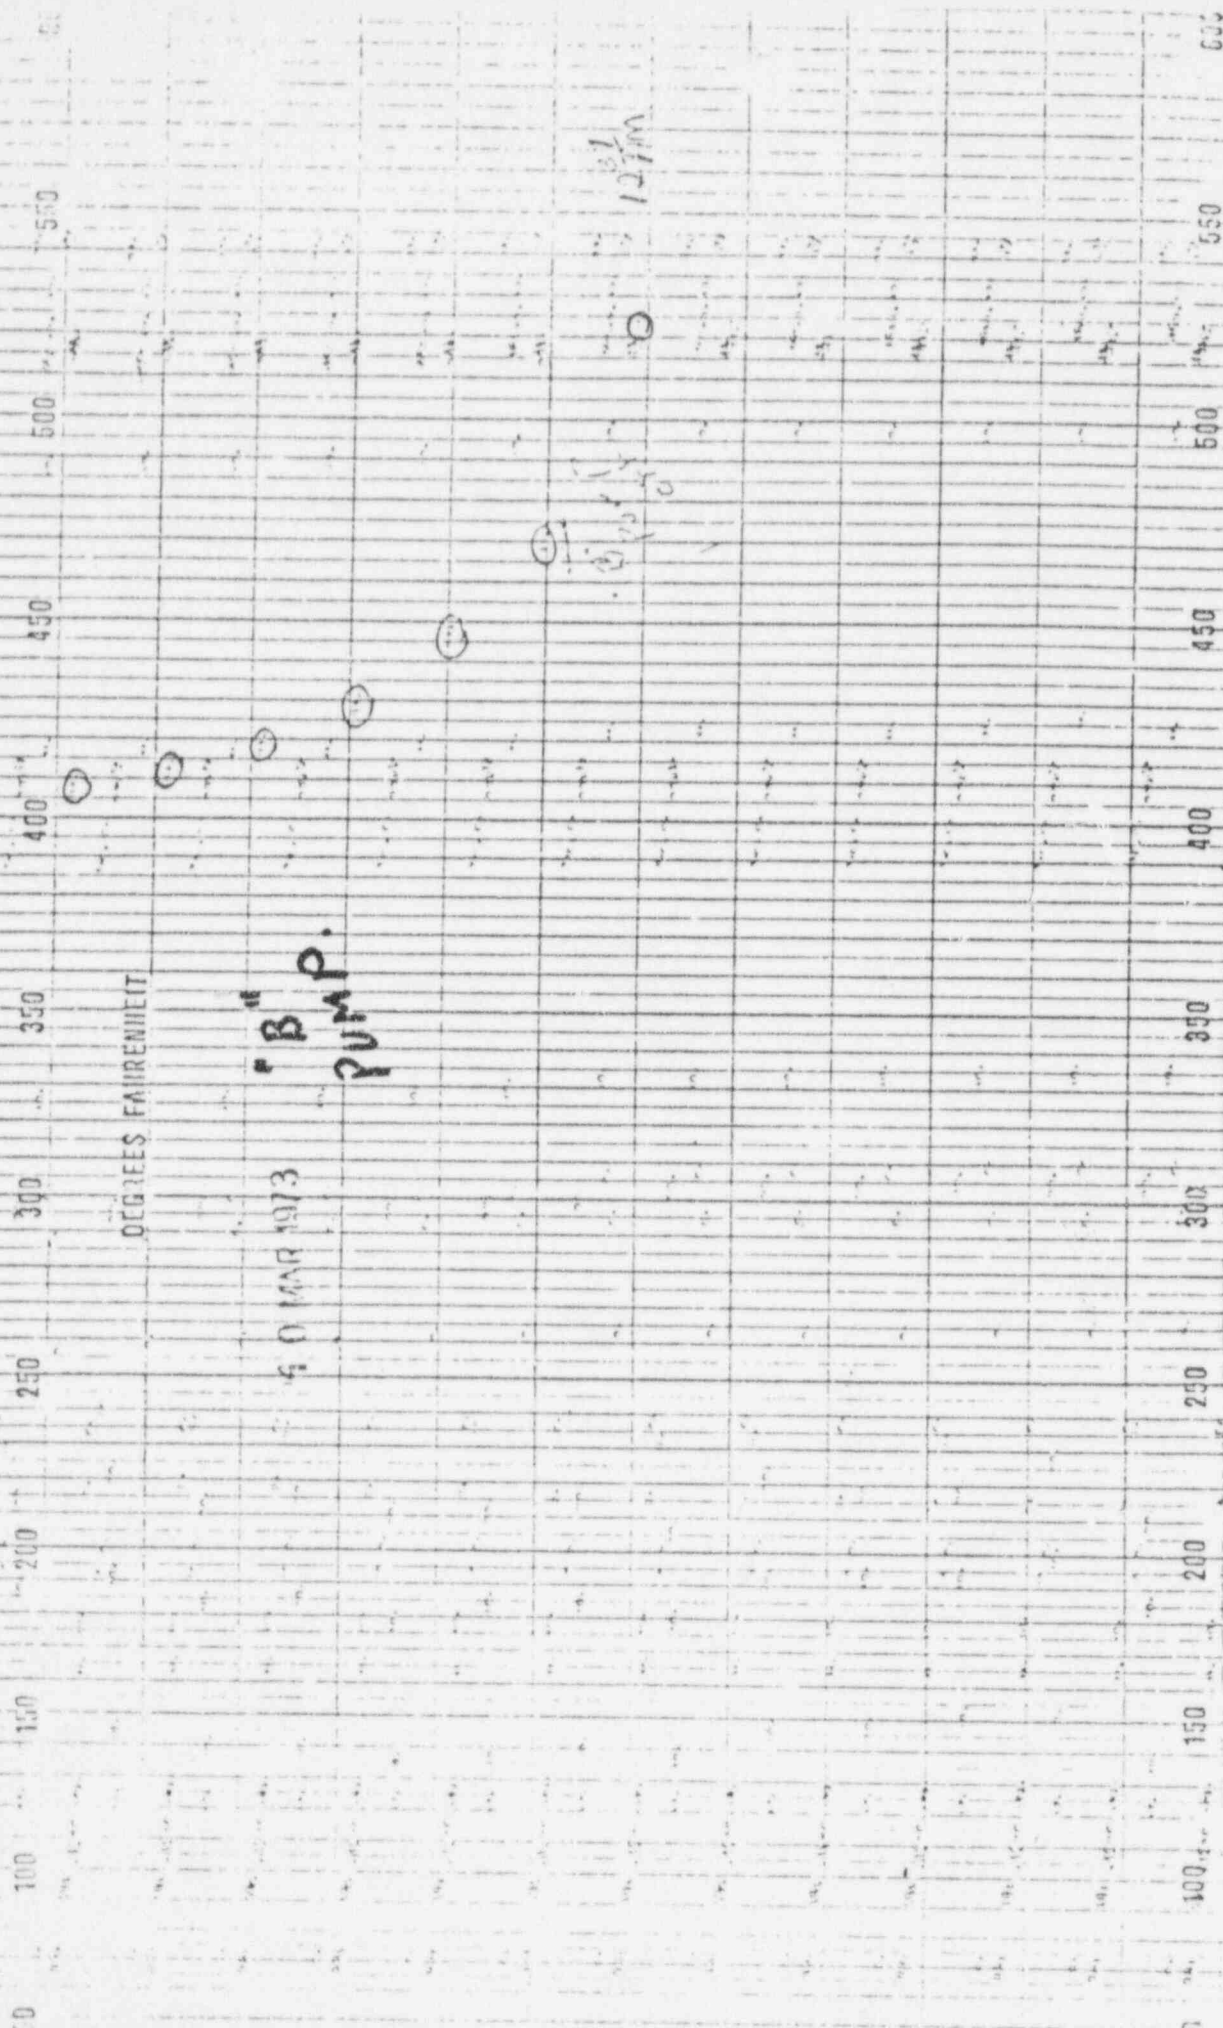
Recirculation Loop Temp.
B Loop

The B recirculation loop was returned to service on March 10, 1973 with a differential temperature of 117°F between the temperature of the reactor coolant and the temperature of the coolant in the idle loop. The APRM recorders in the same reactor quadrant as the B recirculation loop showed that the flux increased approximately 17% when the pump was restarted.

The B recirculation loop was returned to service on March 10, 1973 by opening the discharge valve, restarting the B recirculation pump and closing the bypass valve. At the time of this action, there existed a differential temperature of 117°F between the temperature of the reactor water and the loop water. Technical Specifications paragraph 3.3 prohibits restarting an idle loop unless the temperature of the coolant within the idle recirculation loop is within 50°F of the reactor coolant temperature.

The B recirculation loop had been removed from service to replace brushes on the MG set that supplies power to the recirculation pump motor at 12:30 AM on March 10, 1973 by closing the pump discharge valve, opening the bypass around the discharge valve, and de-energizing the MG sets. Opening the bypass valve permits backflow through the recirculation loop and normally maintains the coolant temperature in the loop within approximately 10°F of the reactor coolant temperature, however, operating personnel did not consider the effect of continued operation of the cleanup system on idle loop temperature. The clean up system is fed from the B loop, upstream of the suction valve, and discharges to the B loop, downstream of the discharge valve. With the loop discharge valve closed and the bypass valve open, the colder water from the clean up system backflowed through the bypass valve gradually lowering the temperature of the water in the recirculation pump and the temperature of the feedwater to the clean up system. The recorder for the recirculation loop temperature showed that the B loop temperature dropped approximately 117°F while the loop was isolated and increased the same amount when the pump was restarted approximately 2 hours later (Attachment 1). The recorders for the average power range monitors (APRM) in the same quadrant as the B recirculation loop showed that the flux increased approximately 17% when the pump was restarted (Attachments 2 and 3). This flux increase is attributed to the associated increase in recirculation flow when the recirculation pump was restarted, and to a negative moderator temperature coefficient. Rod block alarms were received when the pump was restarted, but the flux increase was less than that required to initiate a high flux scram. The narrow range reactor pressure recorder showed a pressure surge of 4-5 psig at the time the B recirculation pump was restarted.

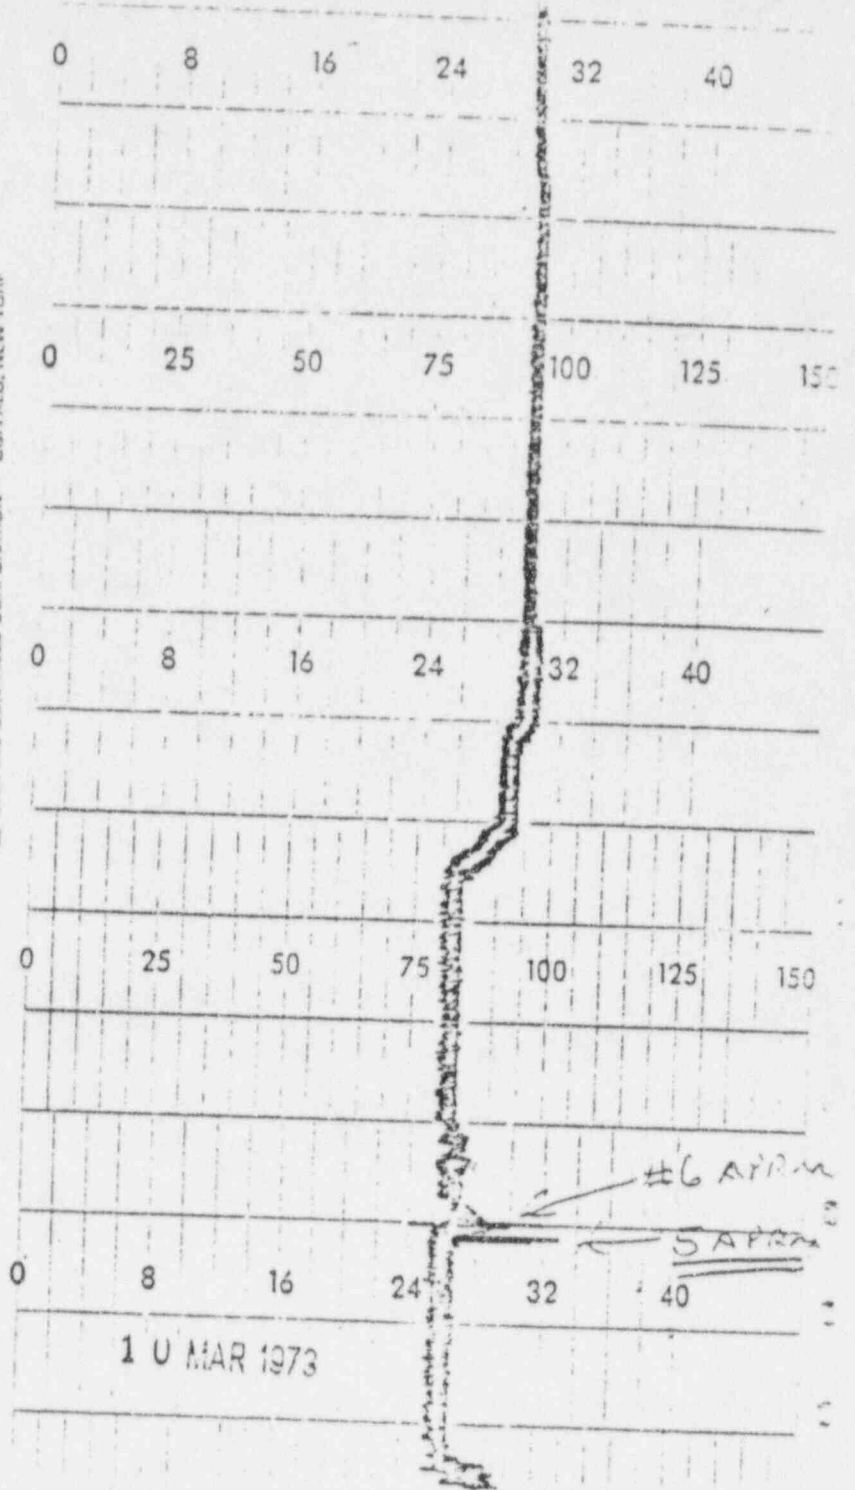
Recirculation Loop Temp.
D Loop
Attachment No. 4

Subsequent to the above, the D loop was isolated and returned to service without the above effects. (Attachment 4)
