U. S. ATOMIC ENERGY COMMISSION  
DIRECTORATE OF REGULATORY OPERATIONS  
REGION I

RO Inspection Report No.: 50-219/72-05

Licensee: Jersey Central Power and Light Company

Oyster Creek

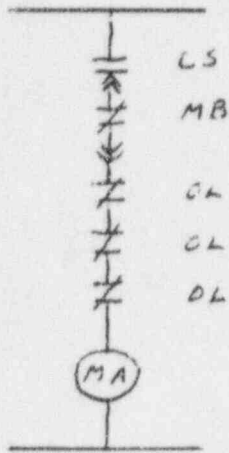
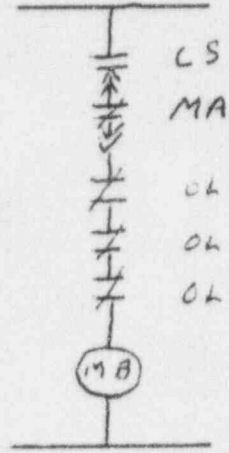
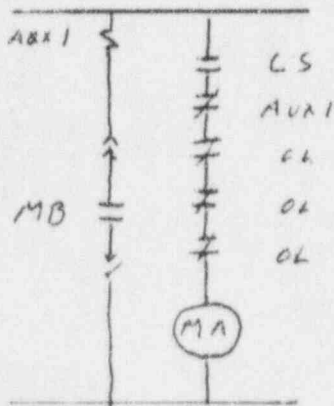
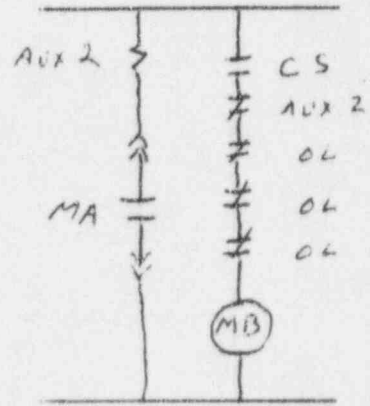
# LIQUID POISON PUMP INTERLOCK

On September 25, 1972, the A standby liquid poison pump was removed from service for replacement of the pump packing. The A pump breaker was racked out in accordance with plant safety procedures. Work was not completed by the end of the day shift and the A pump was left racked out. In order to comply with Technical Specification requirements for daily surveillance testing of the operable pump, a surveillance test was started on the B pump on September 26, at 4:20 a.m.; however, the pump would not start. As soon as it was determined that

A logic circuitry change was completed to the liquid poison system and the Standby Gas Treatment System. (Report Details, Paragraphs 11 and 17D)
