PRAIRIE ISLAND NUCLEAR GENERATING PLANT

INSERVICE INSPECTION - EXAMINATION SUMMARY
PRAIRIE ISLAND NUCLEAR GENERATING PLANT - UNIT I
OCTOBER 23 to NOVEMBER 4, 1984
STEAM GENERATOR TUBE - EDDY CURRENT EXAMINATION
INSPECTION PERIOD 3

NORTHERN STATES POWER COMPANY
MINNEAPOLIS, MINNESOTA

REPORT DATE: January 8, 1985

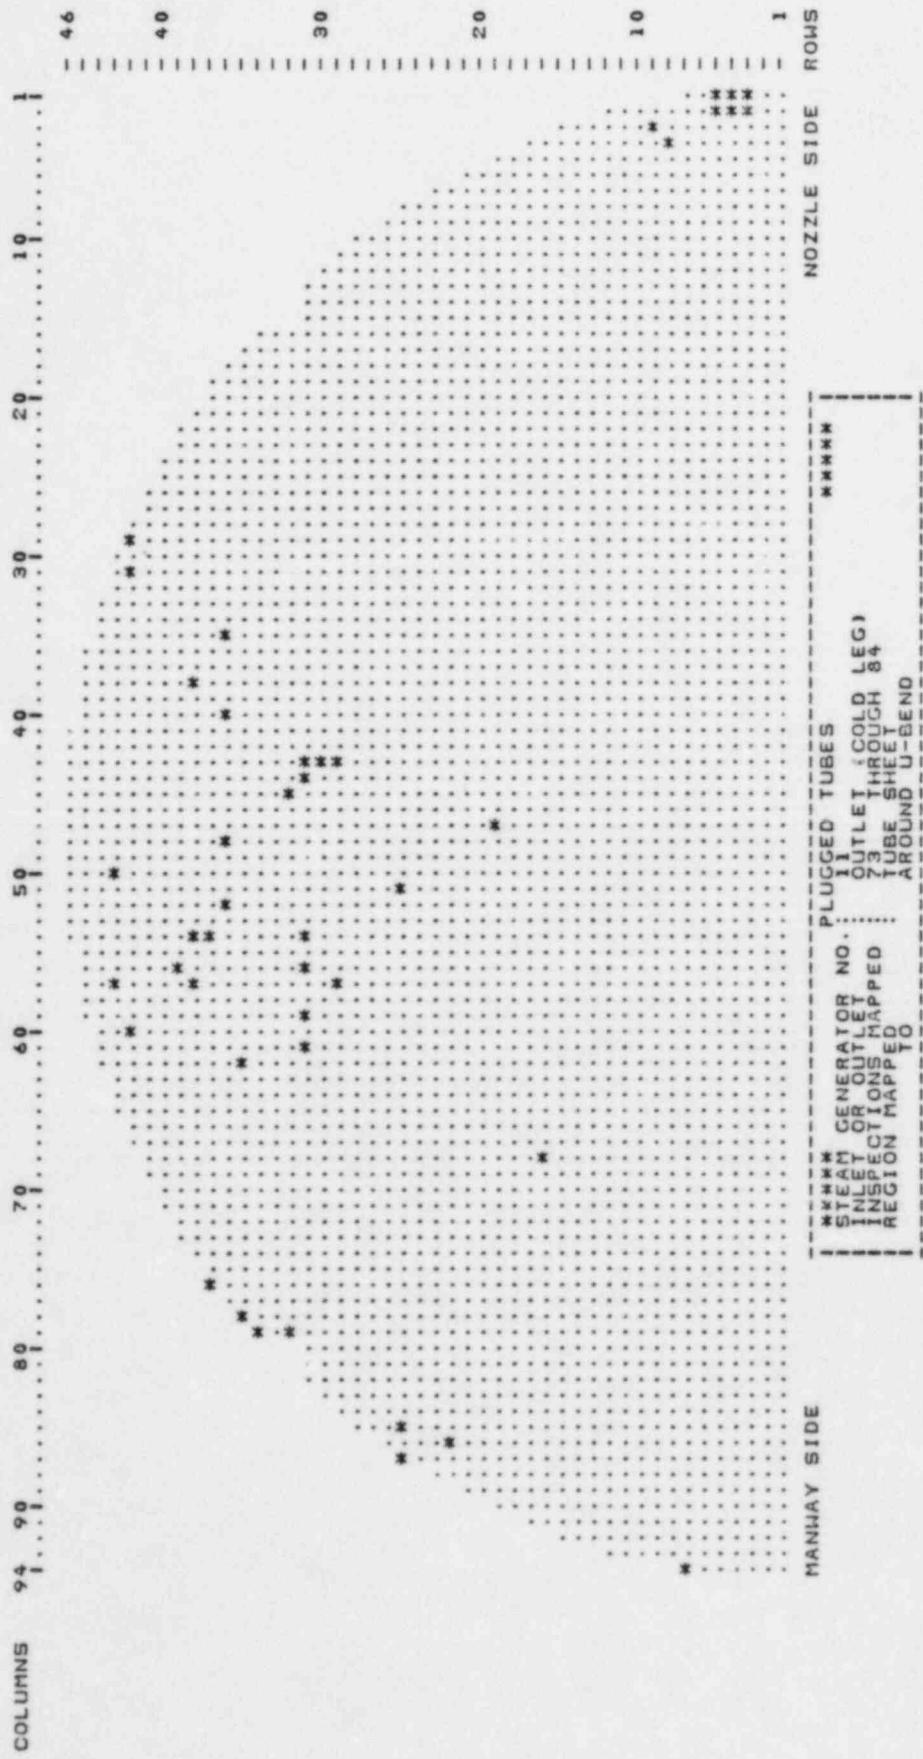
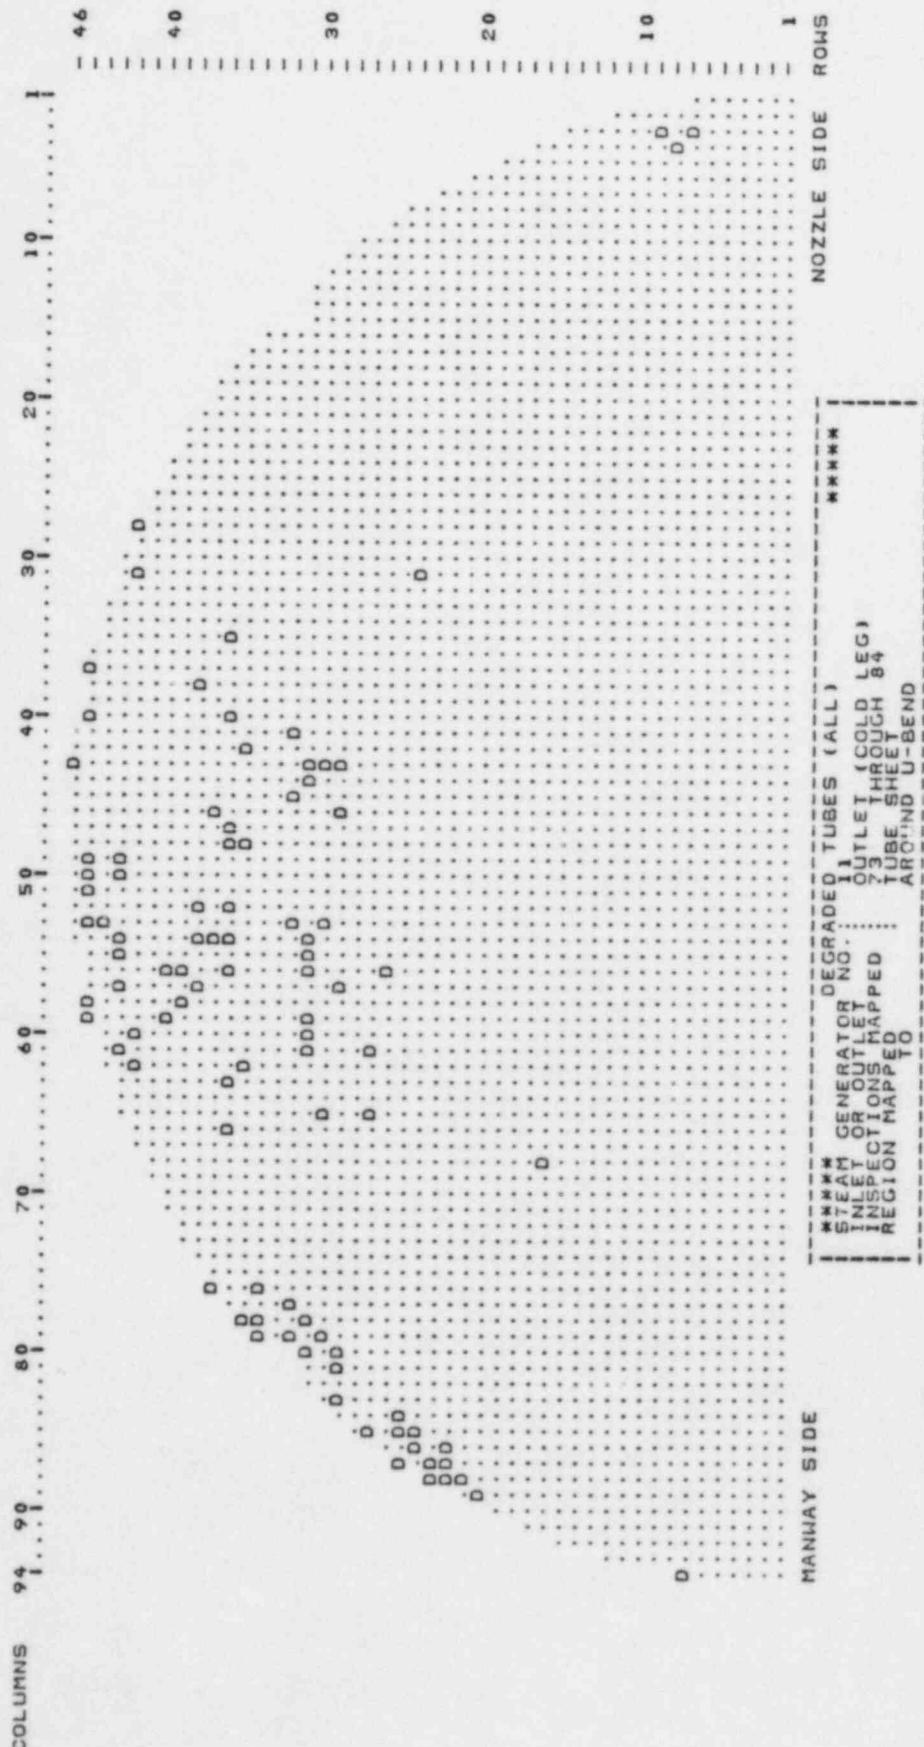
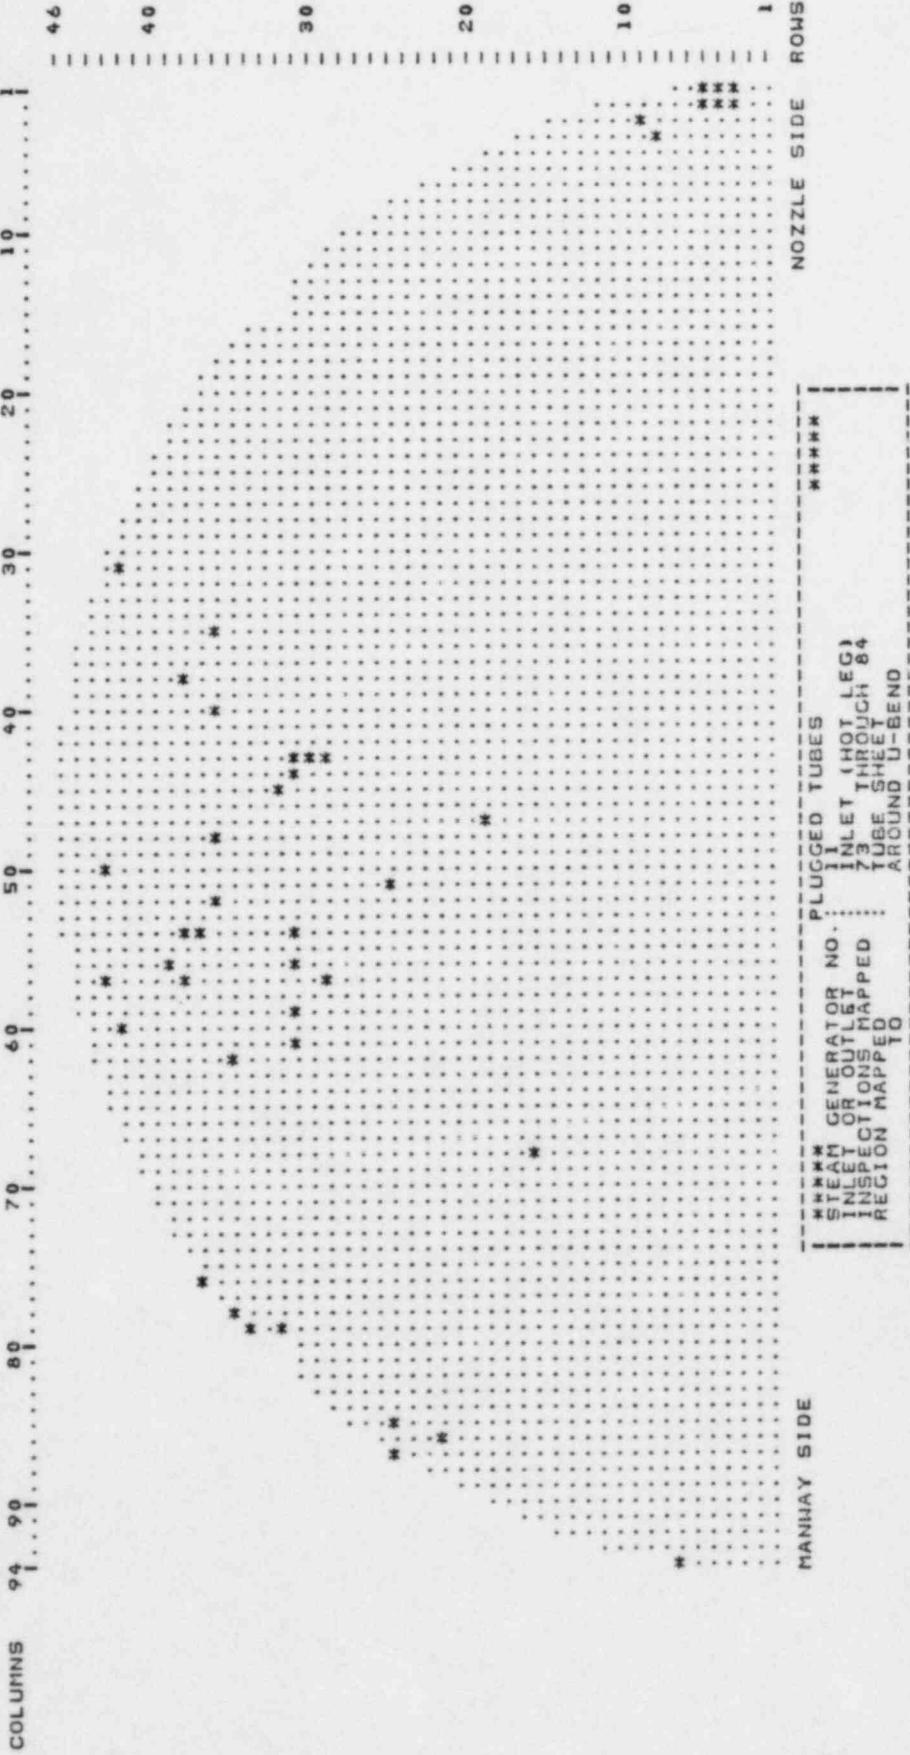
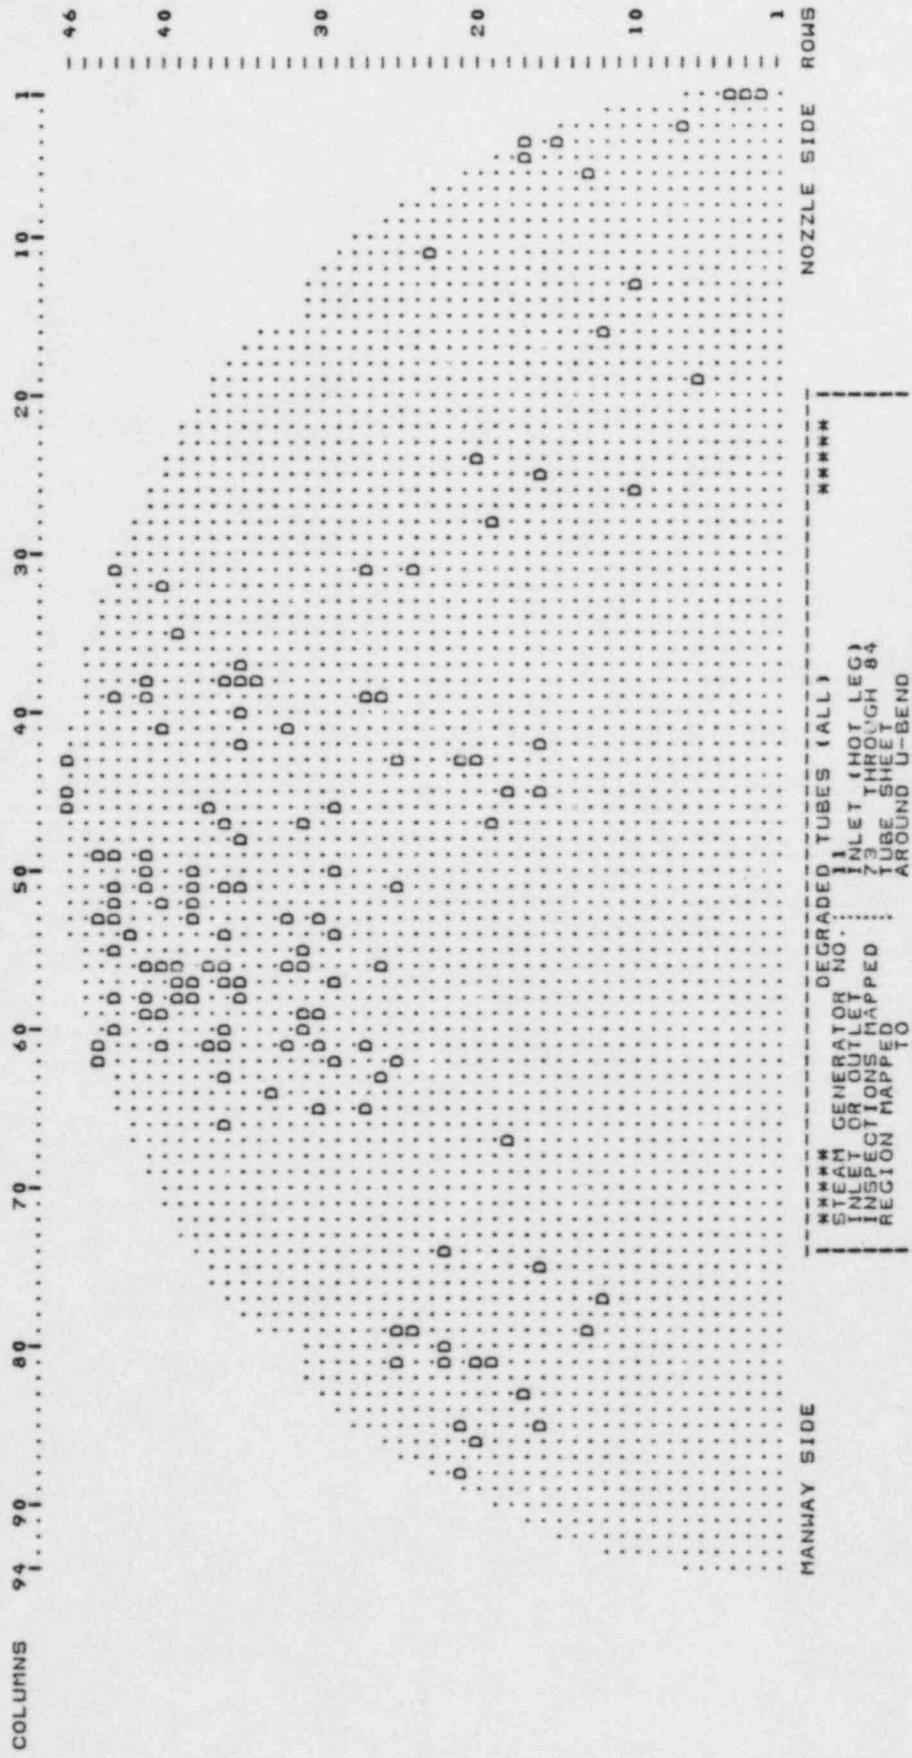
**STEAM GENERATOR NO. 11
EDDY CURRENT EXAMINATION RESULTS AND TUBE
SHEET MAPS**

<u>S/G-#11</u>	<u>Location of Defect</u>
R25 C87	#7 Tube Support Plate - Cold Leg
R7 C94	Tubesheet - Cold Leg (Previous Commitment)*
<u>S/G-#12</u>	<u>Location of Defect</u>
R17 C42	Tubesheet - Hot Leg
R13 C15	Tubesheet - Hot Leg (Previous Commitment)*
R6 C93	Tubesheet - Cold Leg (Previous Commitment)*

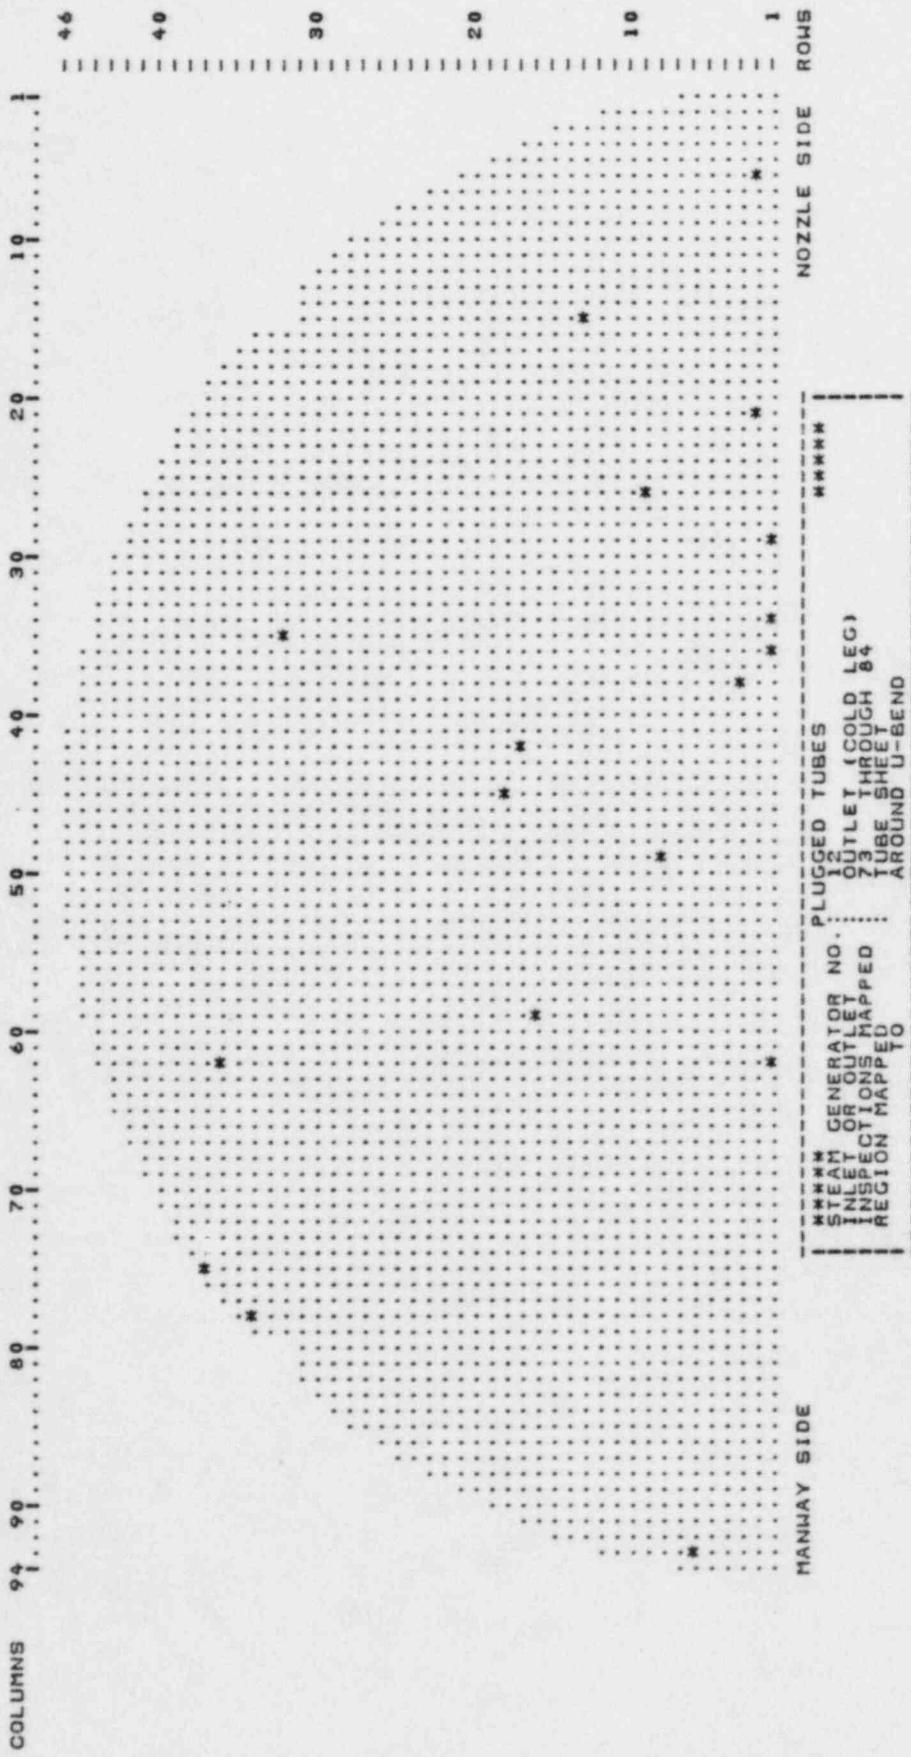
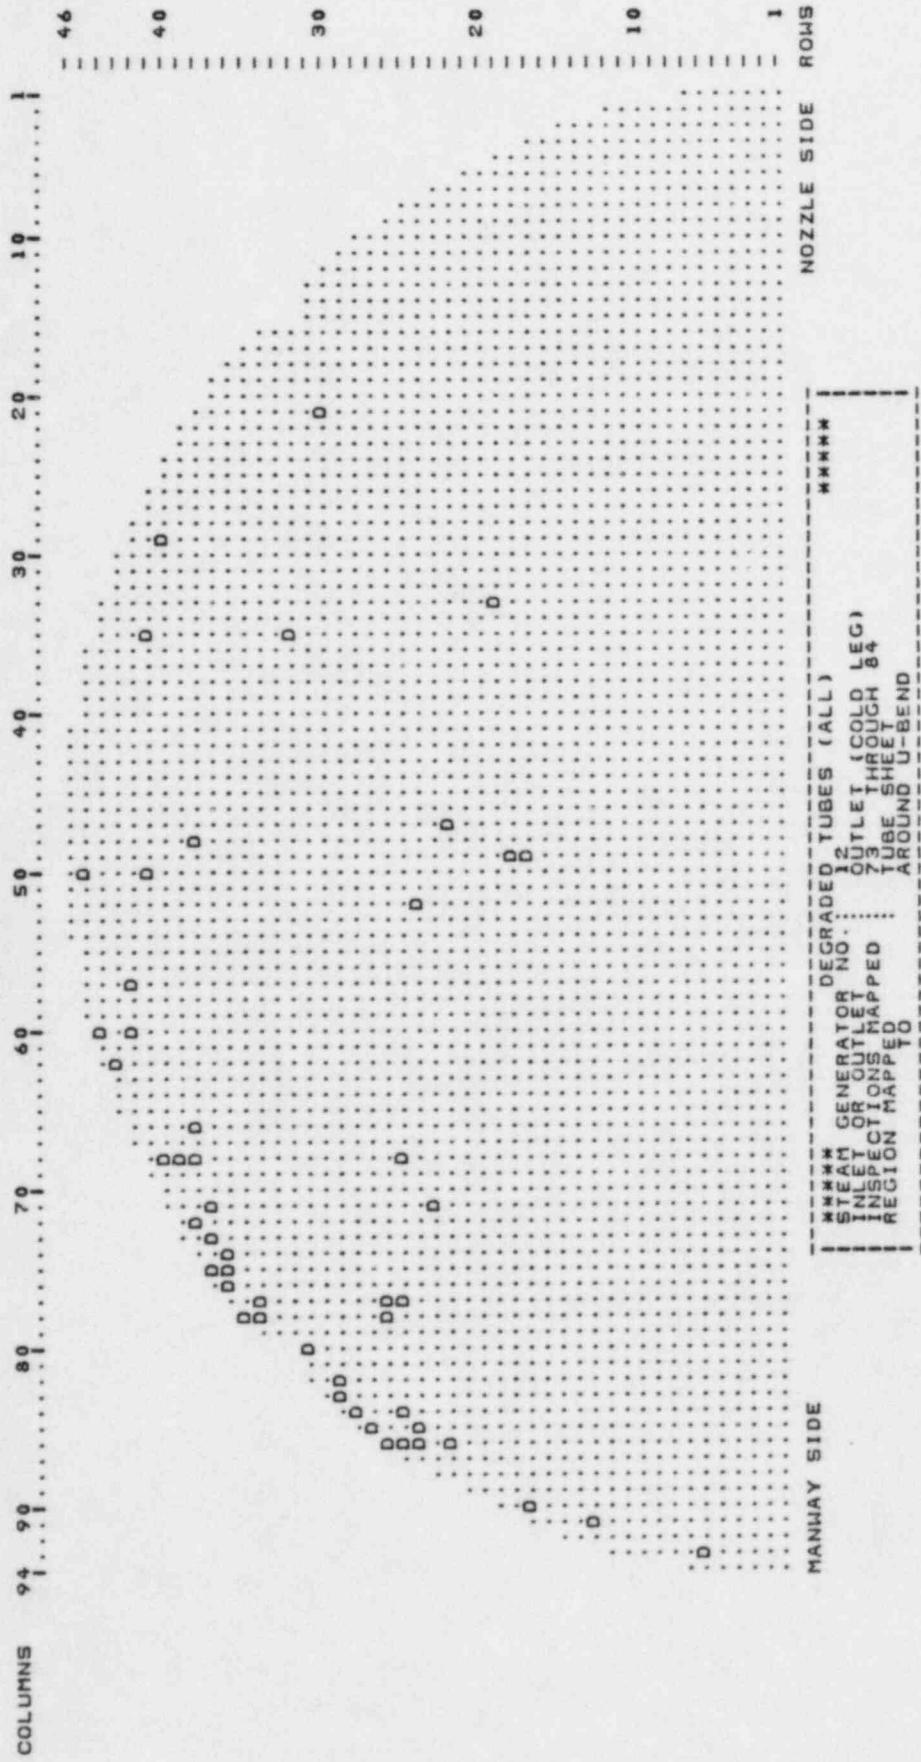
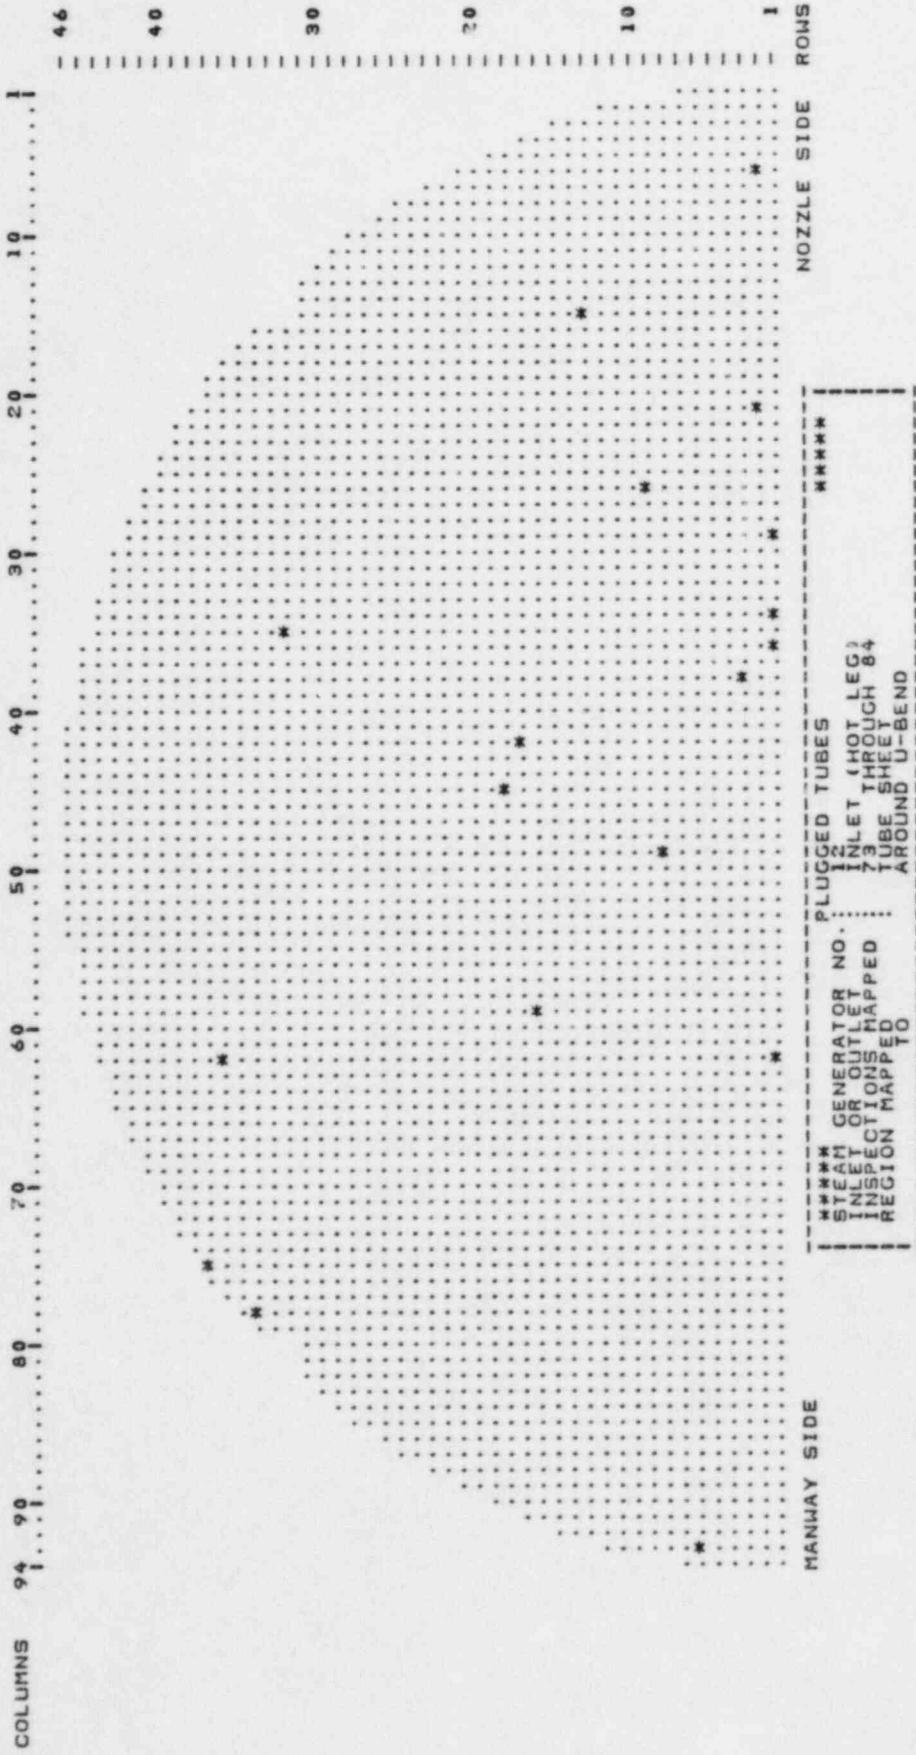
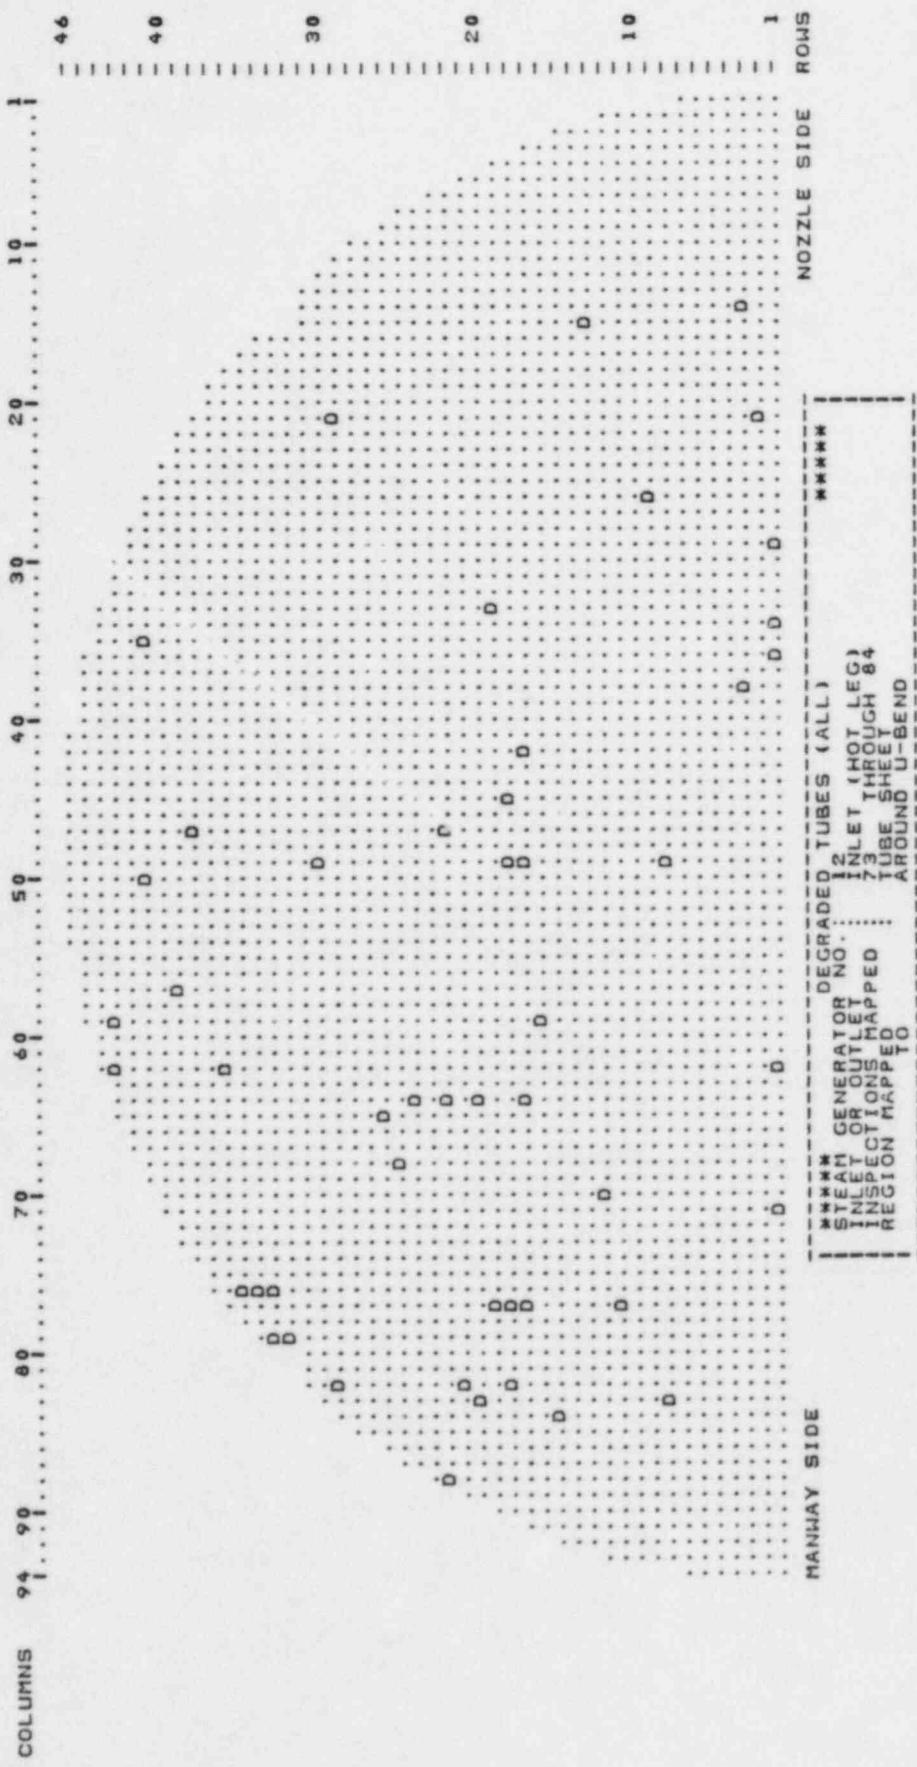
**STEAM GENERATOR NO. 12
EDDY CURRENT EXAMINATION RESULTS AND TUBE
SHEET MAPS**

<u>Tube Number</u>	<u>Defect Location/Severity</u>	<u>Comments</u>
R18 C45	Tubesheet - Hot Leg/100%	Observed Leak Visually
R9 C26	Tubesheet - Hot Leg/92%	
R37 C75	First Tube Support Plate - Cold Leg/46%	Preventative
R34 C78	First Tube Support Plate - Cold Leg/42%	Preventative
