UNITED STATES
ATOMIC ENERGY COMMISSION
WASHINGTON, D.C. 20545

Docket No. 50-219

MAIN STEAM ISOLATION VALVE FAILURE-TO-CLOSE EXPERIENCE

CORRECTIVE ACTIONS TO ASSURE
MAIN STEAM LINE ISOLATION VALVE
OPERABILITY

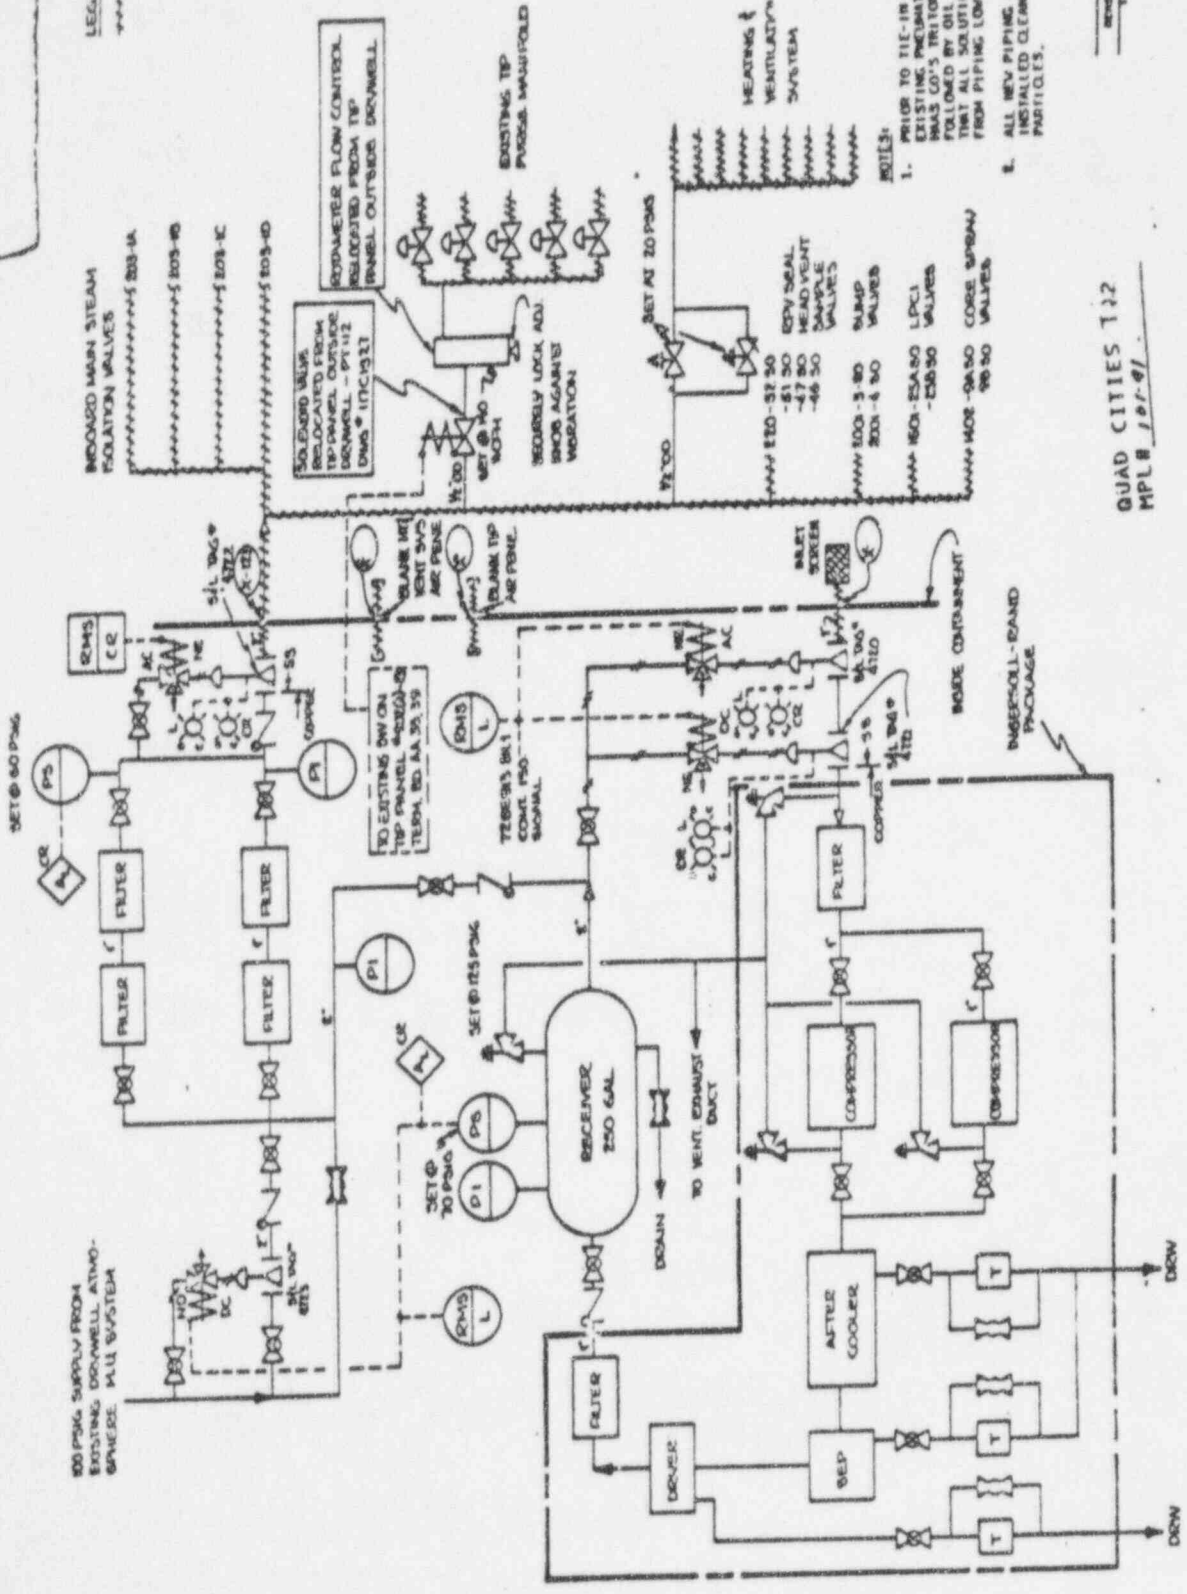
- a. The valves inside the drywell will take their supply from a pumpback system. This system consists of two air compressors, filters, separator and dryer, a 250 gallon receiver, and associated piping, valves, controls and instrumentation. The drywell pneumatic supply system takes suction from the drywell atmosphere, compresses and cleans the gas and stores it in the 250 gallon receiver at a nominal 100 psig. The receiver discharges to the equipment in the drywell which require motive gas. This system provides a source of clean gas for use in all pneumatic equipment thus limiting the effects of dirt and oil on the operation of MSLIV's. This system is being installed during the current outage. The system will be connected to the presently installed pneumatic system to supply all the equipment within the drywell requiring motive gas. The back up supply is nitrogen from the Drywell Atmosphere Make-Up System. A copy of the P&ID for the Drywell Pneumatic Supply System is attached.

NOTES:
 1. PRIOR TO TIE-IN OF NEW PIPING CLEAN ALL EXISTING PNEUMATIC PIPING WITH DRY AIR & BLOWERS FOLLOWED BY OIL FREE DRY AIR BLOW. INSURE THAT ALL SOLUTION IS REMOVED--ESPECIALLY FROM PIPING LOW POINTS.
 2. ALL NEW PIPING & COMPONENTS TO BE INSTALLED CLEAN--NO VISIBLE DIRT OR FOREIGN PARTICLES.
