LICENSEE EVENT REPORT (LER)

FACILITY NAME (1) H. B. Robinson Plant, Unit No. 2	DOCKET NUMBER (2) 0 5 0 0 0 2 6 1	PAGE (3) 1 OF 0 4
---	--	------------------------

TITLE (4)
Main Steam Isolation Valves

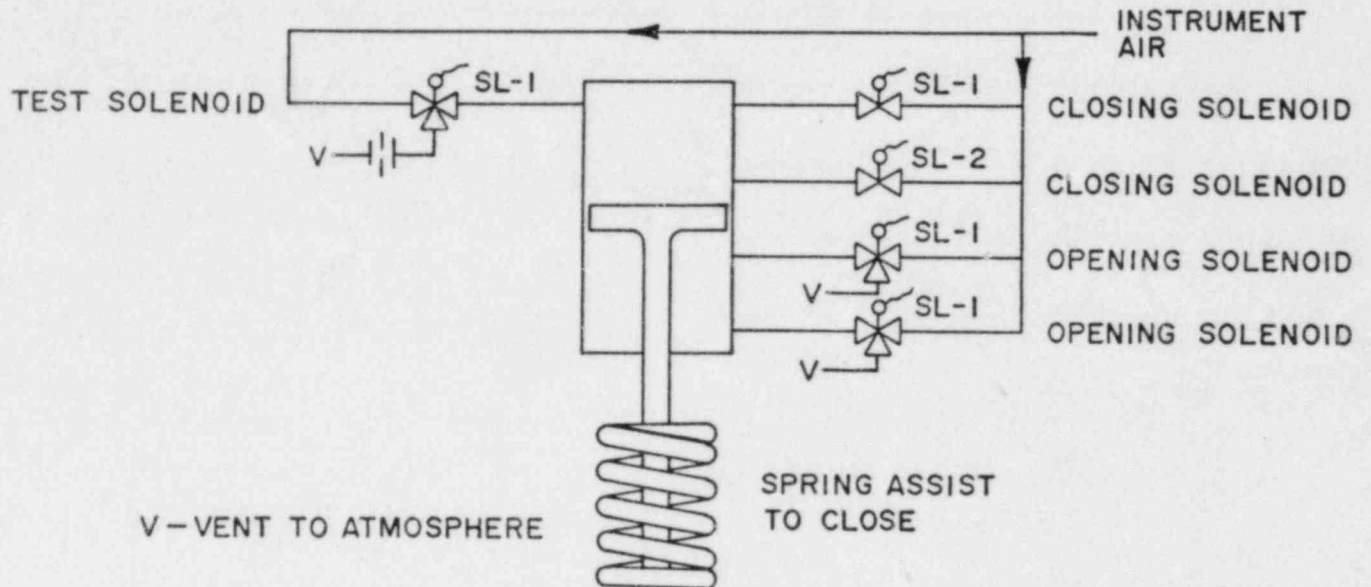
"A" MSIV
BEFORE MODIFICATION

Our review of the MSIV control circuitry revealed that true redundancy was not provided by the method in which the ESF signal was applied to the MSIV operating solenoids. Because of this, it could be postulated that "B" and "C" MSIVs might not close on a failure of a single active component in "B" train of safeguards and that "A" MSIV might not close on a failure of a single active component in "A" train of safeguards. As an example, a failure in "A" train of safeguards is assumed, and the resulting operation of "A" MSIV is discussed. (Reference the enclosed sketch). In this case, the failure prevents the operation of the SL-1 contacts, and thus, the following response is obtained:

1. The three-way "opening" solenoids remain in the position which pressurizes the bottom of the operating piston.
2. One of the two "closing" solenoids opens to pressurize the top of the operating piston.
3. The test solenoid remains in position to continue venting the top of the operating piston through an orifice.

In this scenario, the forces applied by the air pressure above and below the operations cylinder are judged to be approximately equal. Therefore, the direction in which the valve moves will be determined by the spring force (CLOSE). The spring will not, however, expand to the full length required to close the valve, and once the spring is fully extended, the valve will tend to drift. Although it is expected

that the valve disk will enter the steam flow and then fully shut, this is not considered a responsible design. The operation of "B" and "C" MSIV is similar with the SL-1 and SL-2 logic function reversed.
