U.S. ATOMIC ENERGY COMMISSION  
DIRECTORATE OF REGULATORY OPERATIONS  
REGION I

RO Inspection Report No: 50-219/74-02 Docket No: 50-219  
Licensee: Jersey Central Power and Light Company License No: DPR-16  
Madison Avenue at Punch Bowl Road Priority: -  
Morristown, New Jersey Category: C  
Location: Oyster Creek, Forked River, New Jersey

Type of Inspection: Routine, Unannounced

Dates of Inspection: January 21-25, 1974

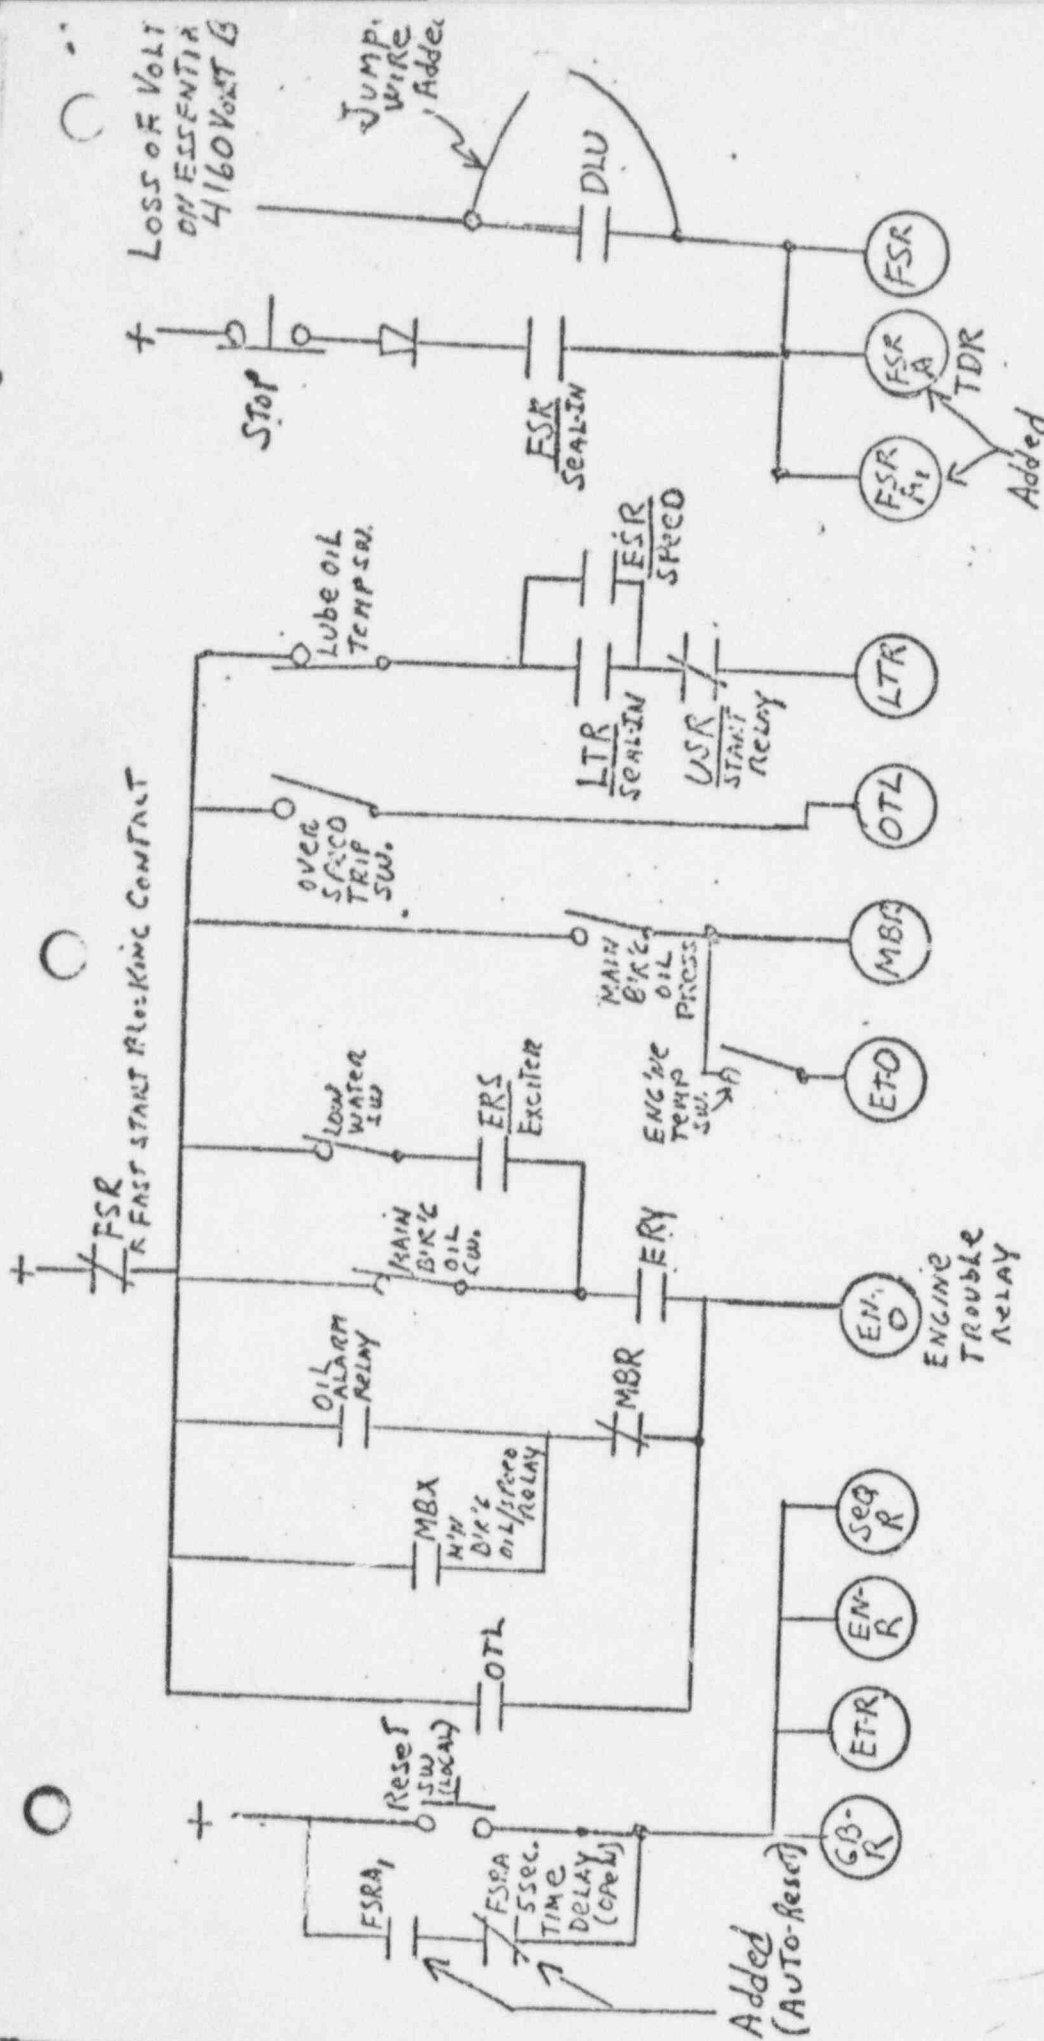
Records reviewed and discussions with licensee representatives indicated that the licensee has installed a single relay for each diesel generator to replace relays referenced in Details, Section II. Simplified schematics of this change are shown in Figures 1-2. Records indicated PORC and GORB review of the diesel generator modification. The FSR-A relays for both generators was installed and tested on January 3 and 7, 1974. According to licensee representatives the fast start testing resulted in a successful start of both units with an engine fault present. Testing was conducted in accordance with an approved procedure.

Loss of Volt  
ON ESSENTIAL  
4160 Volt G

Jump Wire Added
