Jersey Central Power & Light Company

Subject: Oyster Creek Station
Docket No. 50-219
Abnormal Occurrence Report No. 50-219/74/21

Abnormal Occurrence
Report No. 50-219/74/21

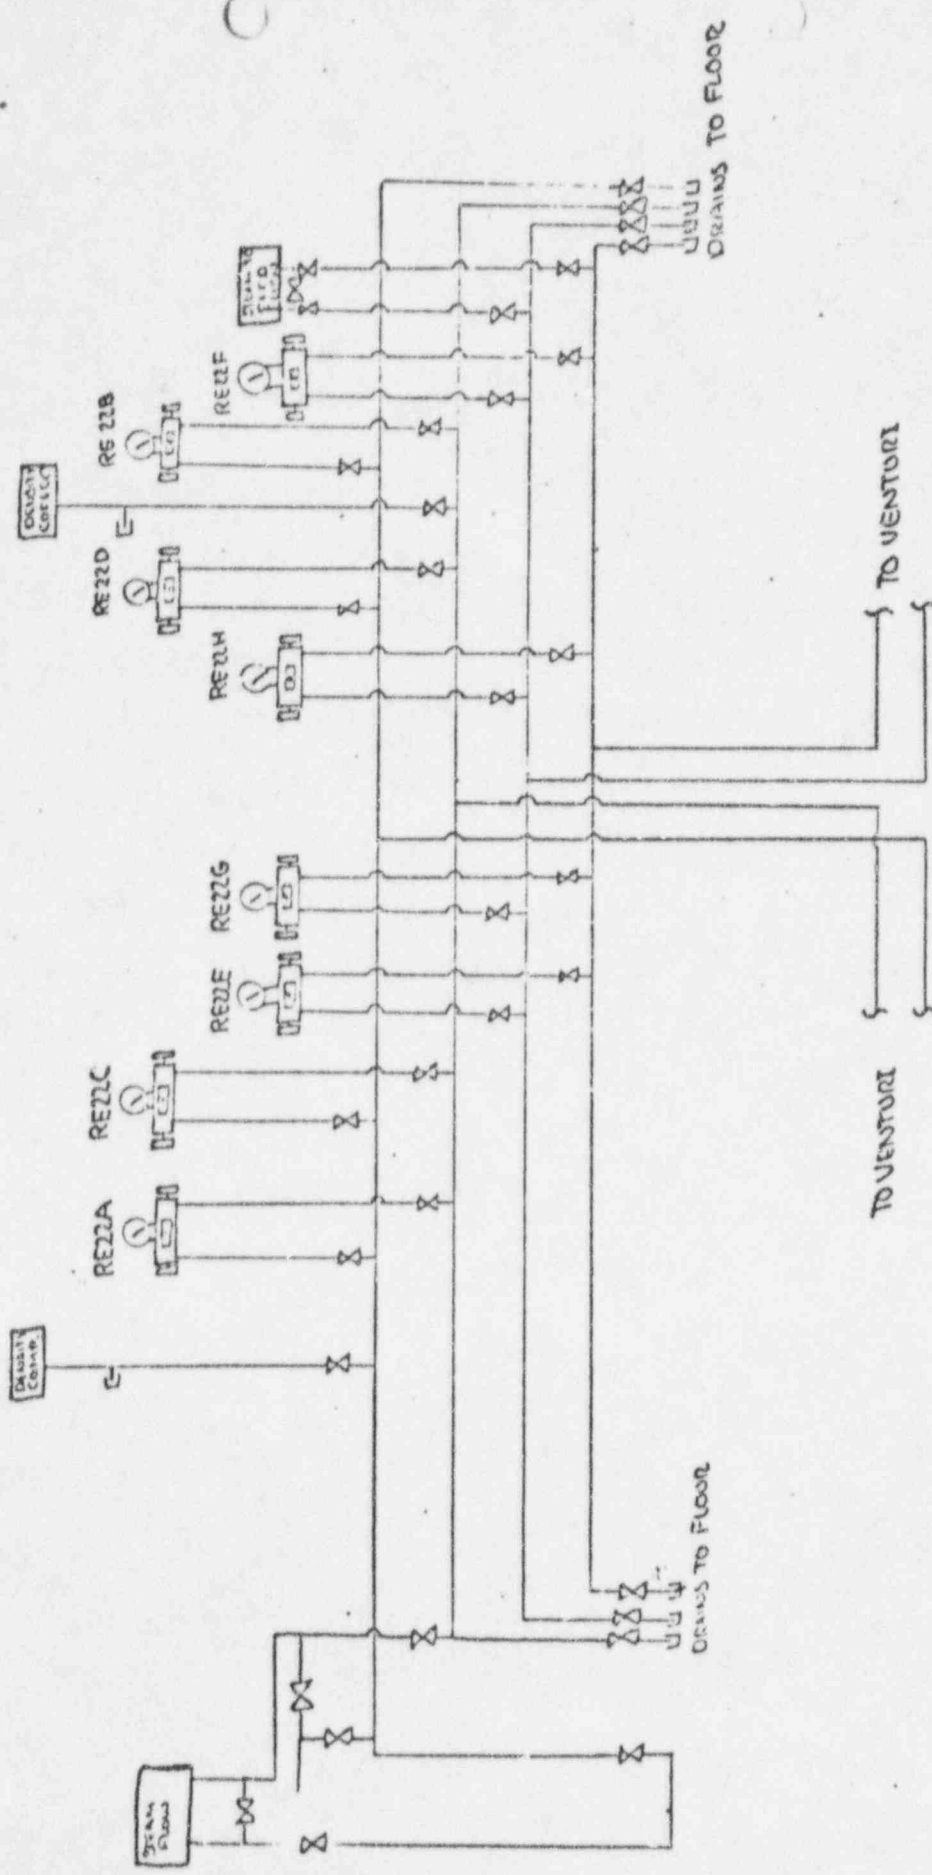
MAIN STEAM FLOW SENSING PIPING (AS INSTALLED)

At 0040 on March 13, 1974, while taking daily Technical Specification log readings, an operator noted and reported to the shift foreman that the differential pressure indicator for Sensor RE22D indicated 0 psid and that the instrument lines were hot. The operator found the RE22D bypass valve to be open, causing Sensor RE22D to be inoperable. Upon closing the bypass valve, the RE22D differential pressure indication returned to normal.

The apparent cause of this incident was incorrect valve positioning. Investigation has not established the exact time or the individual(s) involved in the opening of the RE22D bypass.

The original report of this incident (March 13, 1974) stated that the safety significance of this occurrence was minimal since seven of the eight RE22 sensors remained operable during the period when the RE22D bypass was open. At that time, it had not been noted that the RE22D bypass could have bypassed the differential pressure signal to RE22A, B, and C and the No. 1 steam line steam flow sensor had the bypass flow path been less restrictive. The fact that the RE22A, B, and C and the No. 1 steam line flow sensor remained operable and accurate is demonstrated by log readings and the steam flow recorder graph. The operator who discovered the "0" differential pressure indication of RE22D recorded the readings of all eight sensors as found while the RE22D was open. The indications of RE22A, B, and C were comparable to those of the unaffected sensors, RE22E, F, G, and H. A check of the steam flow recorder graph shows no increase in indicated steam flow as would be expected had the differential pressure applied at the steam flow sensor undergone an increase when the RE22D bypass valve was shut.

Instrument technicians will be advised via a memorandum of the details of this event, the critical importance of valve lineup checks on systems associated with reactor protection, and the importance of immediately reporting instances in which valves are found to be incorrectly positioned.
