U. S. ATOMIC ENERGY COMMISSION
REGION I
DIVISION OF COMPLIANCE

Report of Inspection

CO Report No. 219/70-7

Licensee: JERSEY CENTRAL POWER AND LIGHT COMPANY
Oyster Creek 1
License No. DPR-16
Category C

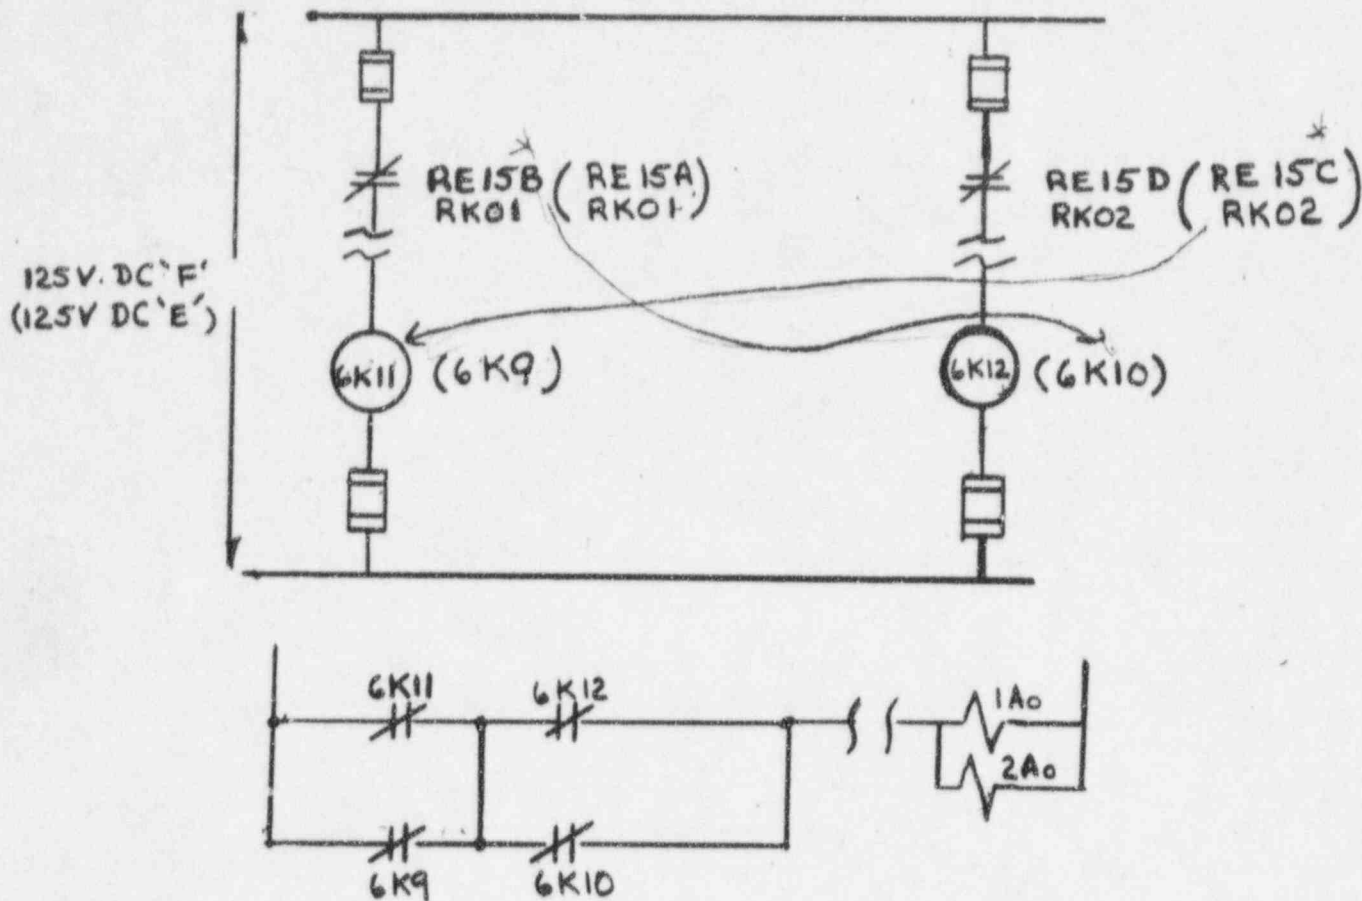
Figure 2

RE15A, B, C, D ^{close} open on high reactor pressure 1060 psi.
 6K9, 10, 11, 12 are 20 sec TDDO relays.
 1A0 and 2A0 are relays that put the isolation condenser in service when de-energized, i.e., open the condensate return line valve.

NOTE: The original circuit would have, under conditions of a loss of pressure sensing capability for one instrument rack (RK01 or RK02), been unable to actuate the isolation condensers on a high reactor pressure. With the modified design shown above, a loss of RK01 would only prevent 6K9 and 6K11 from proper operation as the actuating pressure switches for these relays (RE15A and RE15B) would be the only pressure switches affected. Under conditions of a loss of one instrument rack, the power can still be interrupted to 1A0 and 2A0 by operation of 6K10 and 6K12 which are actuated from RE15C and RE15D and which are located in the other instrument rack RK02. The circuit modifications from the old to the new involve the interchange of actuating pressure switches RE15B and RE15C which previously actuated 6K10 and 6K11 respectively. RE15A and RE15B remain in RK01 and RE15C and RE15D remain in RK02 as in the original design. Two additional sets of fuses were added to provide individual fusing for all of the actuating relays 6K9, 10, 11 and 12 to preclude one blown fuse from preventing proper operation. In the original design relays 6K9 and 6K10 were powered through a common fuse as were relays 6K11 and 6K12. Thus, if a fuse had blown, the automatic actuating capability would have been lost.

The corrective action consisted of interchanging the sensors (high pressure) that operate relays 6K10 and 6K11. (See attached Figures 2 and 3). The present automatic initiating logic for the isolation condensers on sensed high reactor pressure will not be defeated by the closure of a single excess flow check valve (which would remove the sensed pressure from two high pressure sensors). Additional fuses were added to the power supply to relays 6K9, 6K10, 6K11 and 6K12 to preclude the failure of a single fuse from negating the initiating logic circuitry. The change details are shown on Figures 2 and 3 attached.
