JERSEY CENTRAL POWER & LIGHT COMPANY (OYSTER CREEK 1)
CO REPORT NO. 219/70-6

Report of Inspection

CO Report No. 219/70-6

Licensee: JERSEY CENTRAL POWER AND LIGHT COMPANY
Oyster Creek 1
License No. DPR-16
Category C

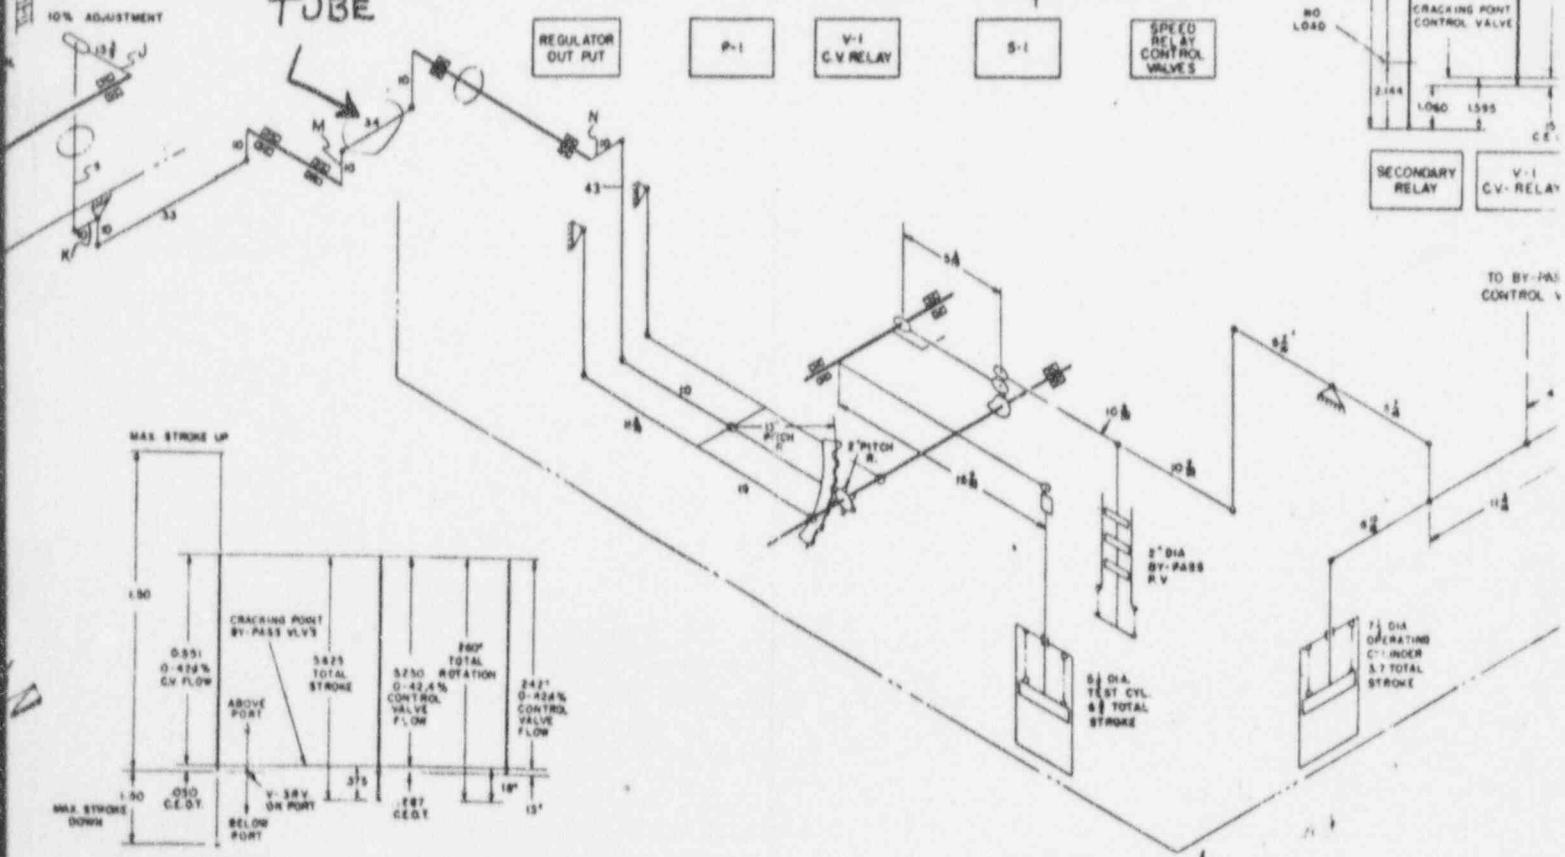
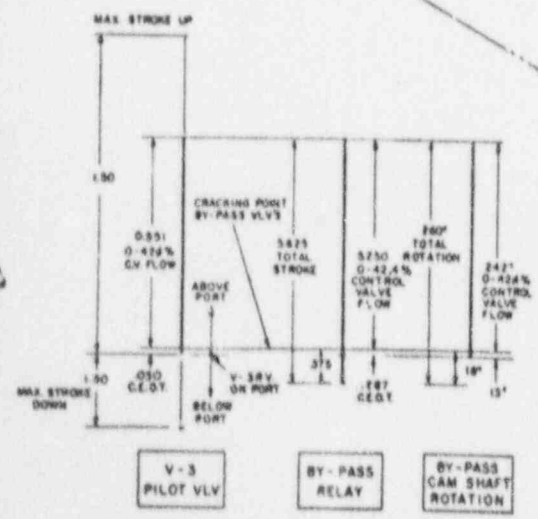
Figure 24

During the course of this investigation, it was discovered that the turbine steam bypass valves would not respond. It was discovered that one of the linkages in the control system had cracked.* The crack in the tube was almost 360° around the circumference and would have prevented proper operation of the bypass valves, but would not impair the normal operation of the control valves. The exact cause of the failure of the rod was not determined. It was thought that the rod may possibly have been damaged by someone stepping on the rod or hanging a chain hoist from it during the construction period of the plant. The rod is mounted horizontally on a span of approximately 12 feet. Metallurgical examination of the rod will be completed as soon as the rod is made available to the GE company. It was stated by Mr. McCluskey that the rod will be removed during the October 18-25, 1970, outage and shipped to GE for a metallurgical examination. He further stated that the results of the examination would be made available to Compliance. The damaged rod or linkage was repaired by inserting a hollow steel sleeve inside the original bar and fastening this with bolts. It was established during discussions with GE that a failure of this linkage or any other linkage within the turbine controls would result in closure of either the control valves or bypass valves as these valves are mechanically biased closed. Several of the other control linkage tubes were dye penetrant inspected for cracks without discovering any additional cracking. GE now plans to provide a replacement linkage for the damaged linkage. The replacement linkage will have a thicker tube wall or be constructed of a stronger material.

The cylinder that fractured or cracked in the mechanical linkage system to the turbine bypass valves is identified as link 34 on Figure 24. This link is about in the middle of the drawing. This tube moves in a horizontal plane

transmitting motion from the rotating bar and lever on one end to the rotating bar and lever on the other end. The tube is always under a compressive load. The tube is made of aluminum with a diameter around 2-1/2 inches, a wall thickness around 0.150 inches and a length around 12 feet. (These were approximate dimensions obtained during visual inspection). Complete failure of this tube would immobilize the turbine bypass valves but have no effect on the linkage to the turbine inlet valves.

The failure of the aluminum tube representing link 34 in the mechanical linkage to the bypass valves was discussed next with GE. The tube was stated to be perfectly straight but had a crack through the wall around almost 360° of the circumference. The tube is under compression from the linkage system at all times. The highest compressive load occurs when the bypass valves open. The failure was noted to appear as a brittle fracture. There were a couple of marks on the tube but no evidence of deformation. Since aluminum is a ductile material and the tube was straight, it did not appear as if it had failed under axial load or through a bending mode.

FAILED TUBE

The JC - Oyster Creek maintenance personnel have visually checked all of the mechanical linkage in the bypass valve and turbine inlet valve control systems. They also dye checked the links for evidence of any cracks. GE is planning to make a careful review of their mechanical linkage design. They plan to install bigger links or use steel in place of aluminum for added strength. These changes are to be made in the next extended outage.

They also are considering placing covers over the linkage to protect them from inadvertent damage. (They are now open and running between steam pipes below the front standard of the turbine.) The broken tube is to be returned to Schenectady for metallurgical examination in the next shutdown. Hopefully, this will enable them to determine the cause of failure. They have already reviewed their mechanical stress calculations for the linkage. They plan to check these against the strain gage measurements on the broken link. The personnel from the LSTG of GE indicated a report on the results of their evaluation of the linkage failure would be made available to JC and the Compliance inspector would be permitted to review it.
