Jersey Central Power & Light Company

Subject: Oyster Creek Station  
Docket No. 50-219  
Abnormal Occurrence Report No. 50-219/74/17

OYSTER CREEK NUCLEAR GENERATING STATION  
FORKED RIVER, NEW JERSEY 08731

Abnormal Occurrence  
Report No. 50-219/74/17

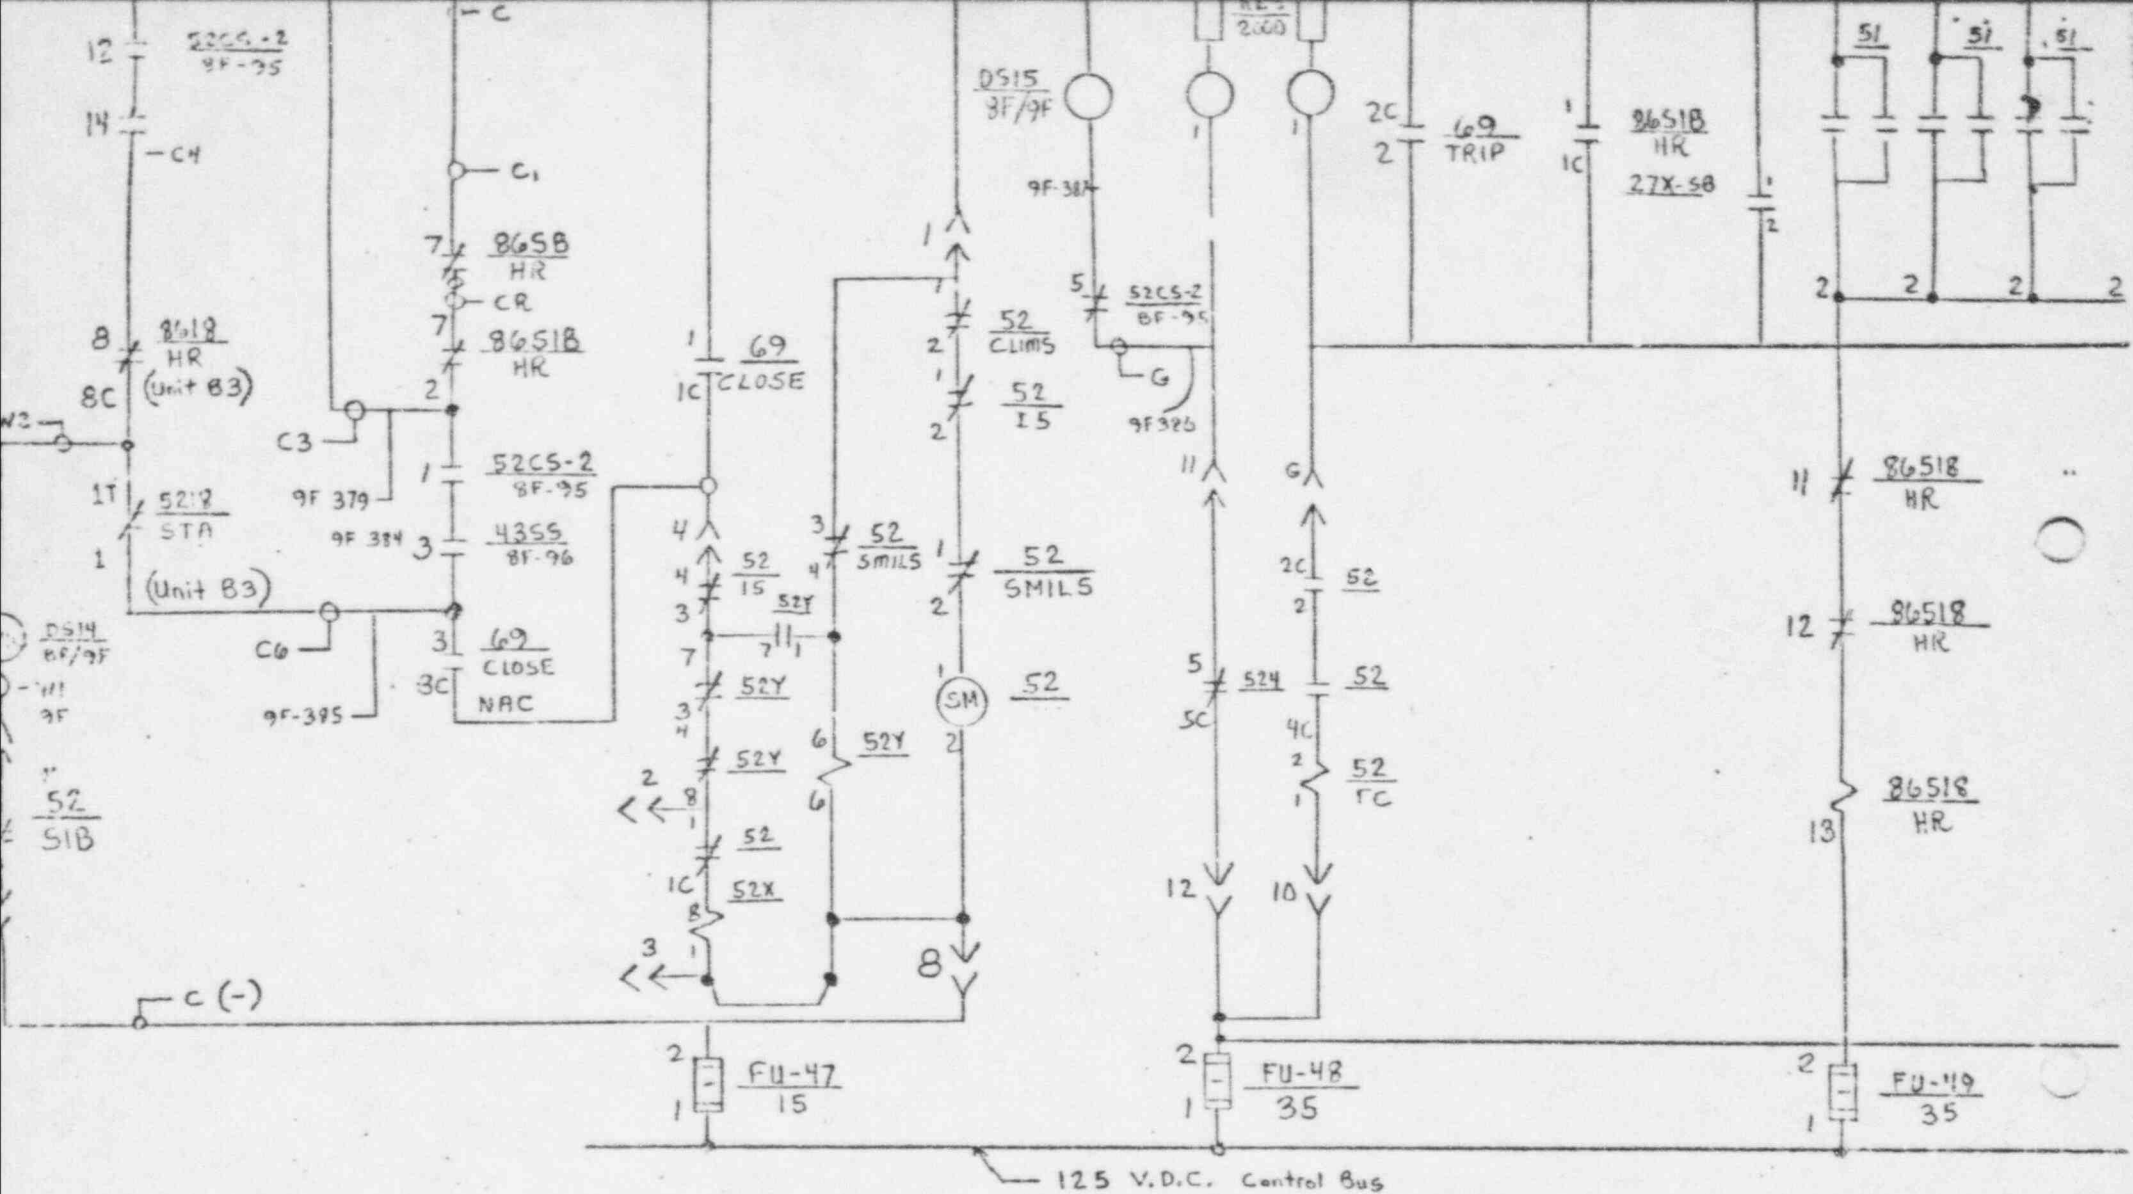
\* See attached reproduction of pertinent portion of General Electric Drawing No. 0223K0173, Sheet 14.

On Thursday, March 7, 1974, at 1700, as part of the routine plant shutdown procedure, it was required to transfer plant power from the 1B auxiliary transformer to the SB startup transformer. The control room operator on duty operated the closing switch for the S1B breaker with no results. The reactor shutdown was terminated, holding the generator electric power at approximately 100 MWe in order to maintain a power supply path through the 1B auxiliary transformer. Inspection of the S1B breaker revealed that the closing spring was not in the charged position; hence, breaker closure was not possible in either the manual or automatic mode. The failure of the spring to wind has been traced to a failed spring cam switch which closes when the spring unwinds.\* The cam switch closure normally causes a relay, 52Y, to energize which in turn deenergizes

the S1B breaker closing coil 52X. Contacts from 52X in turn cause the spring winding motor to start and rewind the spring. Since the cam switch contacts failed to cause 52Y to energize, a continuous current was applied to 52X causing it to burn which resulted in freezing the coil auxiliary contacts in their energized position. It is thought at this time that the failure of the spring to rewind occurred following the January 12, 1974 reactor shutdown operation, since this was the last successful operation of the breaker. After replacing the 52X coil and the failed cam switch, successful transfer of load from 1B auxiliary transformer to the SB startup transformer was achieved.

Component failure was the cause of this occurrence. The failure of the cam switch is presently under investigation.

At this time, it is thought that this occurrence is an isolated incident. However, all 4160 volt safeguard and 460 volt safeguard switchgear will be checked to see that the closing springs have been properly charged. In addition, the feasibility of installing a closing circuit monitoring system will be explored with the Generation Engineering Department.
