U. S. ATOMIC ENERGY COMMISSION  
DIRECTORATE OF REGULATORY OPERATIONS  
REGION I

RO Inspection Report No. 50-219/72-04

Subject: Jersey Central Power & Light Company

Oyster Creek

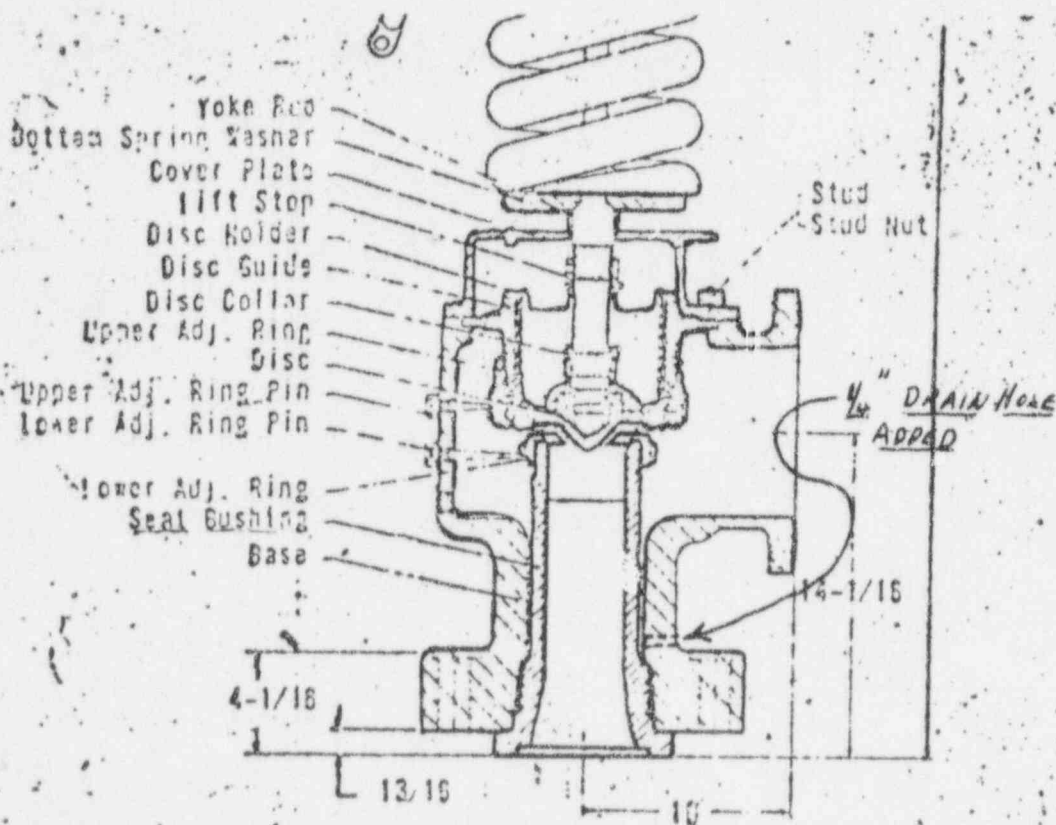
After a liquid penetrant inspection of the seat bushing of the five spare safety valves (Removed from service during the October - November 1971 outage) showed cracks in two of the seat bushings, all of the safety valves were removed and inspected during the May - June 1972 outage. Cracks were found in the seat bushing of seven of the sixteen installed valves. The cause of the cracking was evaluated to be chloride stress corrosion by General Electric and JCP&L's consultant MFR Associates Mr. J. Collins, Regulatory Operation reviewed the analysis performed by GE and concurred in the above evaluation.

According to Mr. McCluskey, the vendors representative stated that the safety valves could be expected to weep when the reactor is pressurized in the cold condition for the hydro test (approximately 1050 psig). He recommended that the safety valves be gagged to prevent building up water on the outside of the seat bushing and this possible contribution to cracking, even though a 1/4" hole was drilled in the base of the safety valve to permit draining most of the leakage from this space in the valve. (See sketch below.)

New seat bushings were purchased to replace the cracked seat bushings.

All of the valves were decontaminated to the levels required for shipment to the vendors shop (Dresser) and inspected at the Todd Shipyard in Galveston, Texas. The valves were reinspected at the vendors shop and rebuilt using new or sound parts. The inspection included a dimensional check as well as a liquid penetrant check. The inspection at both Dresser and Todd were witnessed by JCP&L representatives. The relief set point was set to the specified value on steam (1212 to 1239 psig) and the equivalent cold nitrogen relief correlation was determined before the valves were returned to Oyster Creek. Mr. Ross stated that as expected the radiation level of the valves with cracked seat bushings was higher than the radiation level of the valves without cracks.
