## Section I

CO INQUIRY REPORT NO. 50-219/72-09  
JERSEY CENTRAL POWER & LIGHT COMPANY  
OYSTER CREEK - BWR  
EQUIPMENT DEFICIENCY - CRACKS IN SAFETY VALVE SEAT BUSHING

Title: Equipment Deficiency - Cracks in Safety Valve Seat Bushing

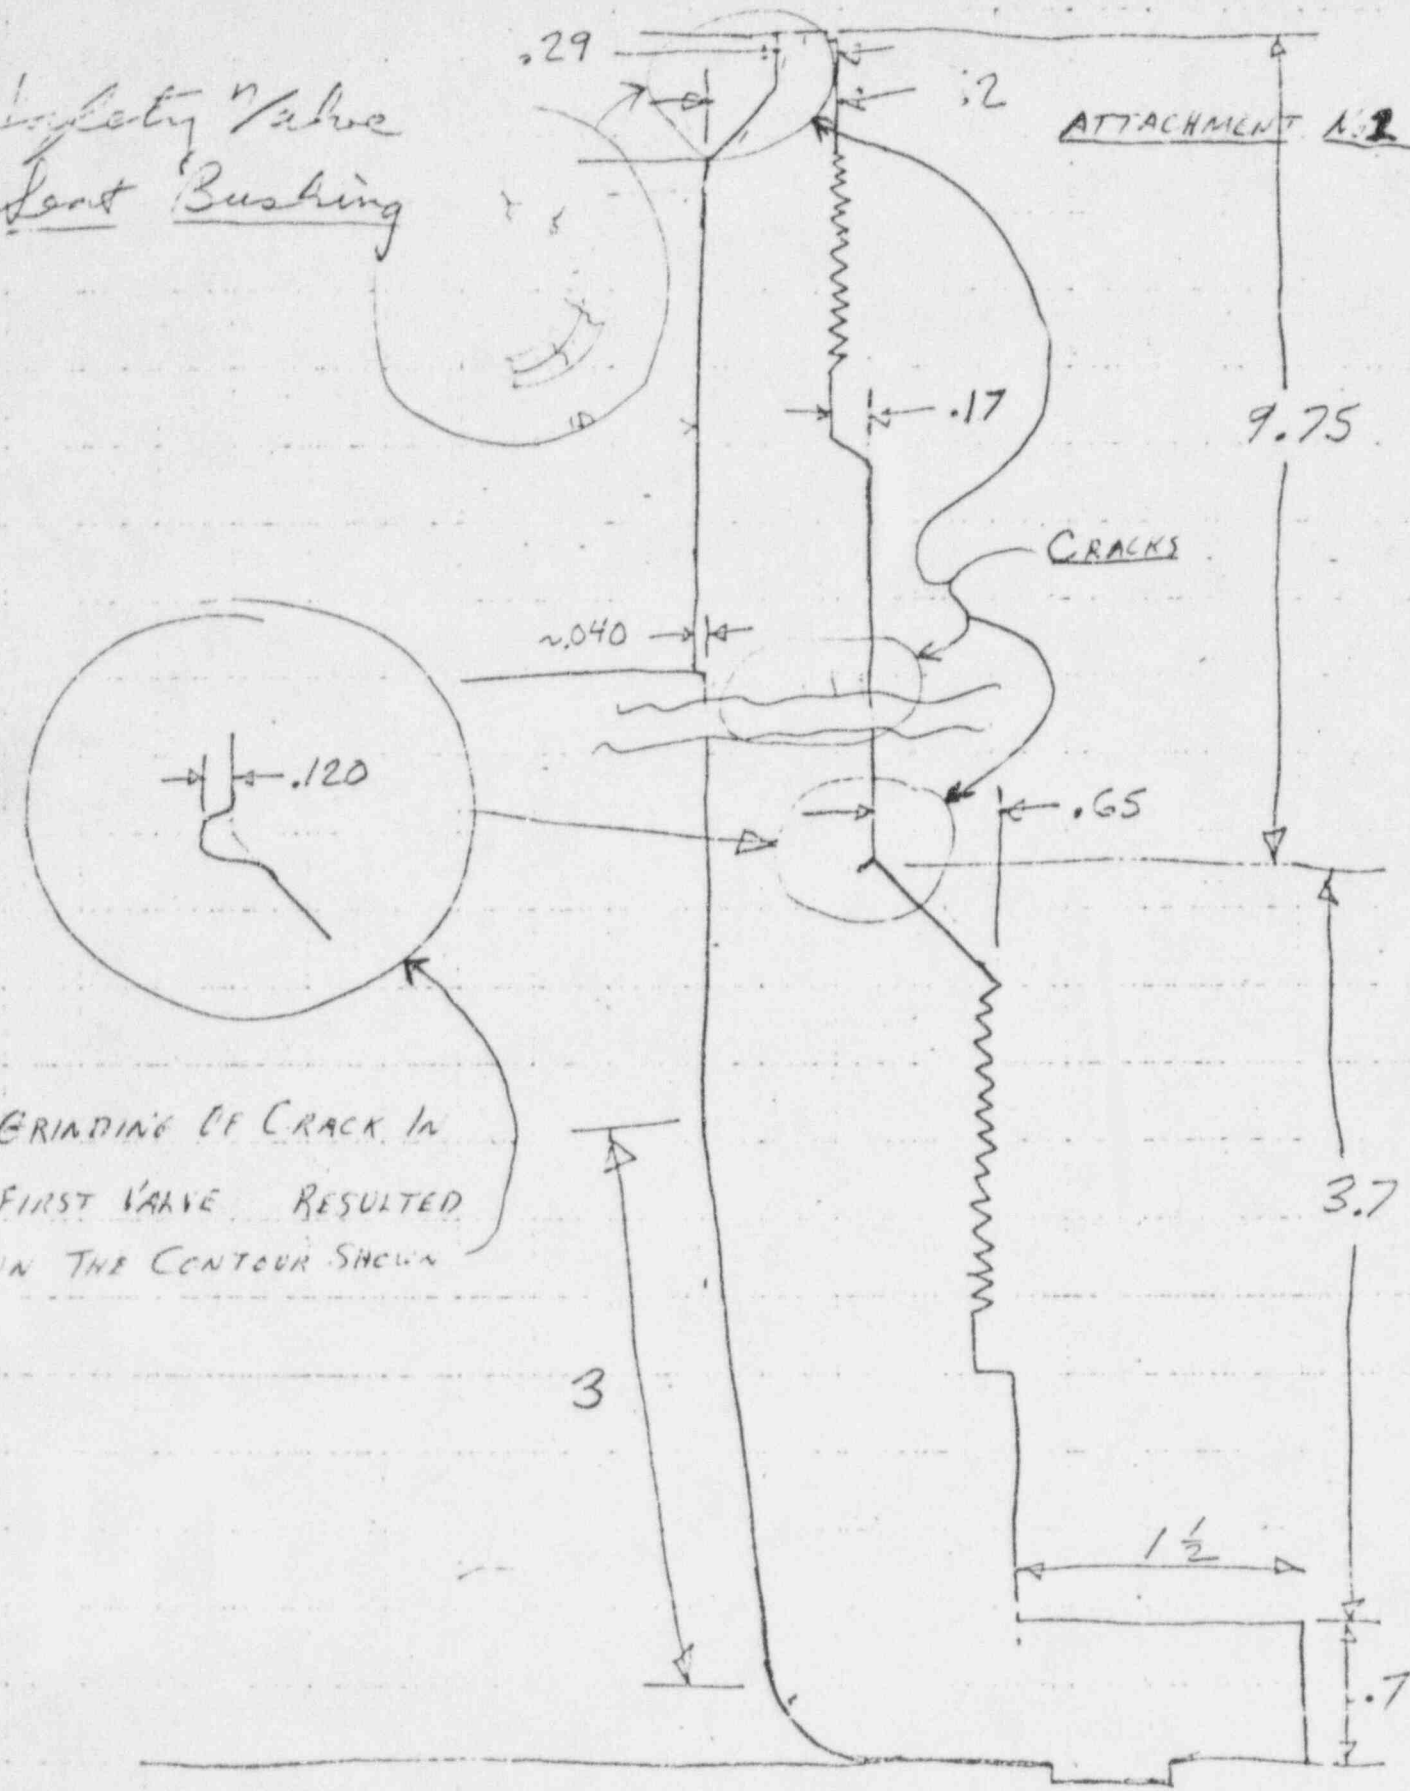
Safety Valve  
Seat Bushing

During the September - November 1971 outage, five safety valves were replaced with five clean tested spare valves. The plans were to test the five valves removed using nitrogen; however, a correlation between testing with cold nitrogen and hot steam was not available. As a result, it was necessary to send the valves to the manufacturer's shop for testing and to determine the correlation between cold nitrogen and hot steam for future testing. Efforts to decontaminate the valves to suitable levels for shipment to the manufacturer's shop (less than 2 mR/hr) were unsuccessful until the valve seat bushing was unscrewed from the valve body. When initial decontamination efforts on the seat bushing of the first valve were unsuccessful, a dye check showed radial cracks on the seat and a circumferential crack approximately 4.4 inches from the base, at a point where the wall thickness completed the transition from 1.4 inches to 0.75 inches. It was necessary to grind to a maximum depth of 0.12 inches to remove the circumferential crack (Attachment No. 1).

Without any further attempt to decontaminate, the seat bushing was removed from the second valve and was dye checked. Cracks were detected at the same locations as in the first valve examined. In addition, several vertical cracks about 1/2 inch long were noted about ten inches above the base (The point at which water could have been standing if the valves were cold).

The remaining three valves were disassembled and dye checked but did not show the crack indications found on the first two valves.

Ten safety valve repair kits were ordered from GE (all that were available) to use in replacing cracked seats.
