# Jersey Central Power & Light Company

Subject: Oyster Creek Station  
Docket No. 50-219  
Abnormal Occurrence Report No. 50-219/74/13

OYSTER CREEK NUCLEAR GENERATING STATION  
FORKED RIVER, NEW JERSEY 08731

Abnormal Occurrence  
Report No. 50-219/74/13

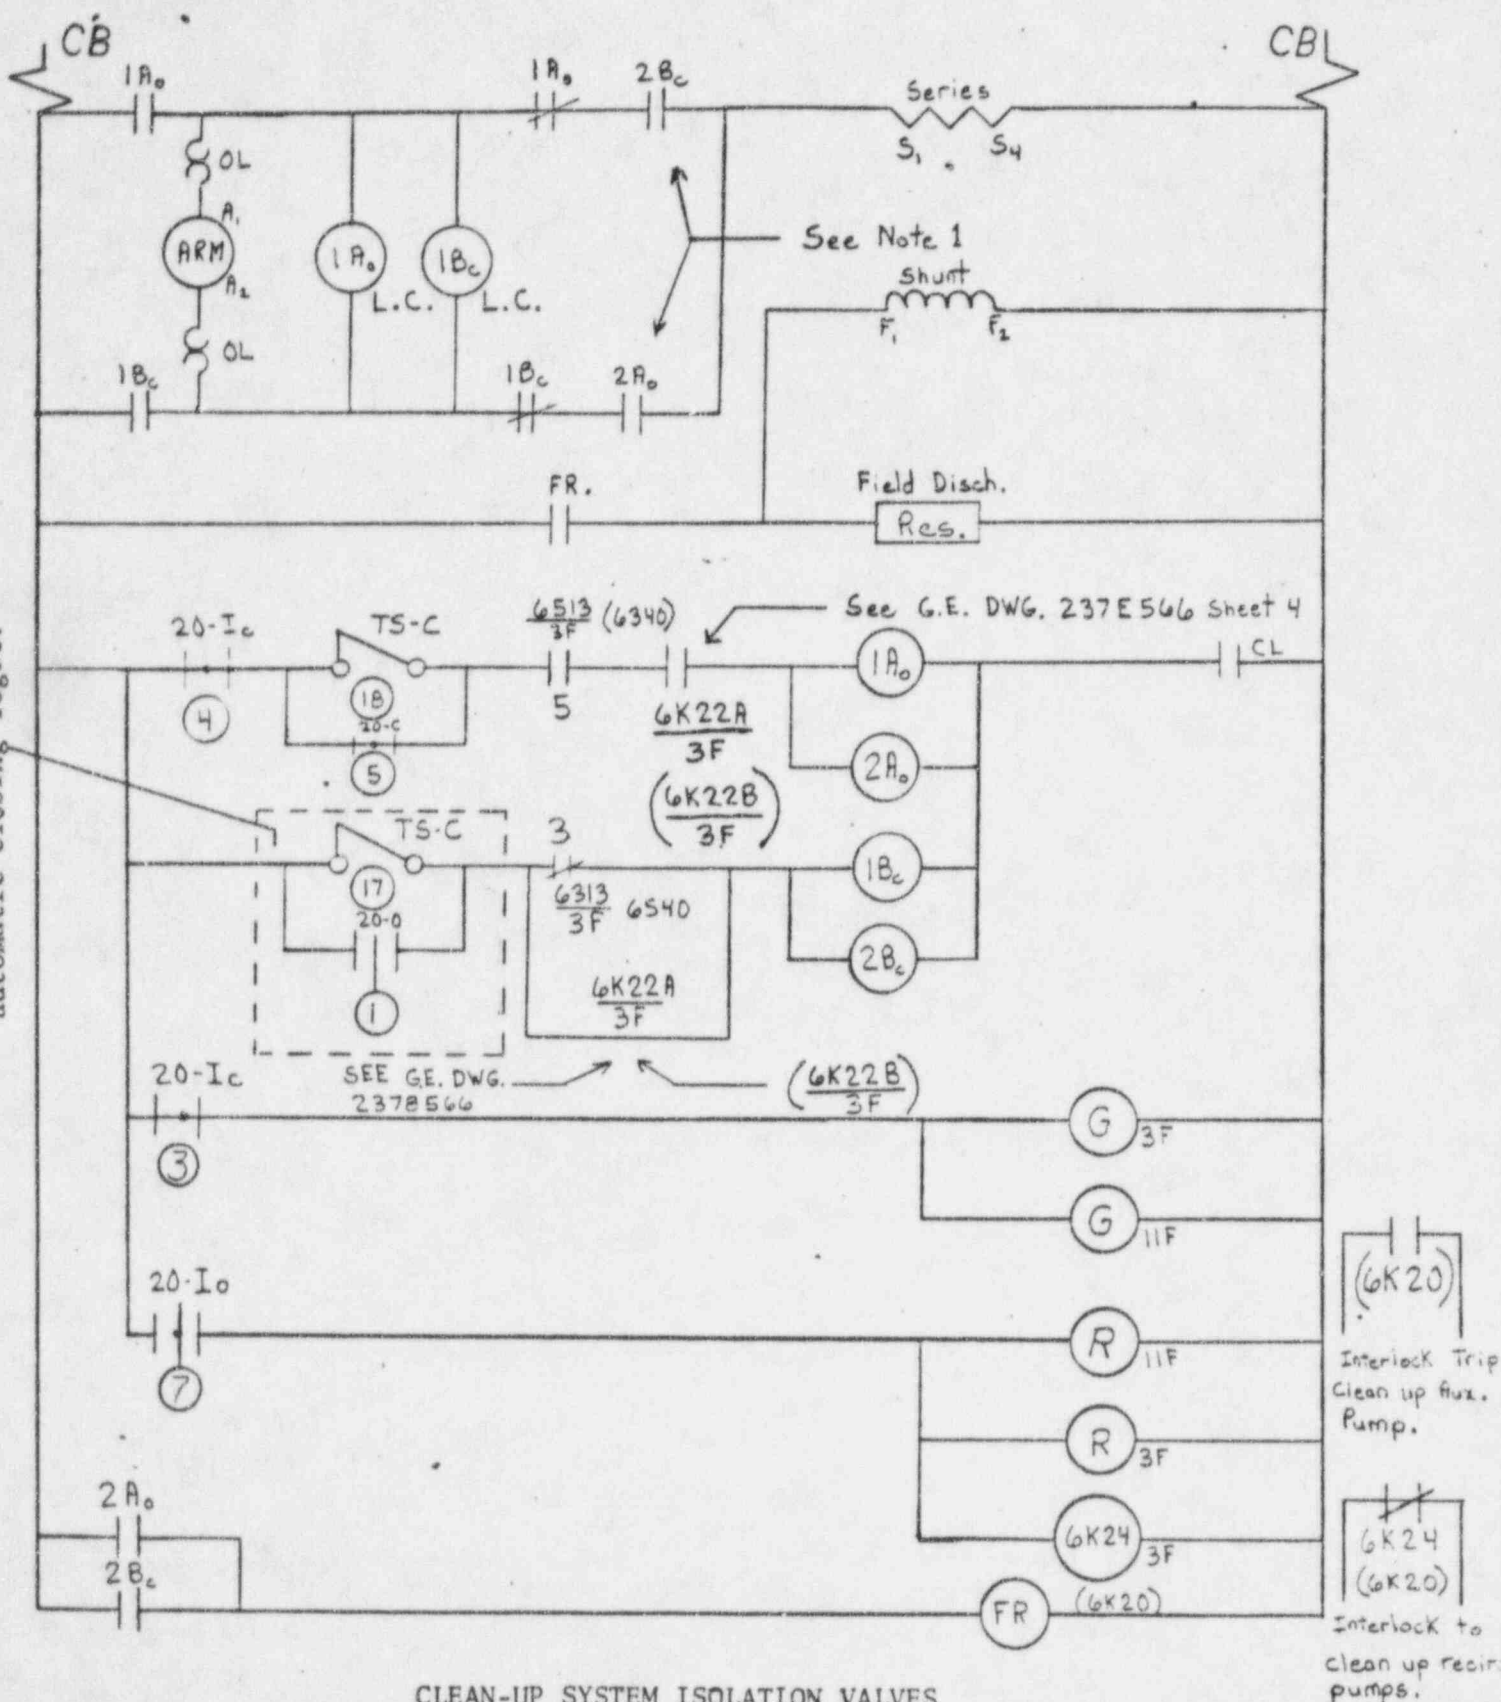
Figure 1

Referenced redundant power feed to the valve manual/automatic closing logic.

CLEAN-UP SYSTEM ISOLATION VALVES

6S13 - V-16-14 Inlet Valve as shown  
 6S40 - V-16-2 Aux. Inlet Valve as shown:
