UNITED STATES  
**ATOMIC ENERGY COMMISSION**  
 DIRECTORATE OF REGULATORY OPERATIONS  
 REGION I  
 631 PARK AVENUE  
 KING OF PRUSSIA, PENNSYLVANIA 19406

REFERENCE: Operating License DPR-28  
Docket No. 50-271  
Abnormal Occurrence No. AO-73-34

As defined by Technical Specifications for the Vermont Yankee Nuclear Power Station, Section 6.7.B.1, we are reporting the following Abnormal Occurrence as AO-73-34.

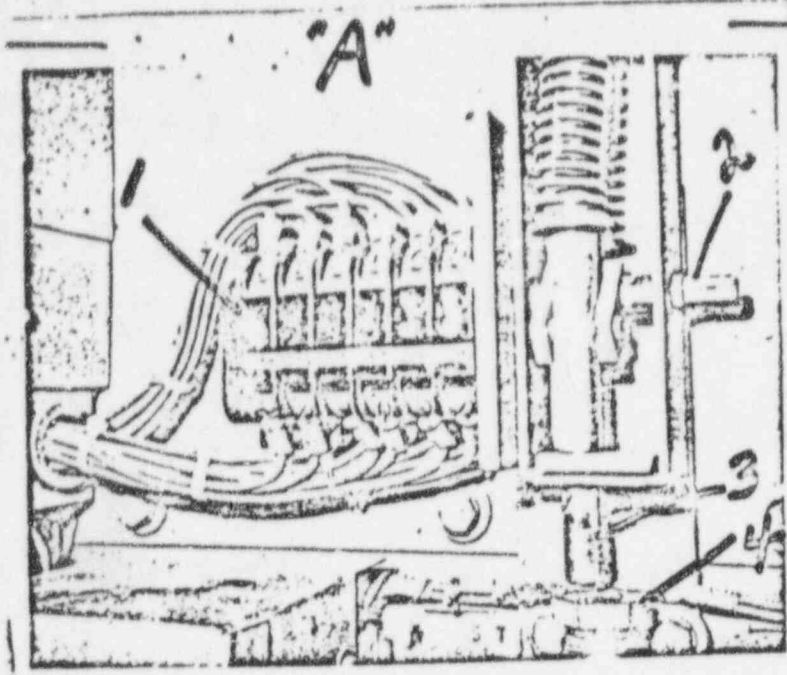
- A. Breaker in open position
  - 1. Stationary auxiliary switch
  - 2. Switch operating shaft
  - 3. Switch operating linkage
  - 4. Breaker operating plunger
- B. Breaker in closed position
  - 1. Breaker operating plunger
- C. Typical breaker in compartment
  - 1. Breaker closed
- D. Typical breaker in compartment
  - 1. Breaker opened

On December 17, 1973, while investigating a reported problem involving the "A" Station Service Water Pump 4 KV breaker, an electrician noted the fact that the breaker stationary auxiliary switch assembly rear mounting tie bolt had loosened and was disengaged from its mounting plate. This bolt serves to assist in maintaining proper switch contact alignment. The loosening and subsequent backing out of the tie bolt caused some misalignment of the switch auxiliary contacts which would have rendered those contacts inoperable had the breaker operated. This failure is not considered to be an abnormal occurrence, but is merely referenced to detail appropriate background information.

Tightening of all loose switch tie bolts was initiated immediately upon discovery and completed by 1000 hours on December 19, 1973. The reactor was operating at approximately 68% power at the time of this incident.

PORC determined that as a result of this incident, all 4 KV switchgear stationary auxiliary switches should be inspected in three months (which would be coincidental with approximately three breaker operations). If a similar condition is found to be developing at that time, the committee will undertake whatever further corrective action is required to assure resolution of the problem. In addition, a complete inspection of all breaker associated devices should be conducted during each plant refueling outage.
