U. S. ATOMIC ENERGY COMMISSION
DIRECTORATE OF REGULATORY OPERATIONS
REGION I

RO Inspection Report No. 50-219/72-03

Subject: Jersey Central Power & Light Company

Oyster Creek

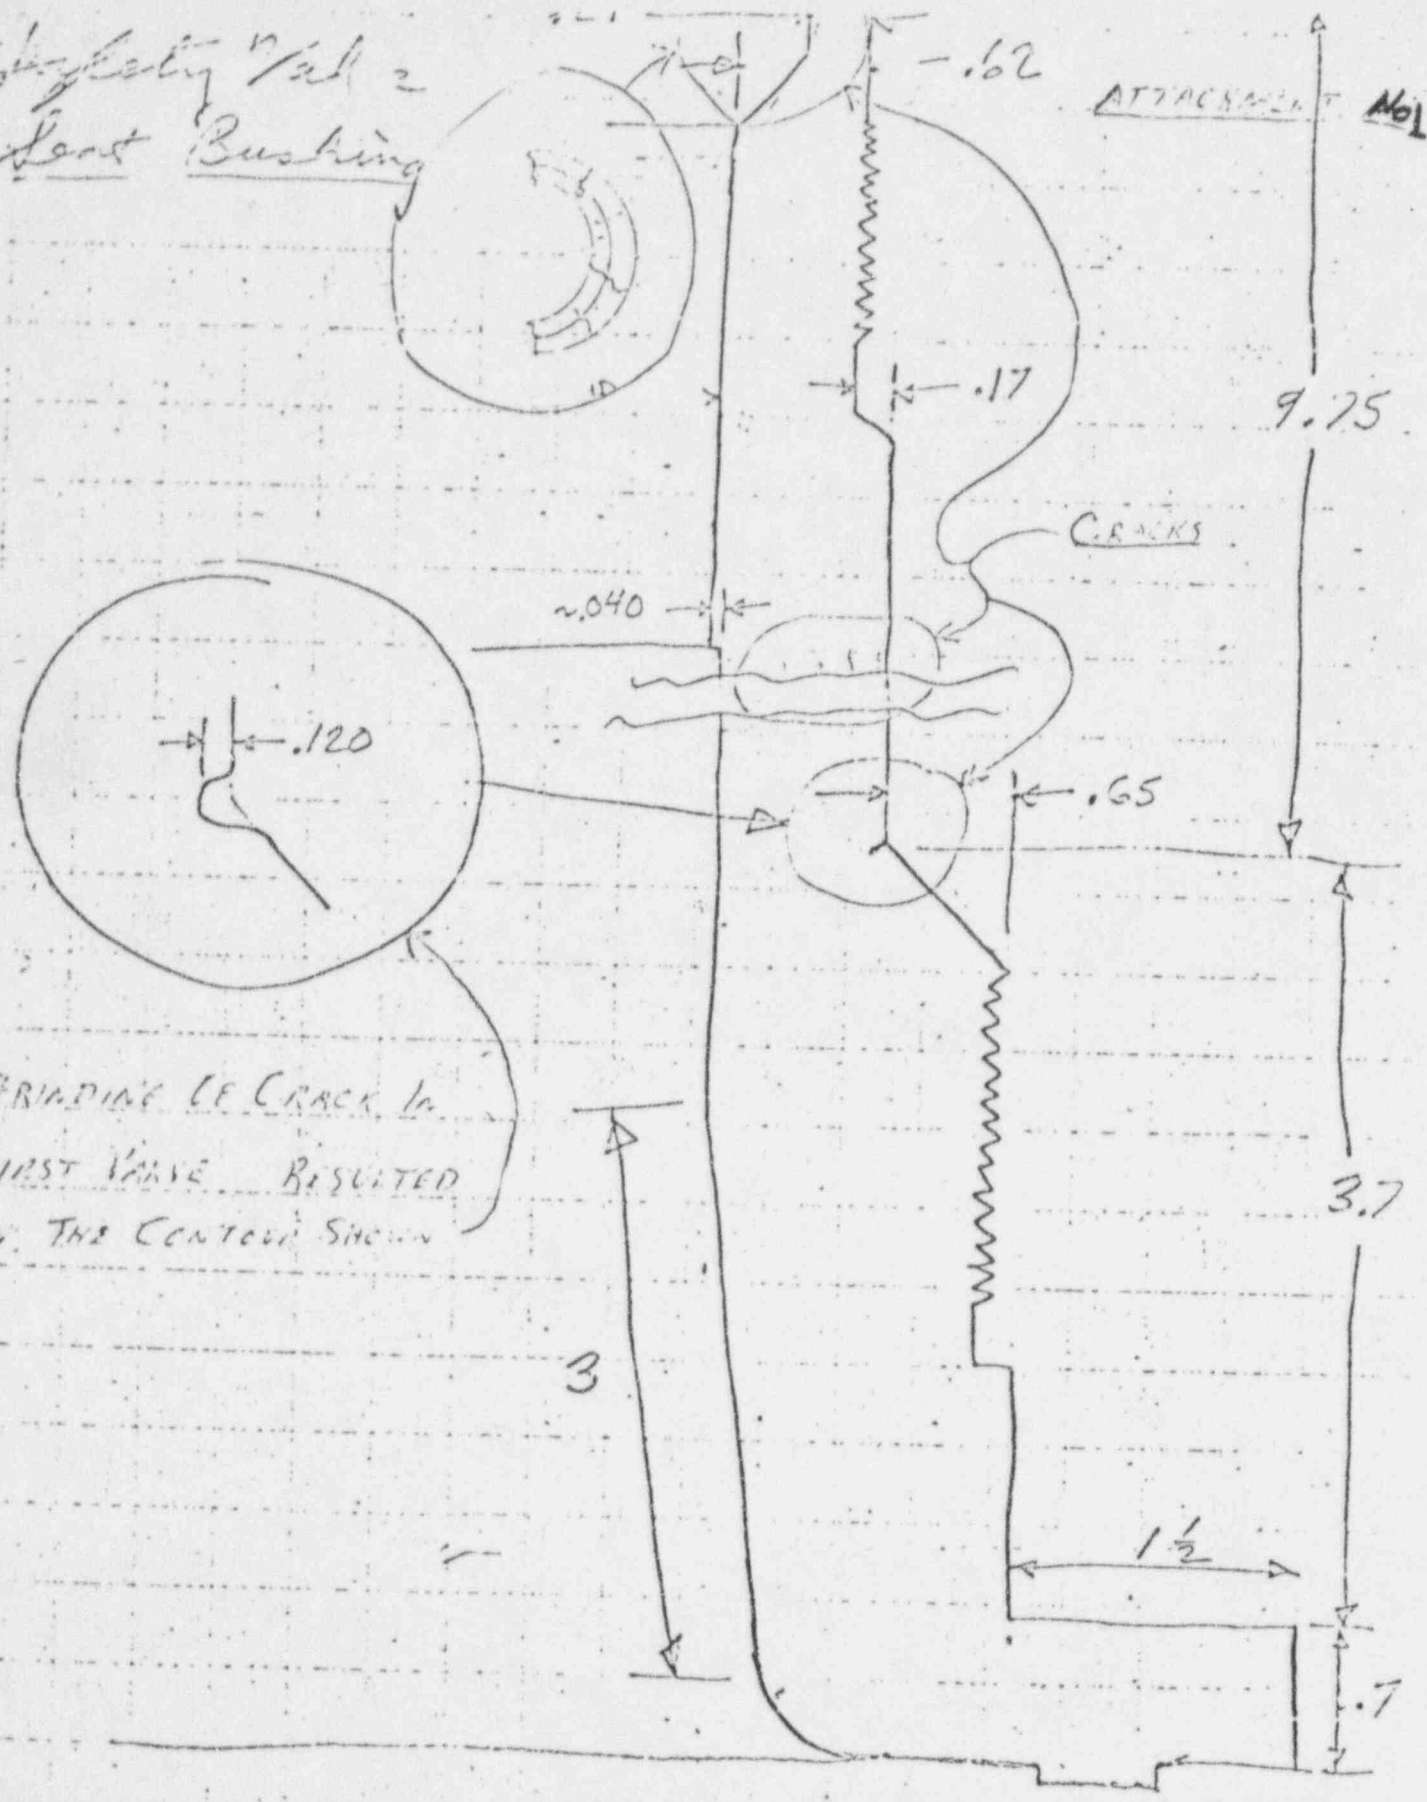
ATTACHMENT No 1

Mr. McCluskey stated that during the September - November 1971 outage, five safety valves were replaced with five clean tested spare valves. The plans were to test the five valves removed using nitrogen; however, a correlation between testing with cold nitrogen and hot steam was not available. As a result, it was necessary to send the valves to the manufacturer's shop for testing and to determine the correlation between cold nitrogen and hot steam for future testing. Efforts to decontaminate the valves to suitable levels for shipment to the manufacturer's shop (less than 2 mR/hr) were unsuccessful until the valve seat bushing was unscrewed from the valve body. When initial decontamination efforts on the seat bushing of the first valve were unsuccessful, a dye check showed radial cracks on the seat and a circumferential crack approximately 4.4 inches from the base, at a point where the wall thickness completed the transition from 1.4 inches to 0.75 inches. It was necessary to grind to a maximum depth of 0.12 inches to remove the circumferential crack. (Attachment 1)

Without any further attempt to decontaminate, the seat bushing was removed from the second valve and was dye checked. Cracks were detected at the same locations as in the first valve examined. In addition, several vertical cracks about 1/2 inch long were noted about ten inches above the base (the point at which water could have been standing if the valves were cold).

Insulating Valve 2
Seat Bushing

BRINDING LE CRACK IN
FIRST VALVE RESULTED
IN THE CENTER SHOWN

Ten safety valve repair kits were ordered from GE (all that were available) to use in replacing cracked seats.

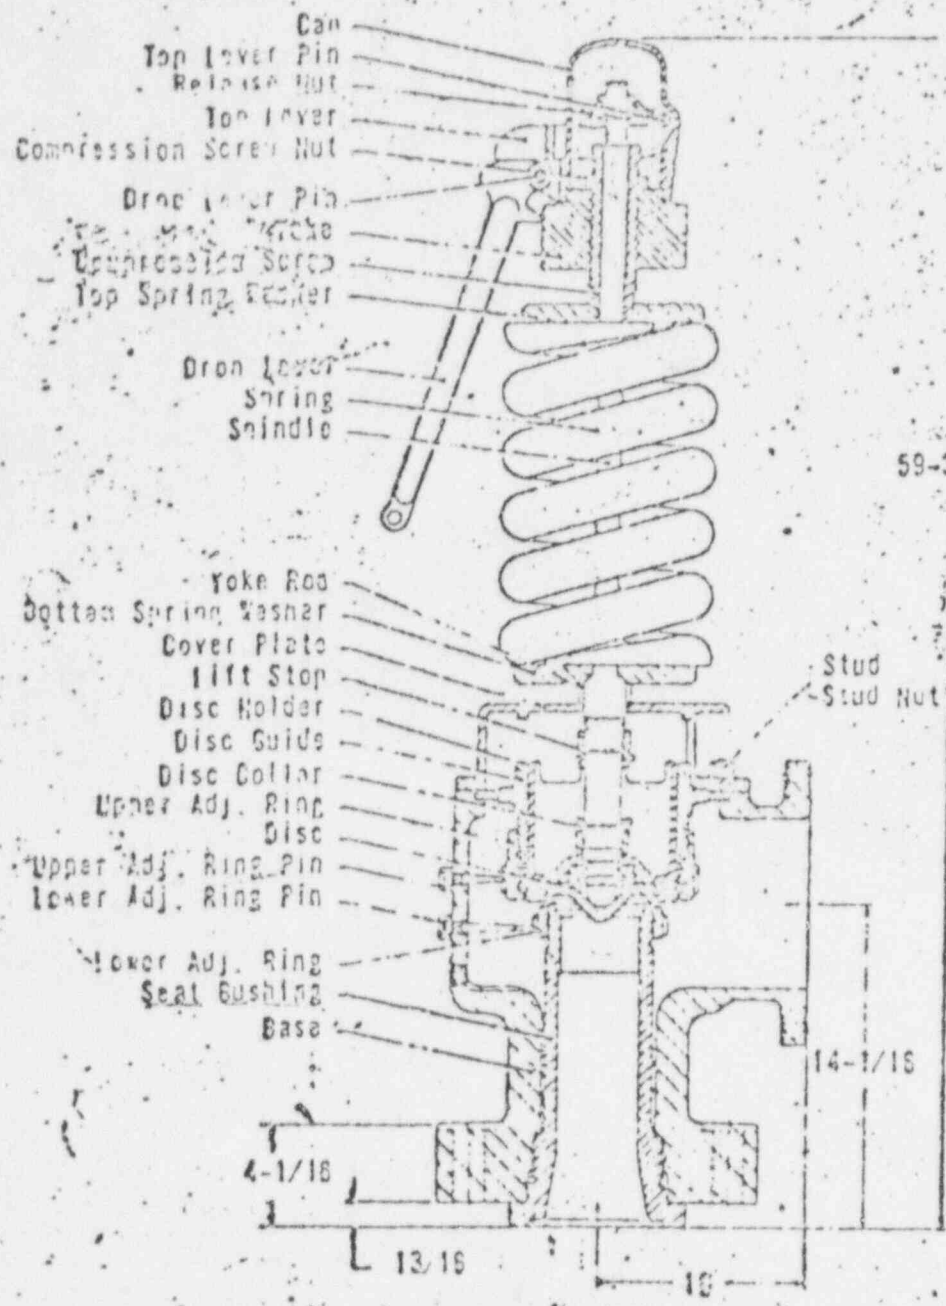
ATTACHMENT No. 2

The valves are Dresser "Maxiflow Safety Valves", Model 6-3777QA, with a six inch inlet and an eight inch outlet (Attachment 2). The seat bushing is ASTM A182, Grade F304 stainless steel. The base (or valve housing) is ASTM A216, Grade WCA carbon steel. Oyster Creek has 16 safety valves installed in the primary system, and five spare valves.
