U.S. ATOMIC ENERGY COMMISSION
DIRECTORATE OF REGULATORY OPERATIONS
REGION I

RO Inspection Report No: 50-219/74-01 Docket No: 50-219
Licensee: Jersey Central Power and Light Company License No: DPR-16
Oyster Creek Priority: _____
Category: C
Location: Forked River, New Jersey

Type of Licensee: BWR, 1930 Mwt (GE)
Type of Inspection: Special, Announced
Dates of Inspection: January 11-12, 1974
Dates of Previous Inspection: December 26-28, 1973

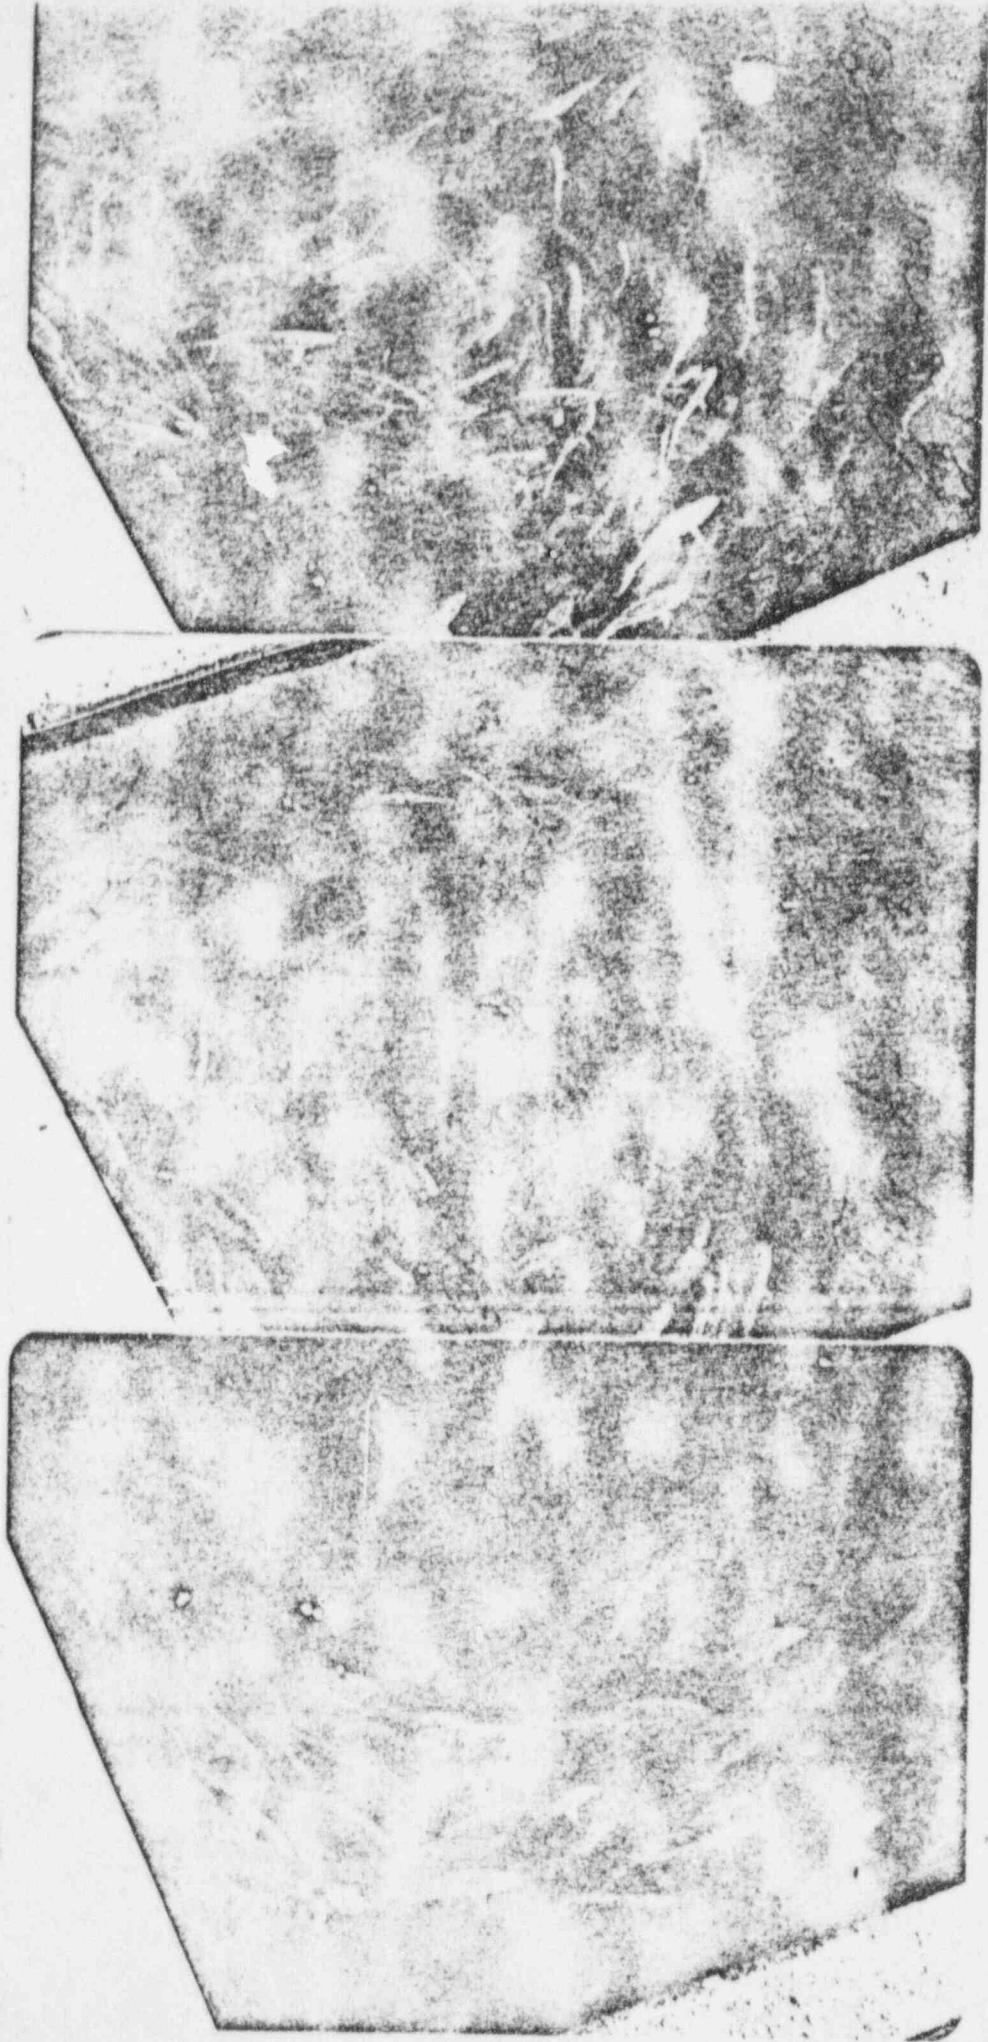
EXHIBIT 1

At approximately 11:00 a.m. the inspectors returned to the area of circulating pump discharge at the plant and observed a large number (several hundred) of menhaden congregated in an area of relatively

still water at the dilution pump discharge point. (See Exhibit 1 which shows three photographs of this.) The inspectors were accompanied at this point by a representative of the State of New Jersey. Dilution pumps were off. Occasionally a fish was observed to be in distress, then rise to the surface, and subsequently sink to the bottom - apparently in the act of dying. (See Exhibit 2 which shows two photographs of fish in distress. The water temperature in this area was measured by the licensee's consultant and found to be 38°F as compared to 36°F at the circulation pump discharge.
