**The Performance of Defected Spent LWR Fuel Rods in  
Inert Gas and Dry Air Storage Atmospheres**

**January 1985**

NUREG/CR-4074  
EGG-2364  
Distribution Category: RJ

**THE PERFORMANCE OF DEFECTED SPENT LWR FUEL  
RODS IN INERT GAS AND DRY AIR STORAGE  
ATMOSPHERES**

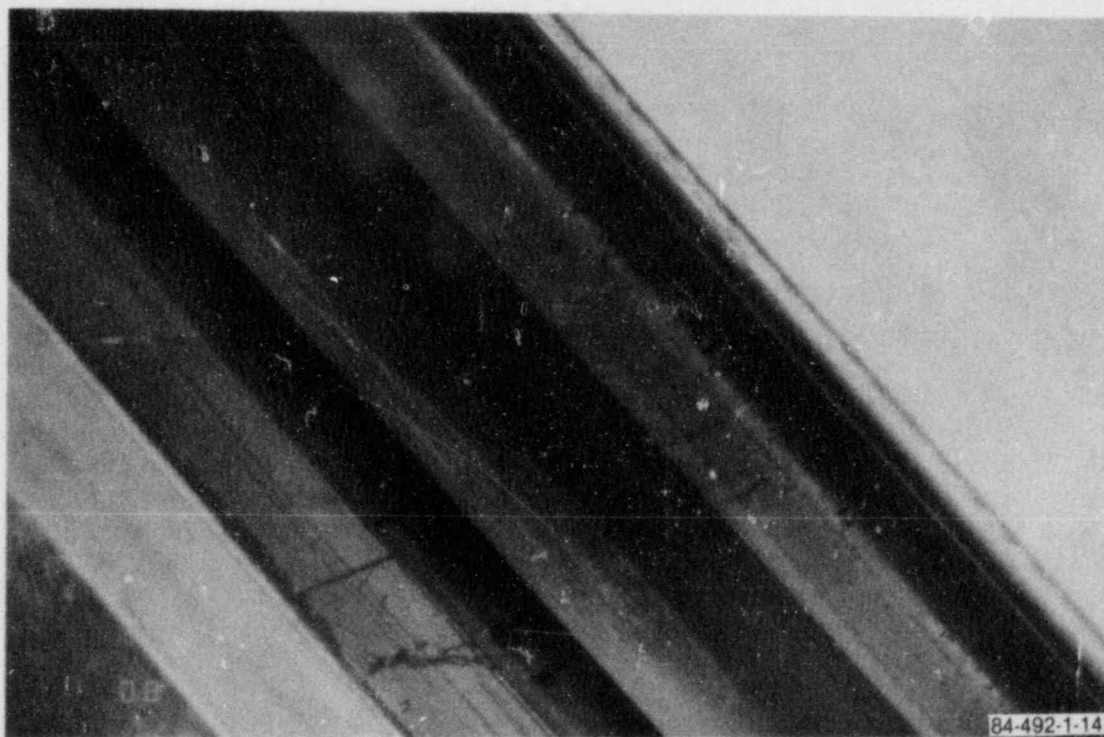
All eight rods were visually examined. The general surface condition of the H. B. Robinson fuel rods appeared to be unchanged. The fuel rods heated in air (both intact and defected) were similar in appearance to those heated in argon (Figures 4 and 5). There is little crud deposition on the fuel rods exhibiting a smooth oxide on the surface.

Figure 4. Top defect in fuel rod BO5-G7 heated in argon.

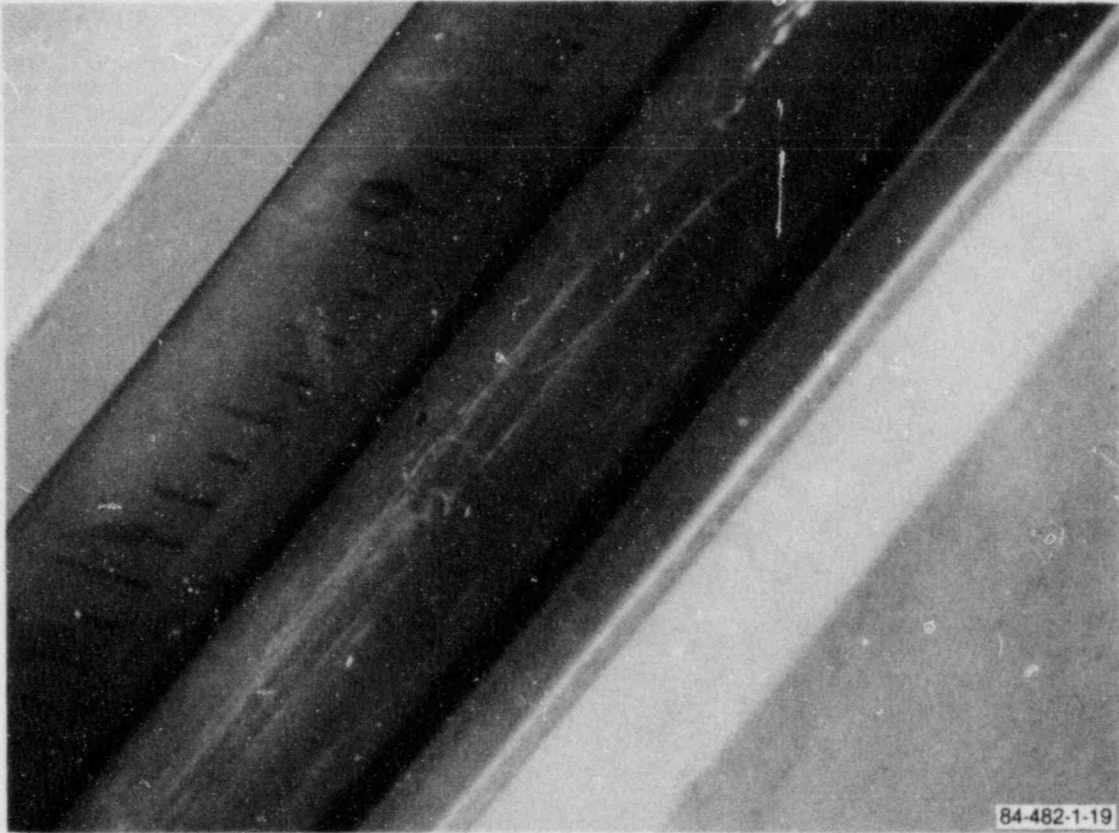
Figure 5. Top defect in fuel rod BO5-E7 heated in air.

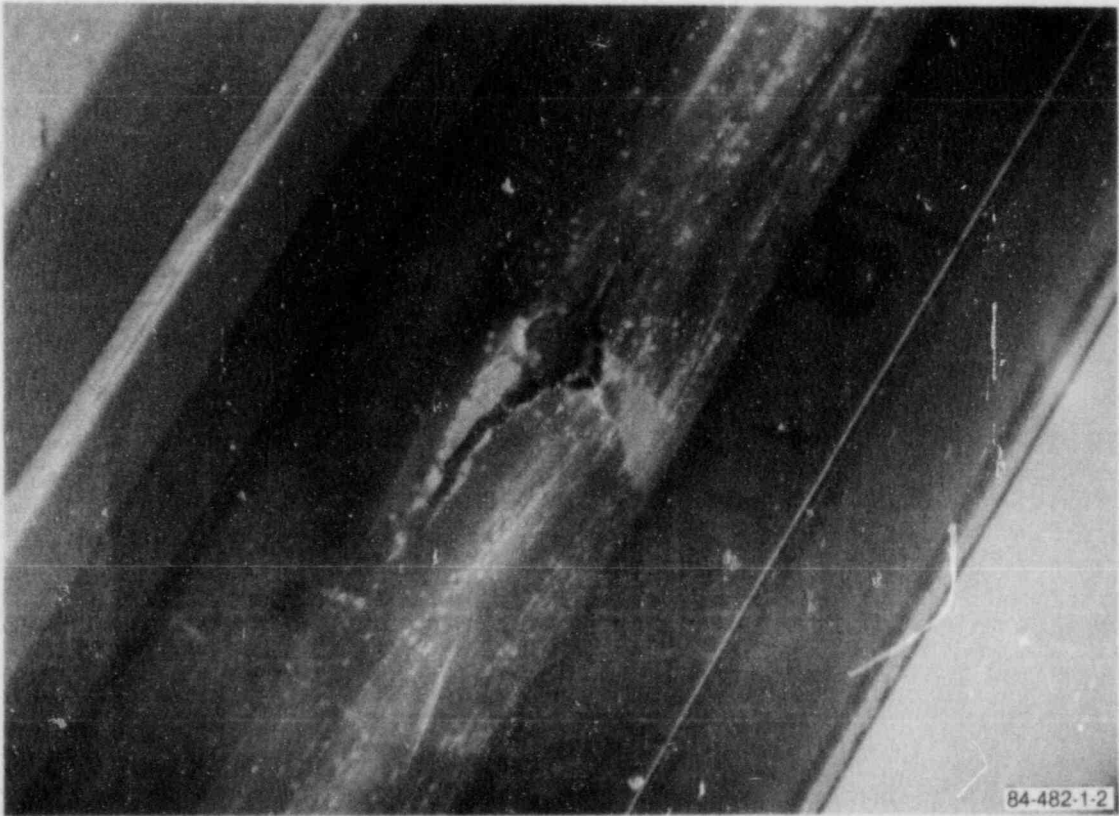
The general surface appearance of the four BWR fuel rods also appeared to have not changed. The artificial defect at the top of rod PH462-C5 did not appear to be fully open. When this hole was drilled into the cladding, indications were that the drill bit had penetrated through the wall. The defect located at the bottom showed significant enlargement and developed an axial crack emanating from both sides of the original hole (Figure 6). Also the top defect in rod PH462-D6 did not appear to be fully open to the atmosphere.

The fuel rod diameter measurements are listed in Table 3, and the defect sizes are listed in Table 4. Significant fuel rod strain was measured in the BWR PH462-C5 fuel rod. The crack size in PH462-C5 was asymmetrical, extending 8.6 mm up the rod and 10.2 mm down the rod from the defect. Its width at the widest point was 1.3 mm. The original defect, which was 0.76 mm, increased by 0.25 mm neglecting the initial crack opening. The fuel rod expanded 17% at 90 degrees from the crack and 7% at 30 degrees almost parallel to the crack. The deformation of the failed BWR fuel rods was apparently constrained by the fuel rod capsule. The maximum deformation of the fuel rod is 1.73 cm, compared with 1.75 cm inside diameter of the capsule. The fuel rod was stuck inside the capsule when the capsule was being unloaded. There is no apparent fuel rod strain in the other three BWR fuel rods, based on the fuel rod diameter measurements.

Figure 6. Crack in fuel rod PH462-C5, 401 cm from the top (bottom defect).

In unlimited air, a crack was initiated from the artificial defect located at the bottom of the BWR fuel rod PH462-C5. The neutron radiograph of this area indicates that about 13 cm of the fuel may be oxidized. The defect at the top of PH462-C5 did not enlarge because the defect may be blocked. The neutron radiograph also does not indicate fuel oxidation in the defect area, but some oxidation may be present at the center defect of PH462-C5. A fuel rod destructive examination will show the condition of the defects as well as that of the defects in other fuel rods. Cracks did not start at all defects in the BWR fuel rods.

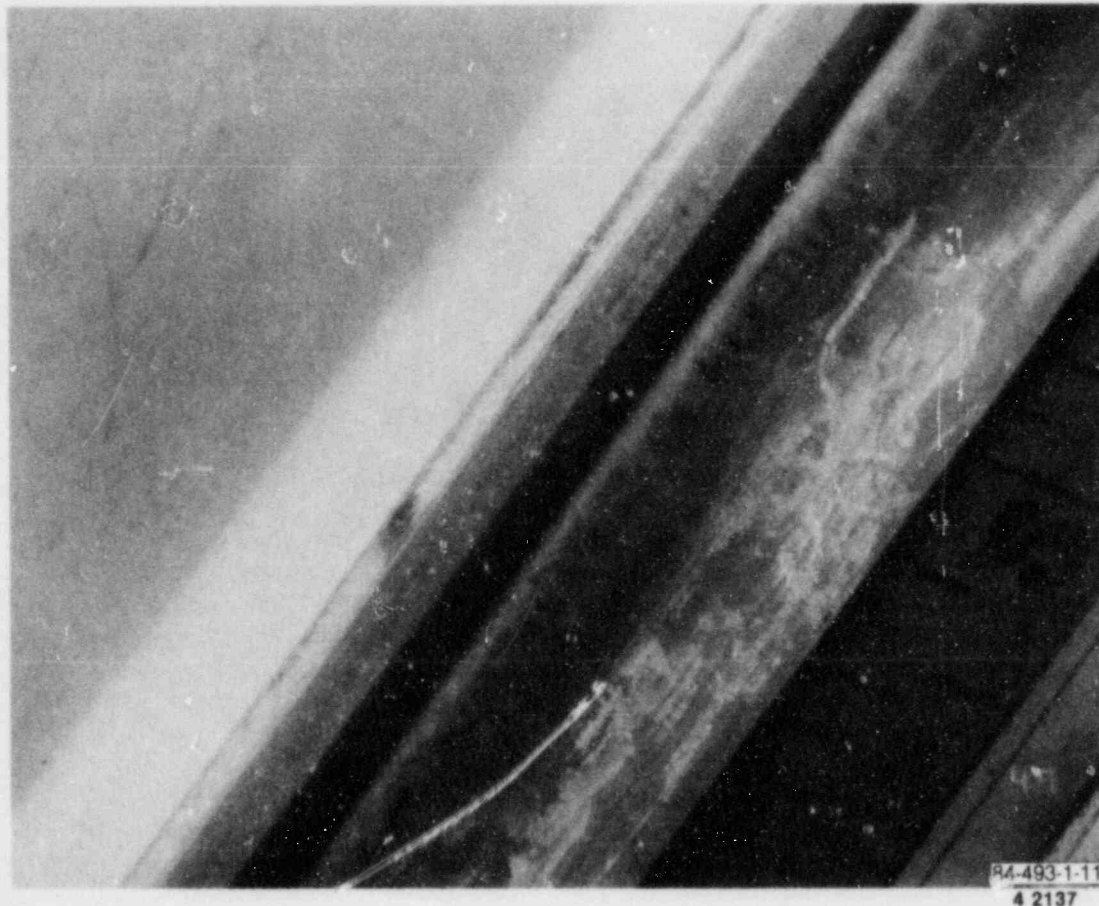
The BWR rods similarly to the PWR fuel rods did not exhibit much crud deposition on the surface of the cladding. An atypical crud deposition is shown in Figure 7.

Figure 7. Typical crud deposits on a BWR fuel rod.

The visual examination indicates that the crud deposition on both the PWR and BWR fuel rods is very small. As a result, these rods may not be typical of heavier crud deposits that may be found on other fuel rods from other plants.

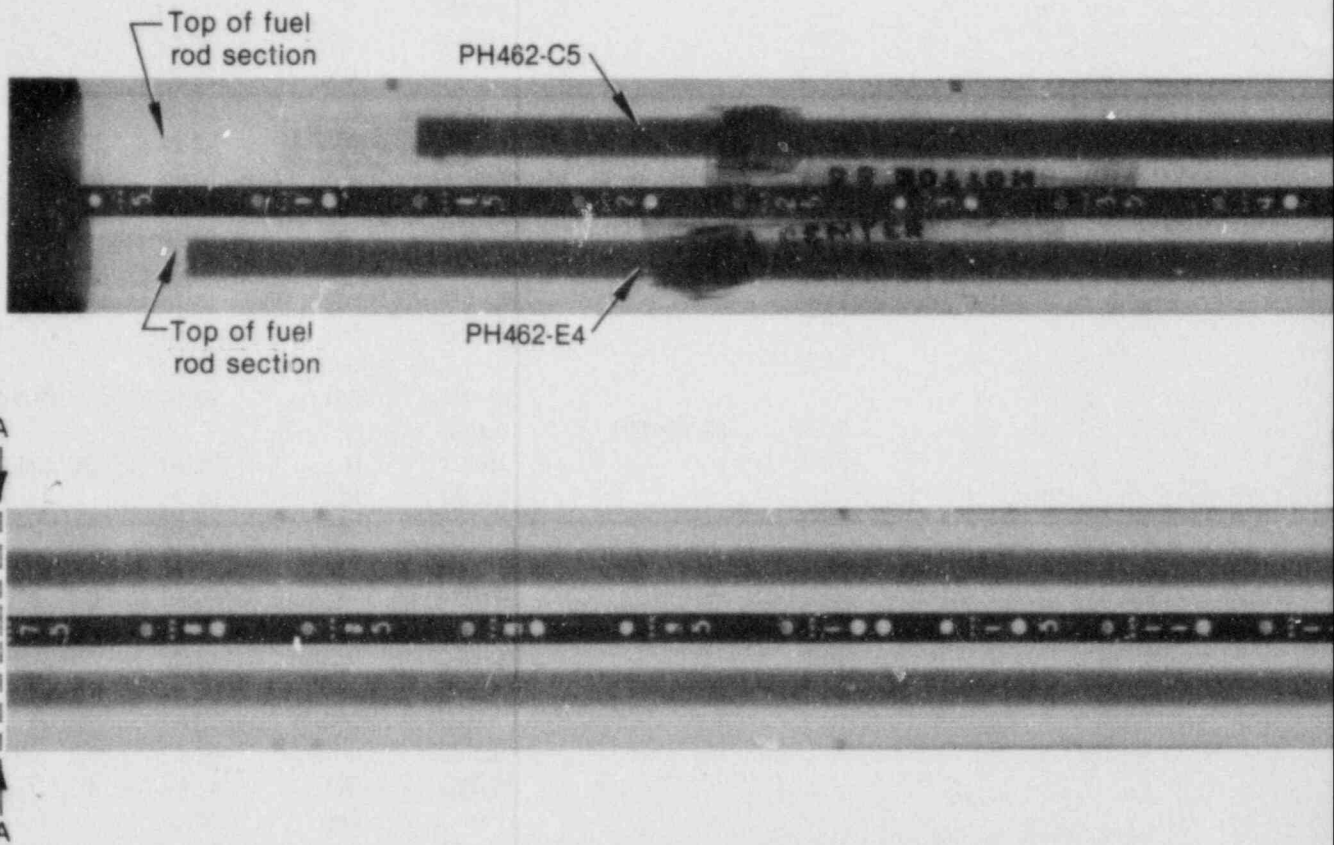
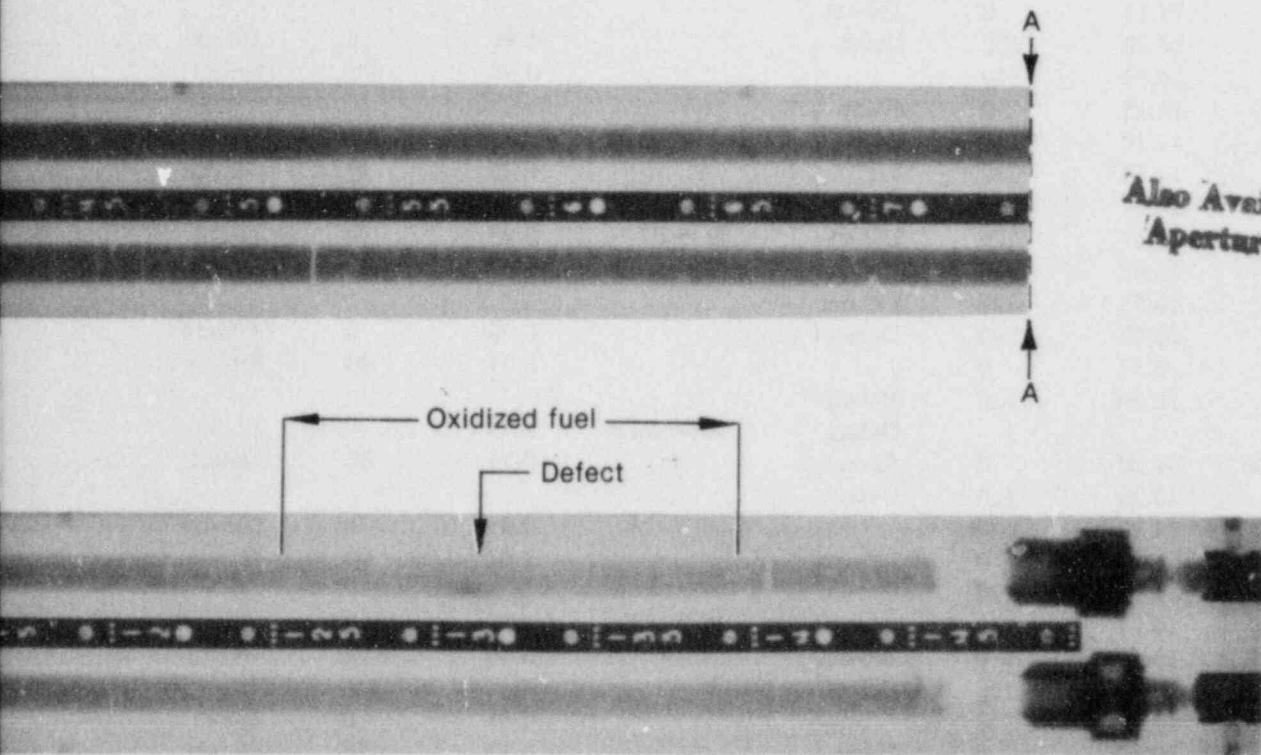
dition, the neutron radiograph of the undefected center section of PH462-E4 is shown in Figure 8. The fuel pellets in PH462-C5 bottom section have distinct pellet/pellet interfaces except in the area of the 1.9-cm crack. At the crack, the pellet/pellet interfaces are not distinct, and the fuel has expanded in this area. About 13 cm of the fuel has apparently oxidized in this area. In contrast, the pellet/pellet interfaces in PH462-E4 are distinct with very little fuel pellet cracking.

Figure 8. Neutron radiographs of PH462-C5

bottom and PH462-E4 center sections.

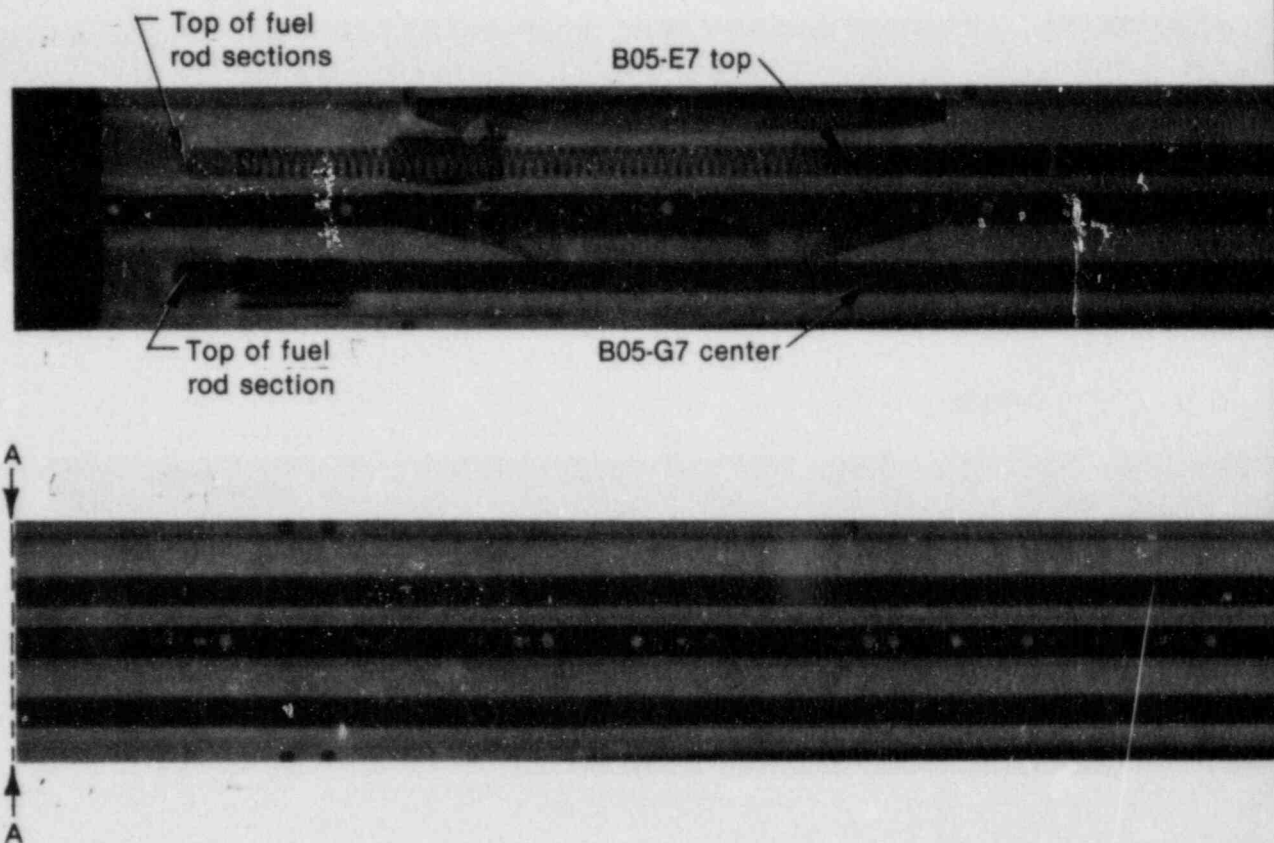
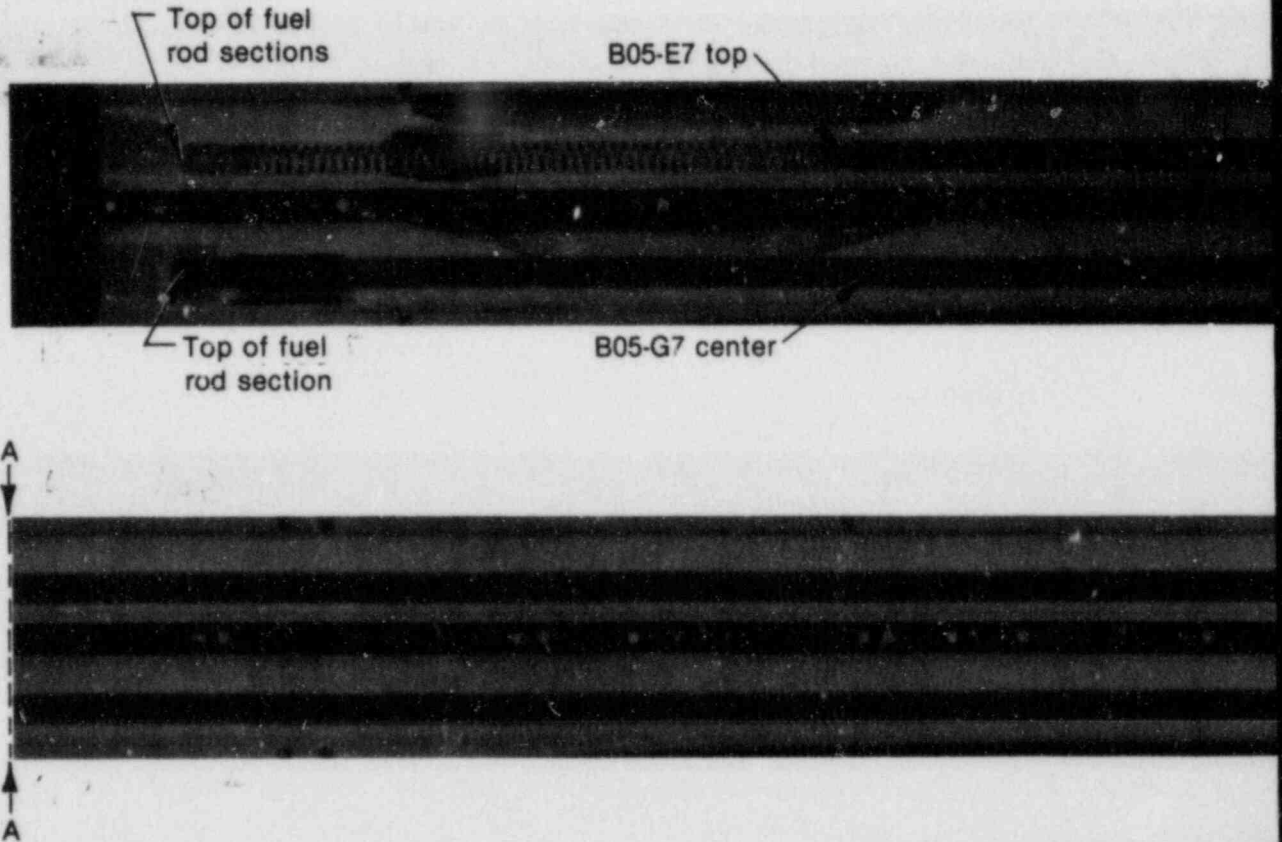
The neutron radiographs for the defected PWR fuel rods are shown in Figures 11 and 12. The radiographs for the sections from the BO5-E7 fuel rod (Figures 11 and 12) and the center section from BO5-G7 (Figure 11) indicate that the fuel is not oxidized. The fuel shows distinct pellet/pellet interfaces with a small amount of pellet cracking in BO5-E7 top section. Some fuel appears oxidized at the defect in the BO5-G7 top section.

Figure 11. Neutron radiographs

of BO5-G7 center and BO5-E7 top sections.

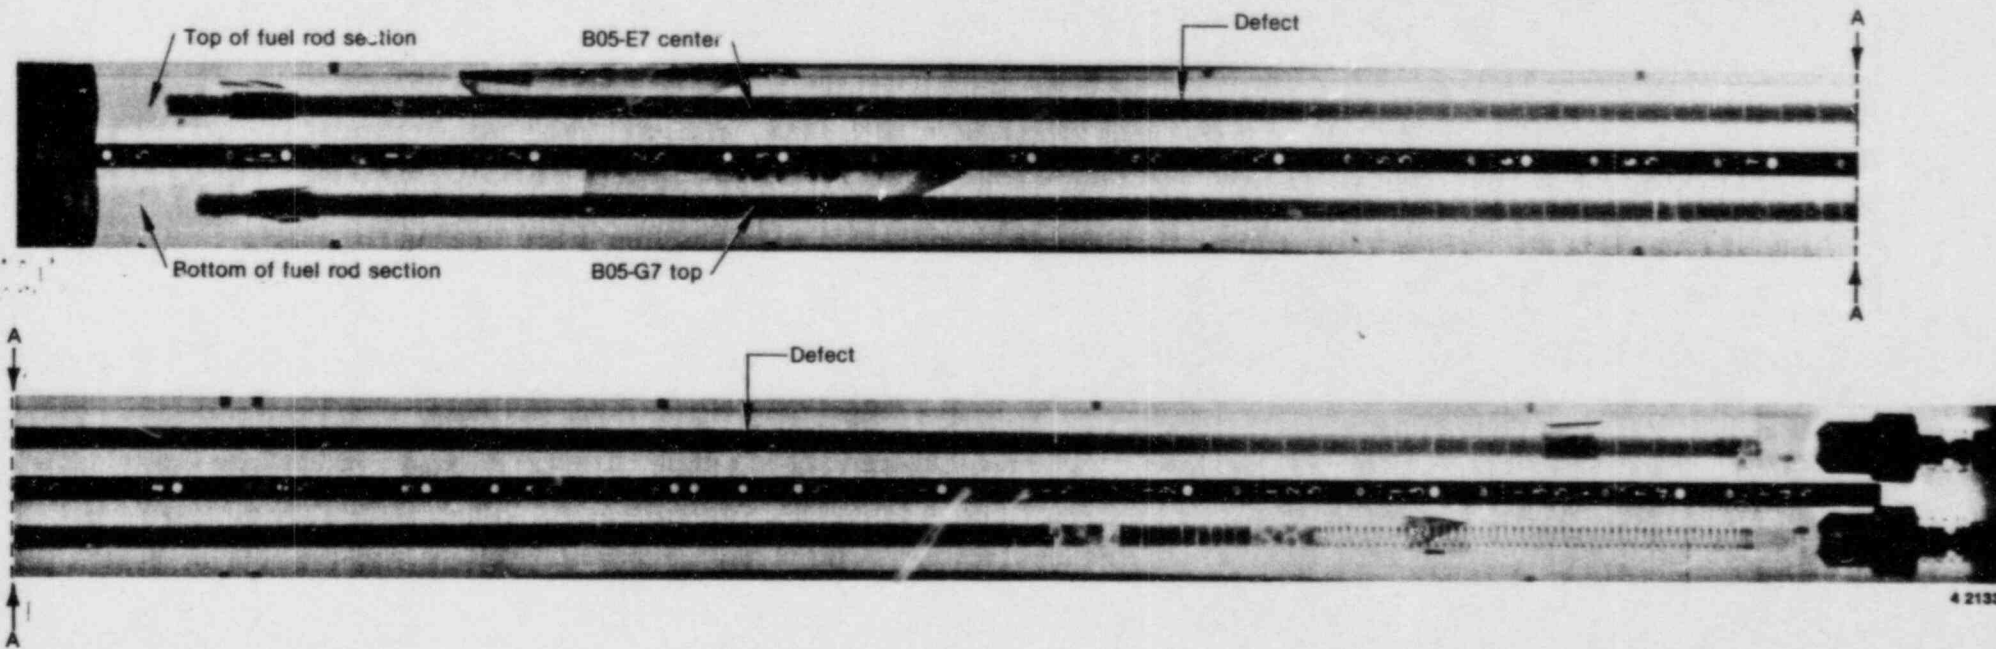
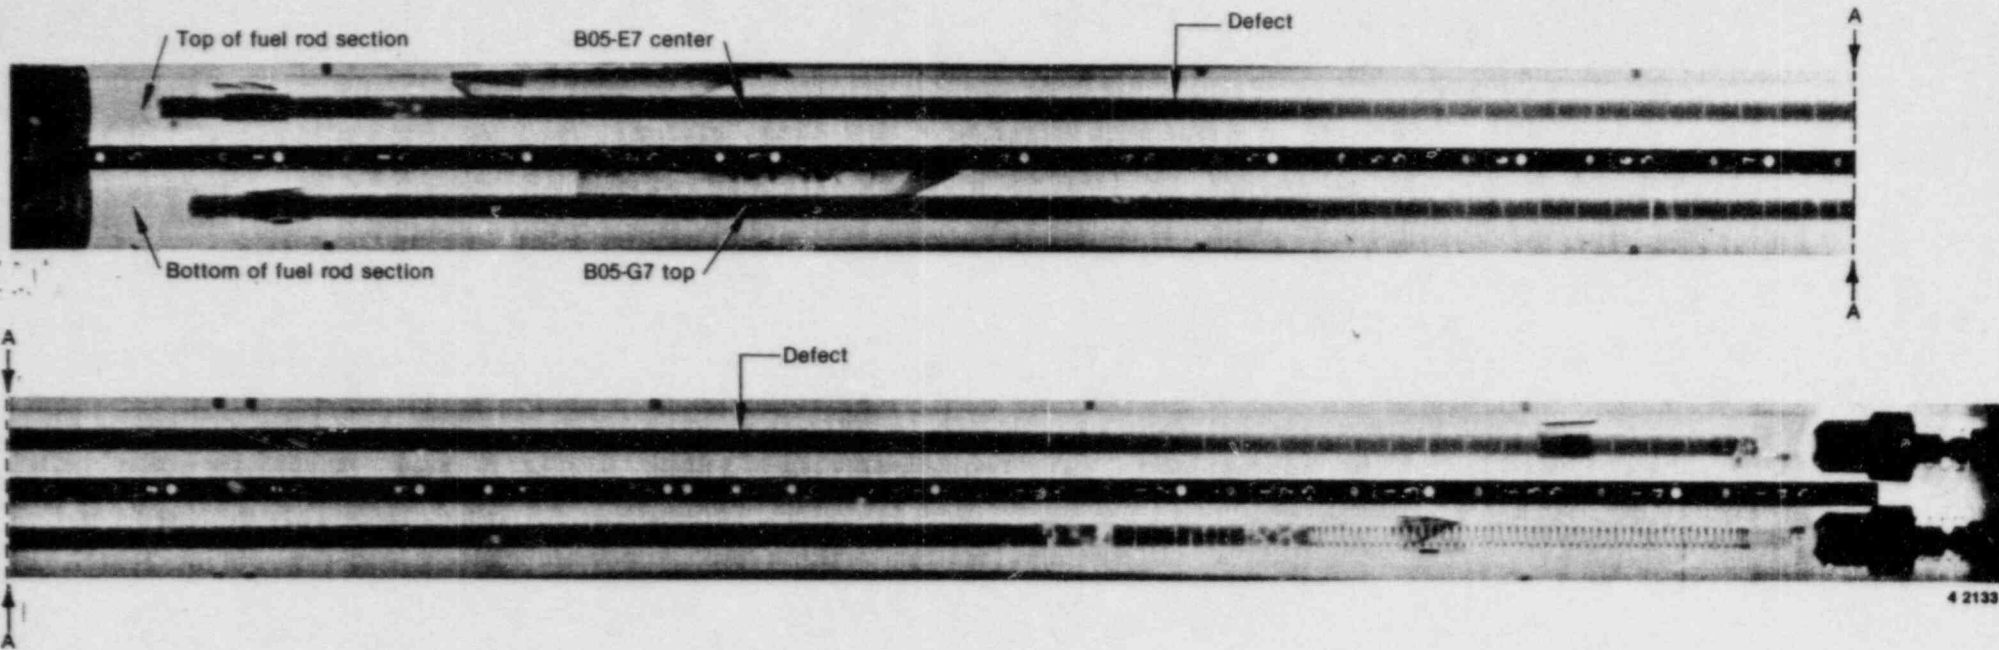
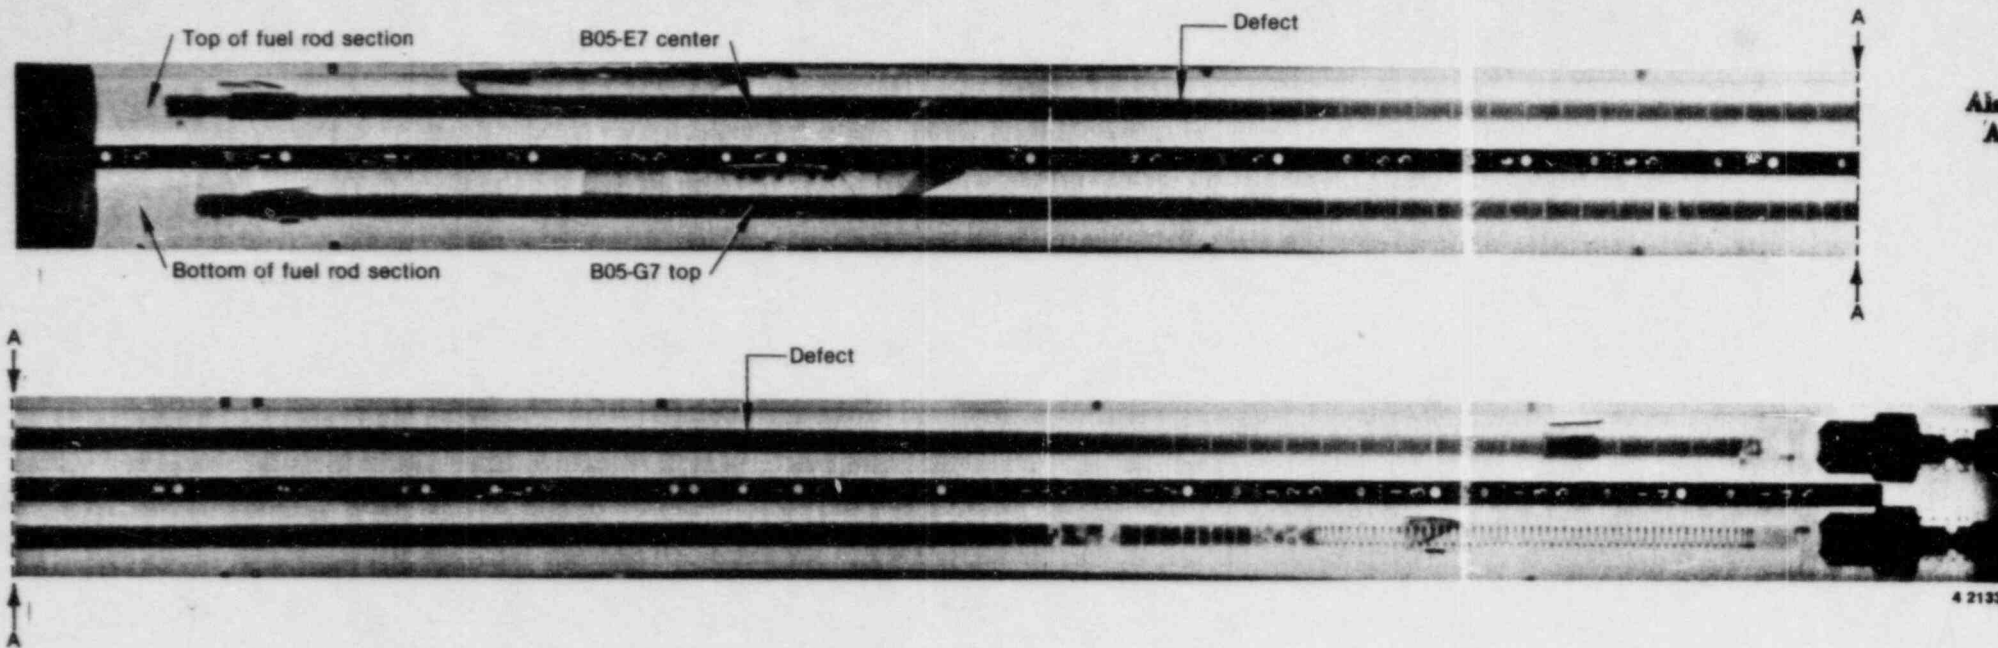
Figure 12. Neutron radiographs of B05-E7 center and B05-G7 top sections.

The neutron radiographs indicate fuel oxidation at the defect of the top section of BO5-G7. The other defects may not have penetrated the cladding.

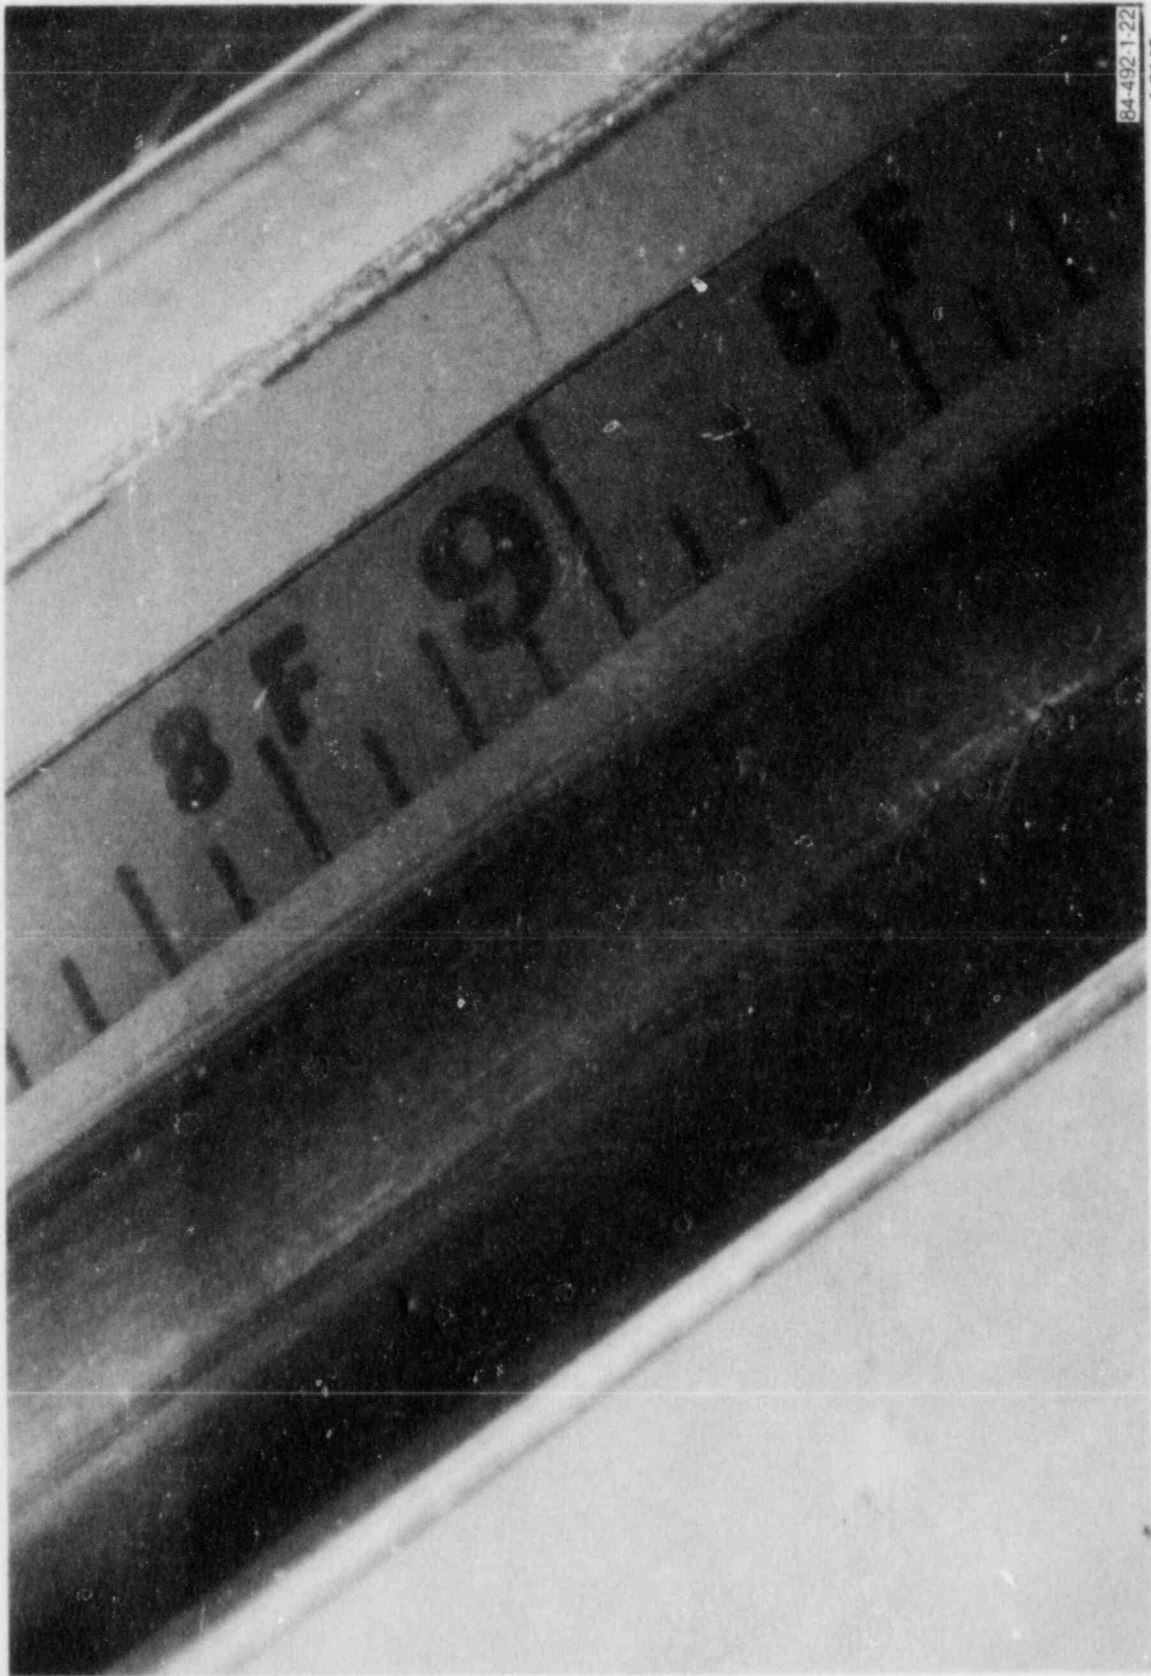
Figure A-1. Defect at 206 cm in B05-G7.

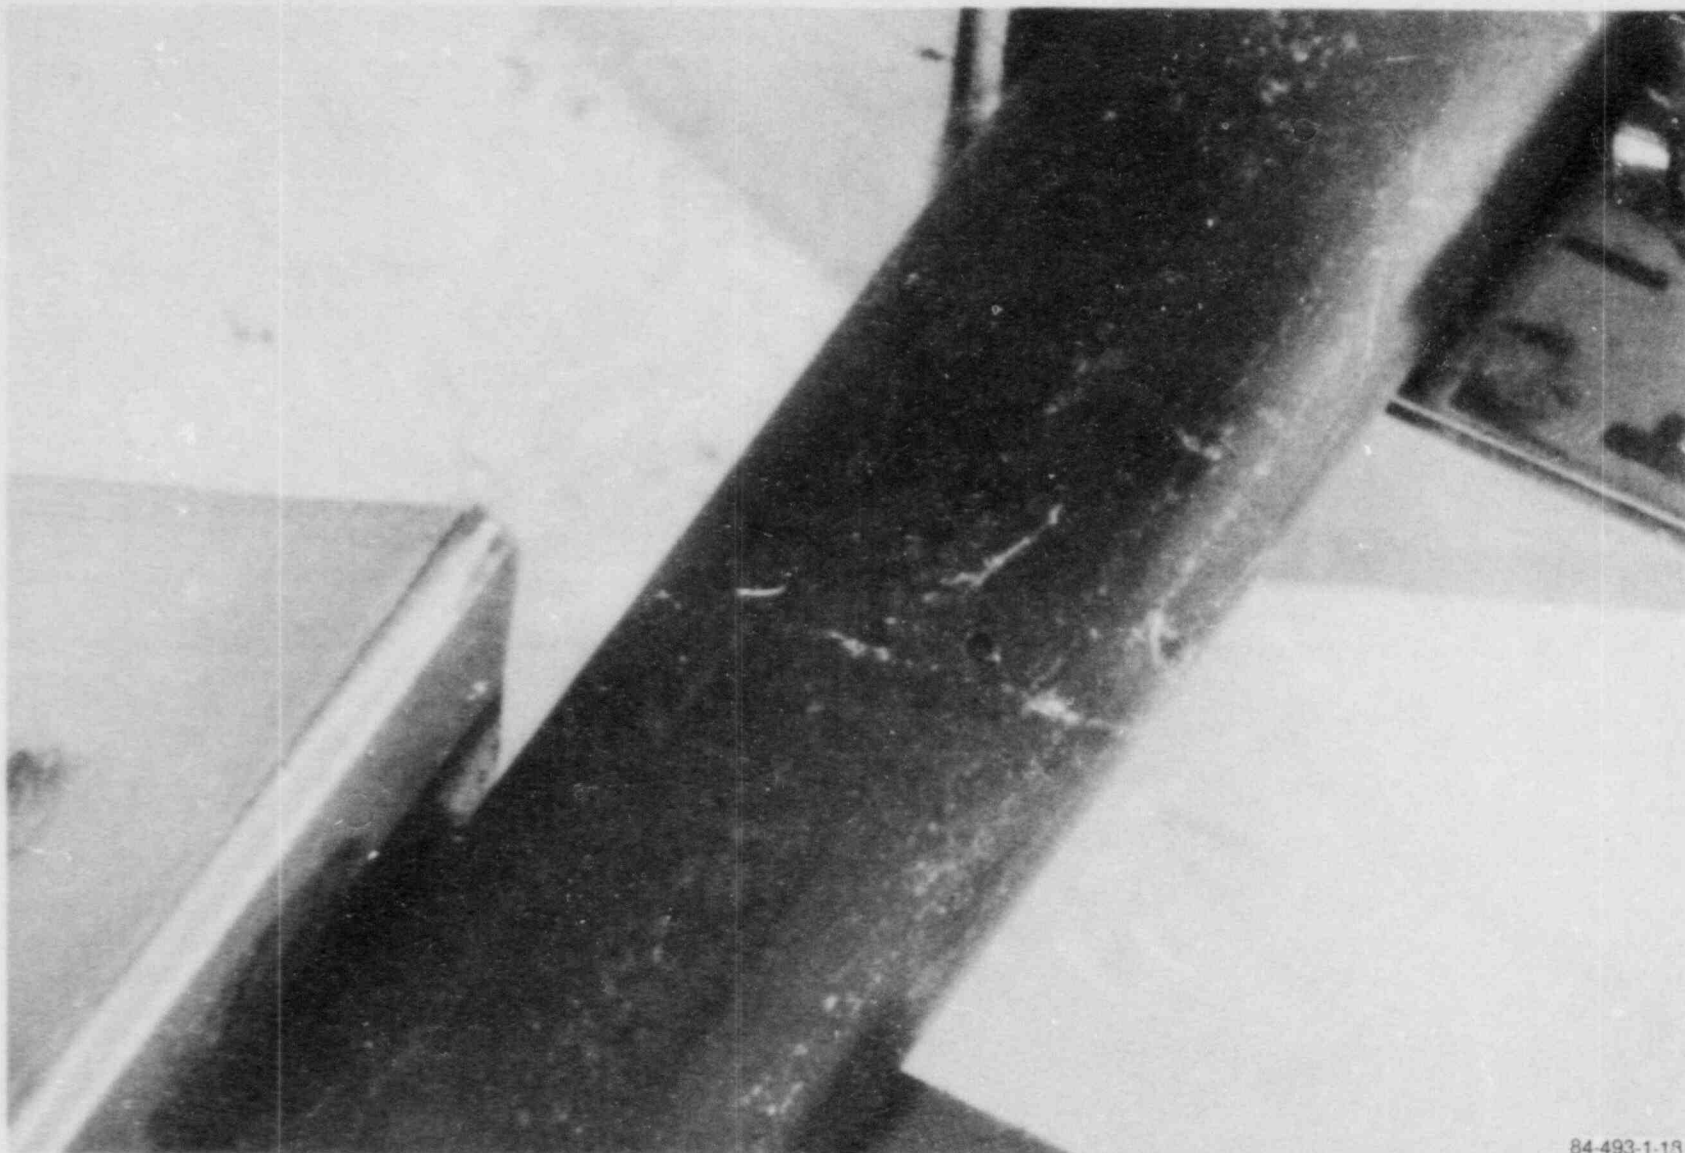
Figure A-2. Defect at 225 cm in PH462-D6.

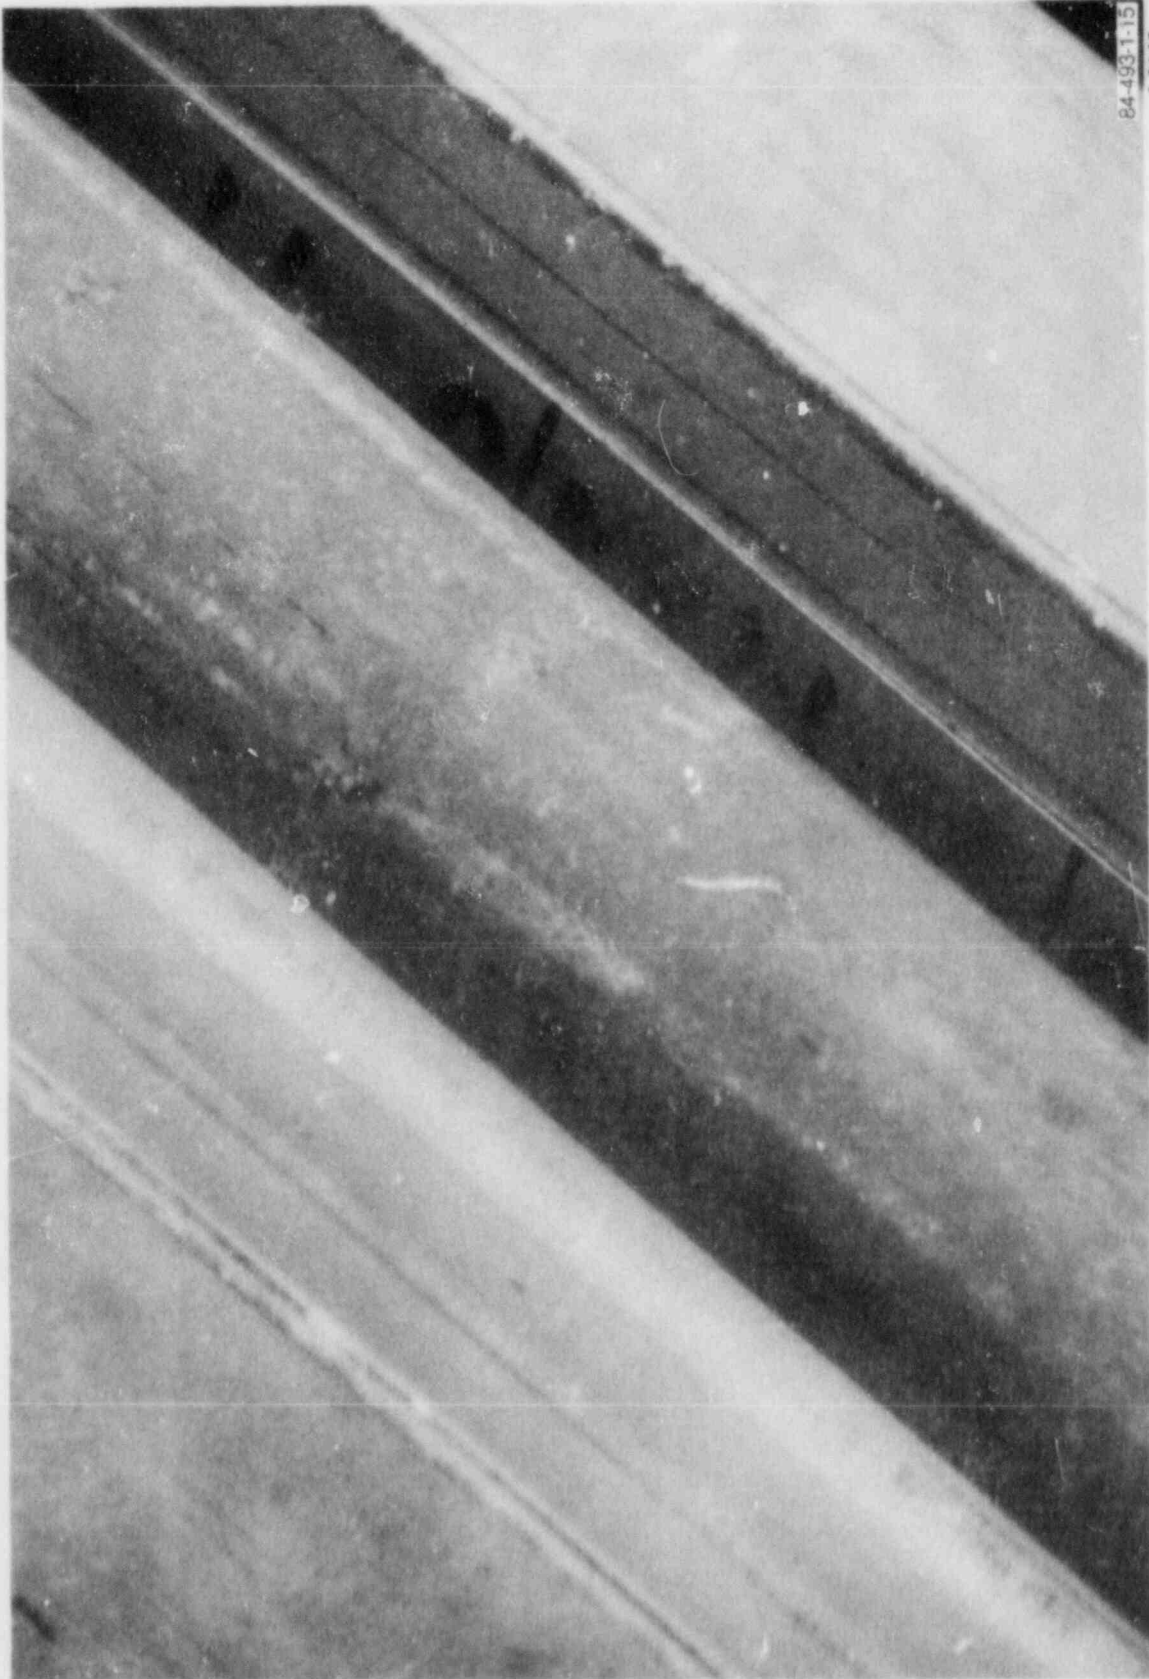
Although the fuel rod diameter indicated no strain, the middle defect in PH462-D6 increased in diameter by 0.13 mm from 0.88 mm measured during the second interim examination to 1.01 mm measured during the third interim examination. The top defect was apparently closed, and measurements indicated nominal defect size.

Figure A-3. Defect at 52 cm in PH462-D6.

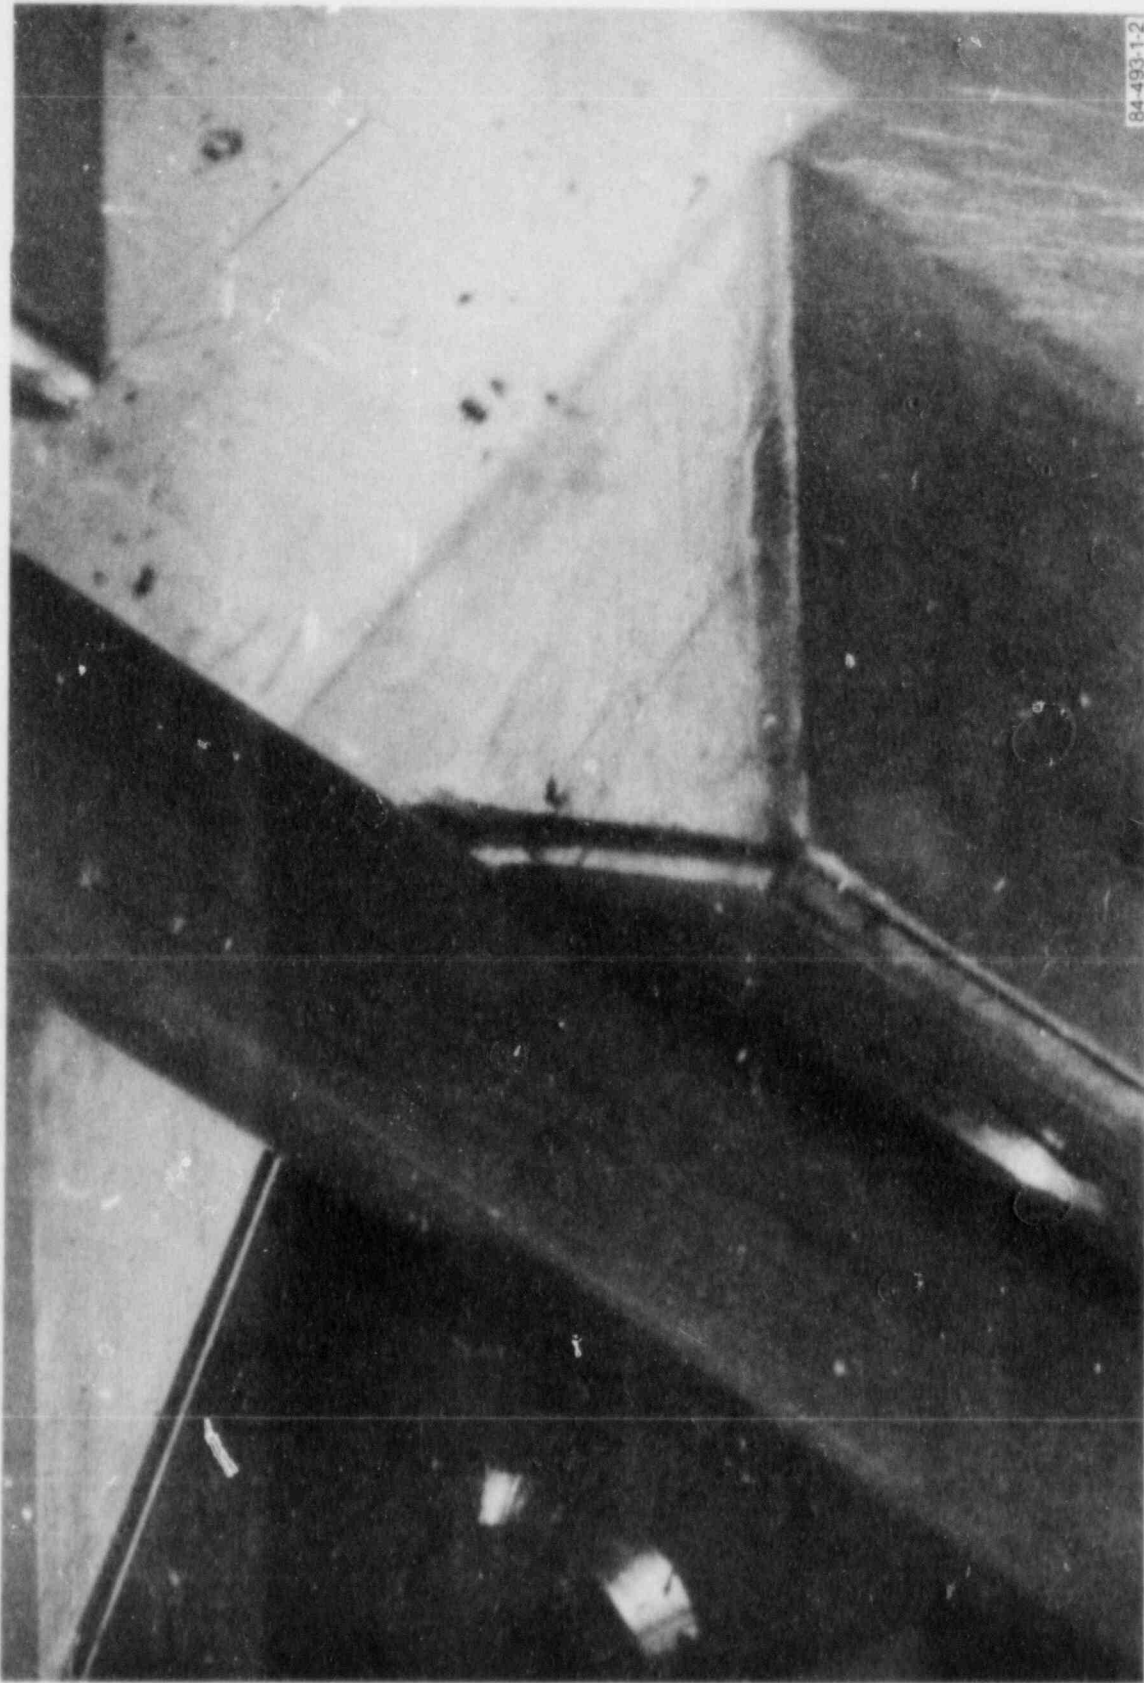
Figure A-4. Defect at 206 cm in BO5-E7.

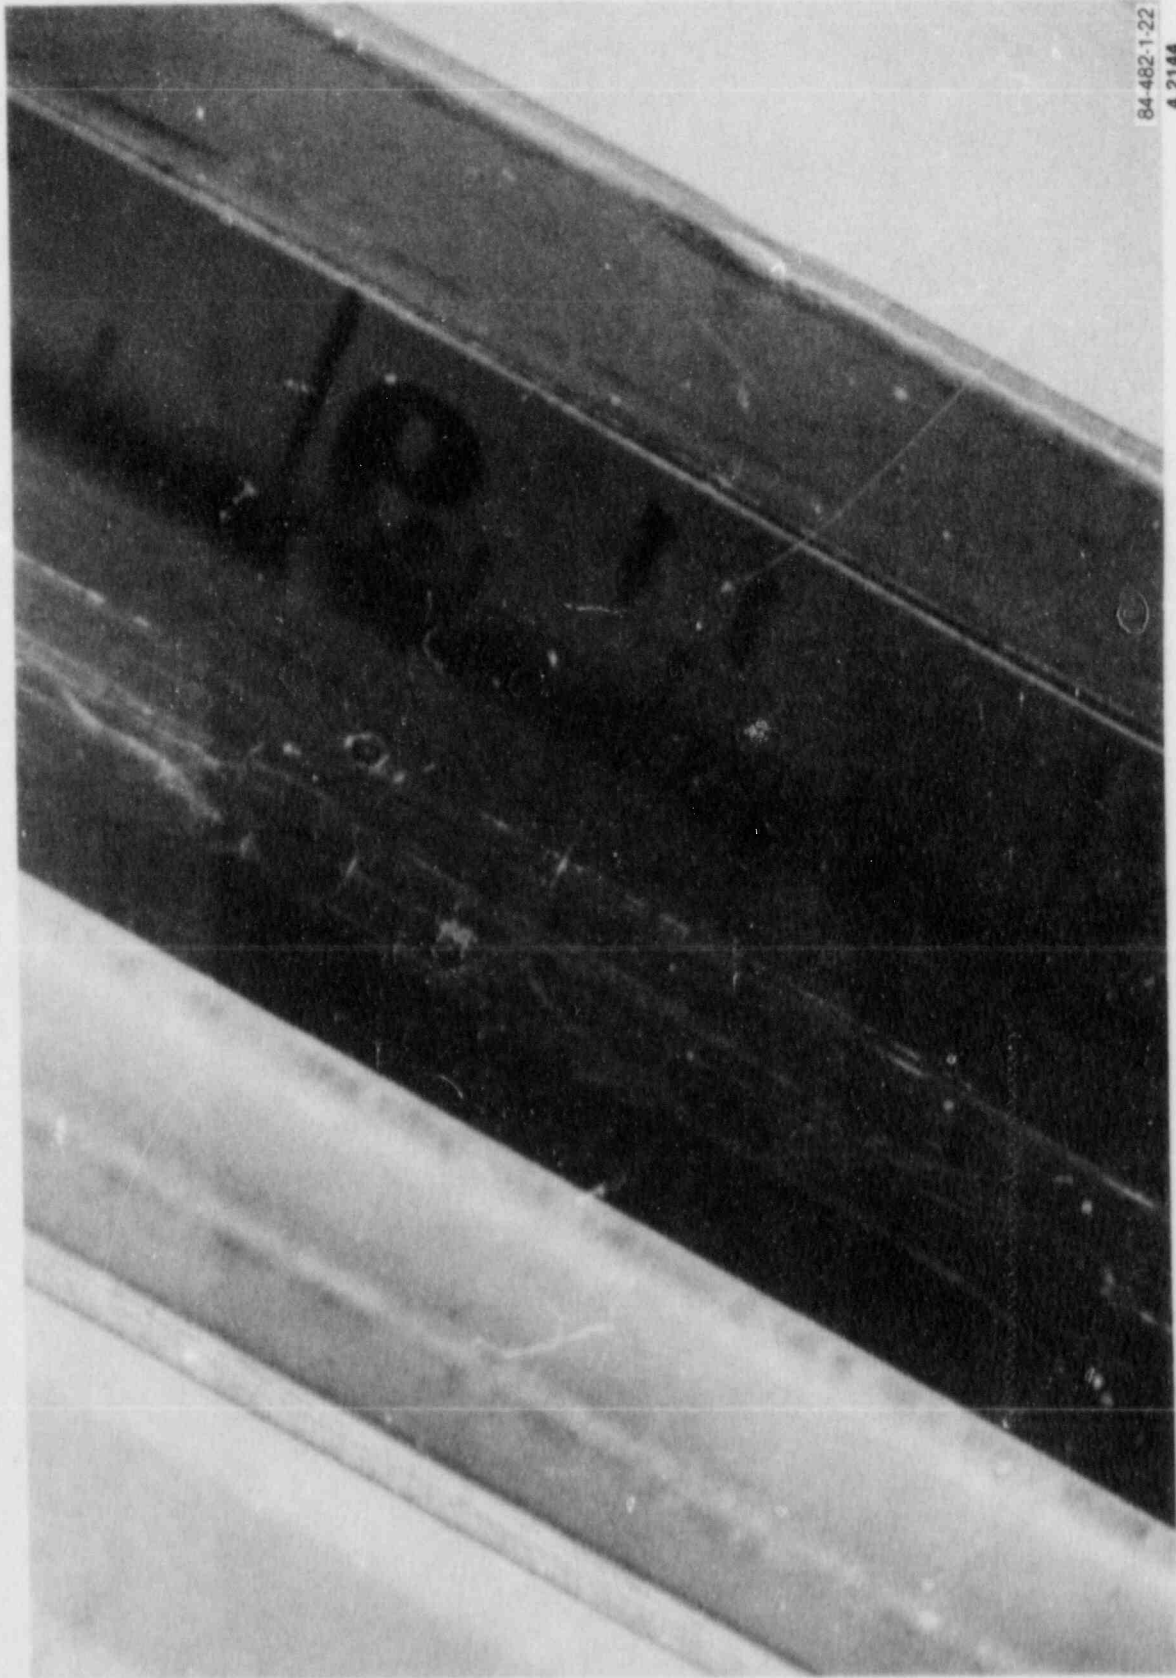
Figure A-5. Defect at 37 cm in BOS-E7.
